Lessons Learned

Tree... Coming Down! Downnnn the Hill! ...

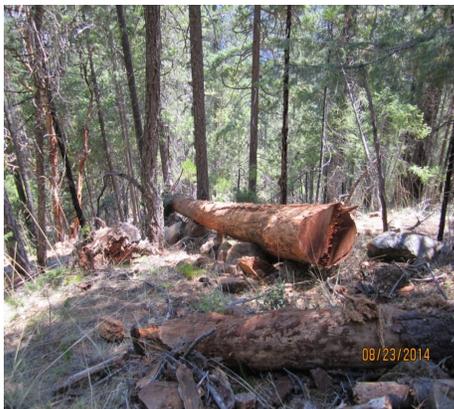
After about 2 hours of work, the lead saw team made up of a B and a C sawyer, had progressed about 300 feet down slope. The next tree they located was a 30" DBH dead sugar pine which had broken off 60-70 feet up, and was about 50' interior of the proposed line location.

The team sized up the "stove pipe" and determined due to its location proximate to other trees, the only option available was to fell the tree straight down the slope. Feeling it was a "straight forward" tree, the C sawyer allowed the B sawyer to fell the tree.

After clearing an escape route to a safe area, the undercut was placed in the tree. Prior to the back-cut being initiated, a warning shout was given, after which the sawyer progressed with the final cut. As the tree fell and impacted the ground, the bole shed its bark and limbs and "rocketed" down the slope. Surprised to see the bole respond in this manner, the saw team shouted additional warnings down the slope.

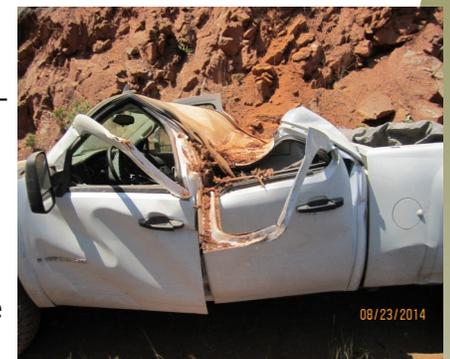
Picking up speed on its downward descent, the tree came off the cut bank, impacting the roof of a pickup truck, and continuing for approximately 200 feet downslope. At the same time the tree was moving downhill, a member of the T2IA crew was retrieving a belt weather kit from

though the vehicle sustained major damage, luckily no firefighters received injuries.

- ***Sawyers need to maintain cutting area control***
- ***When felling on steep ground, use a side hill or quartering felling direction***
- ***Use road guards to maintain cutting area control***
- ***Assure vehicles are parked in an area well clear of felling operations***
