NARRATIVE

On Feb. 12 at approximately 1600 a prescribed fire was being conducted on Mt. Carmel on the Mt. Magazine Ranger District.

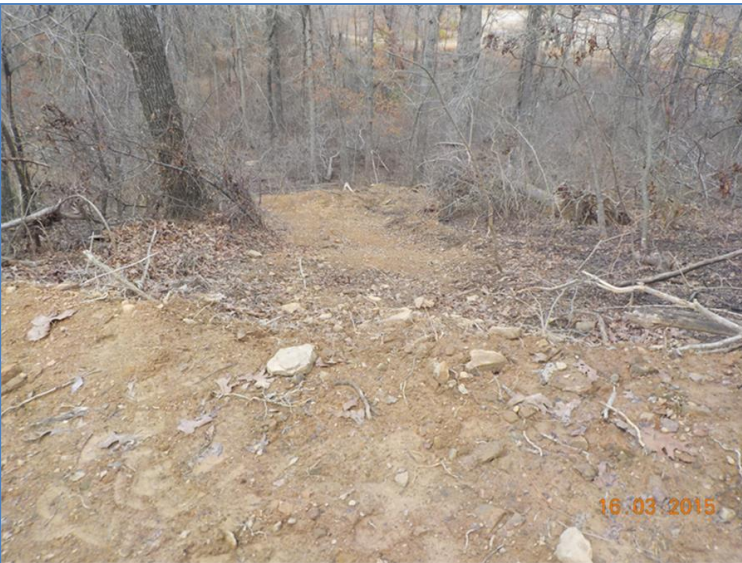
Photo above taken from second water bar looking down the dozer line that the V1 (UTV) drove up.

Approximately 50 yards from that first water bar, they encountered the second dozer-created water bar. Due to this bar's height (approximately 4-5 feet high), W1 realized that he couldn't drive over it.

Once dozer lines are created, attention should be given to water bars with the assumption that a UTV may have to traverse them.

Water bars should not be built extremely high. In this incident, the water bar was approximately 4-5 foot high—making it non-traversable.

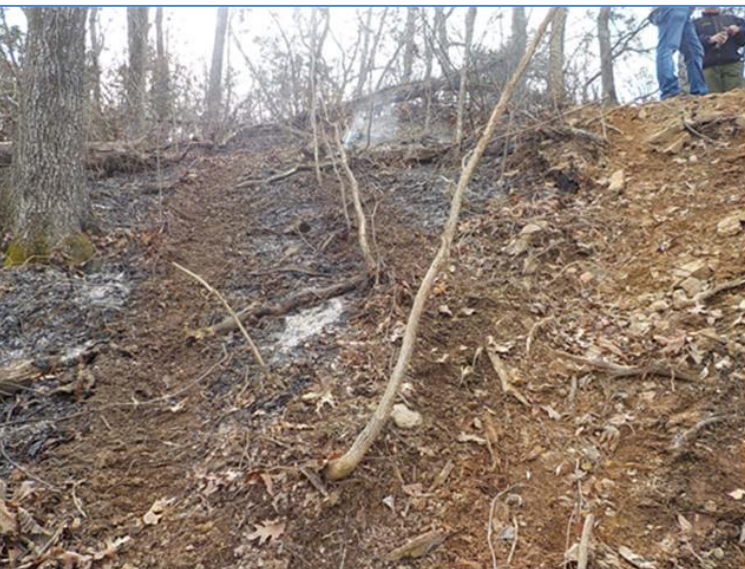
Photo above shows where V1 (UTV) drove into the black to try to go around the second water bar. Photo on right shows the dozer that built the line for this prescribed fire.

Due to the mountain's steep pitch, W1 had V1 fully powered-up. He therefore decided that he couldn't stop to back up—fearing that once stopped the V1 could start sliding back down the mountain. He quickly decided to drive around the second water bar.

Additionally, regardless of how high the water bars are made, the dozer operator should take into consideration that a UTV will have to access the water bar—and ensure that paths are provided on both sides of the water bar for UTVs to drive around it.

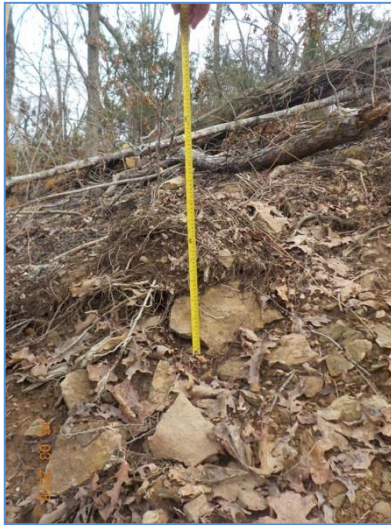
Photo on left shows the height difference between the wood line and dozer line—an approximate 14- to 16-inch drop. Photo on right is the UTV that was involved in this incident.

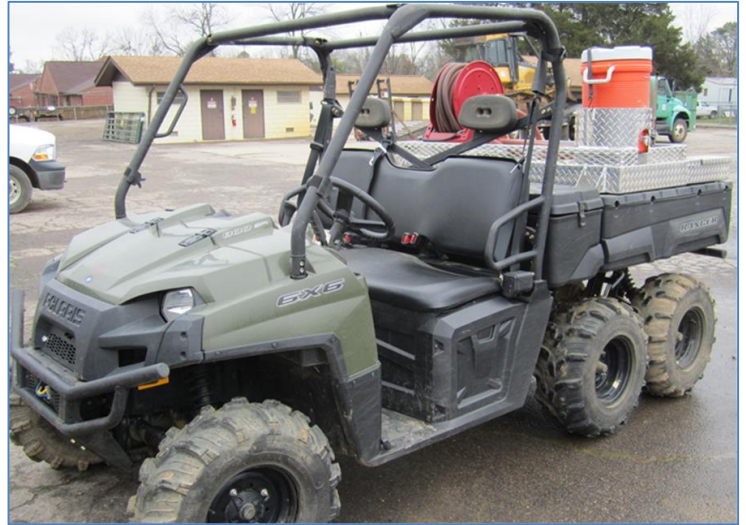
Next, V1 started teetering from right to left. When the vehicle's right tires finally touched the ground—because they were spinning at a rapid rate of speed—the wheels grabbed the ground quickly and V1 teetered to the right. The momentum made V1 roll to the right and do one complete revolution, landing back upright on its wheels.

The Forest Safety Officer observed the UTV at the work center. There was no visual damage to the vehicle. The UTV was started and ran with no issues. Seatbelts prevented death or serious injuries.
