WAMPEE BAY INCIDENT REVIEW

Wampee Bay Fire
Baker County, Florida
June 18, 1988

WAMPEE BAY FIRE SHELTER DEPLOYMENT INCIDENT

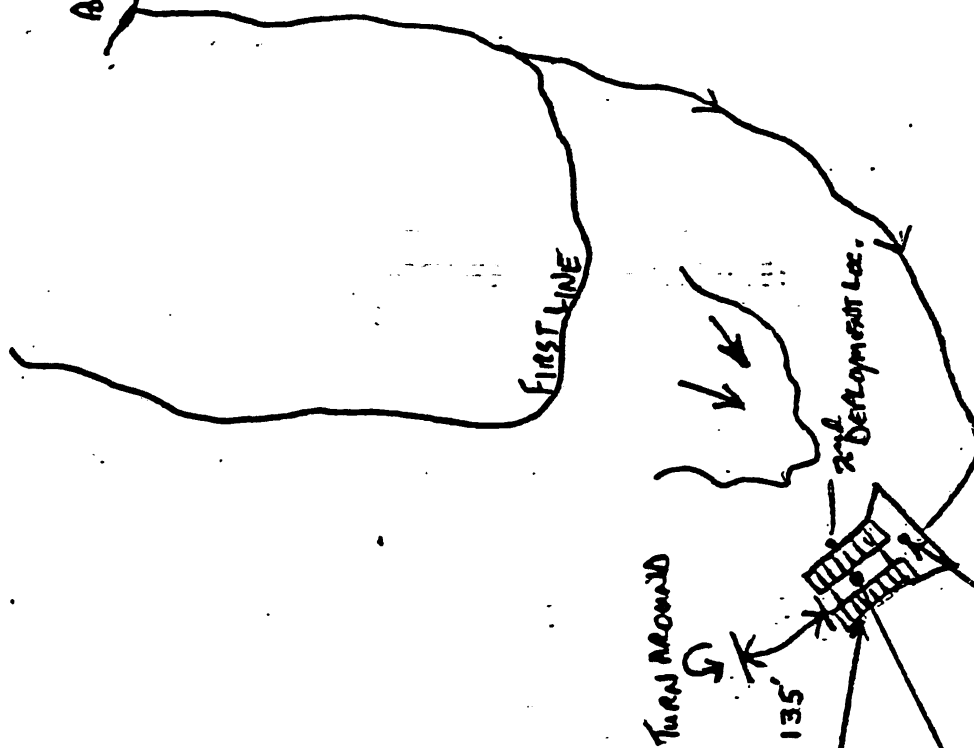
MAP # 3
WAMPEE BAY FIRE
6/19 - 6/21

ESTIMATE P.O.B. TO
TRACTOR LOCATION
~ 1300 FT.

POINT OF
BEGINNING

2nd DEPLOYMENT LOC.

FIRST DEPLOYMENT LOCATION

2 MEN - 1 SHELTER
APPROX. 30 MIN.
