ACCIDENT PREVENTION BULLETIN

No. IA APB 12-01

Date: May 31, 2012

Subject: Wind Effects on Idling Rotorcraft

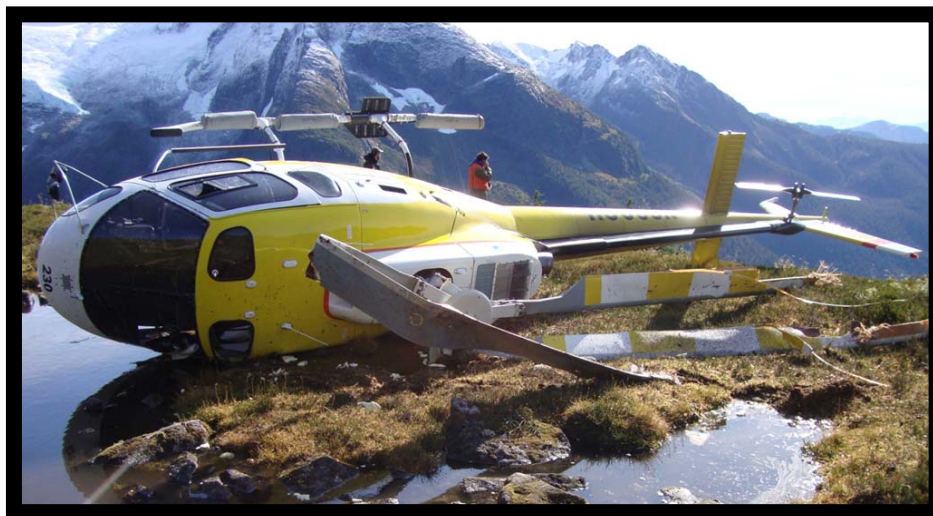
Discussion: In September, 2011 a Eurocopter AS-350BA sustained substantial damage after winds caused the aircraft to lift up and roll over on a ridgeline despite the engine operating at idle RPM ([NTSB # ANC11LA108](#)). The aircraft had landed on the top edge of a steep slope where winds were forecast to be strong and erratic due to an arriving low pressure system over the area. The National Weather Service (NWS) forecasted the surface winds at 35 – 45 knots however, NWS hourly observations from 3 different observation locations indicated maximum velocities ranging from 10 - 29 knots.

In an effort to better understand how this accident occurred, Eurocopter simulated the event with a similar aircraft of the same weight, rotor speed and other environmental features including surrounding terrain (based on pictures supplied from the accident site), landing surface, and winds. The simulation revealed that the aircraft could be lifted off the ground with a wind speed of as little as 37mph (32Kts) when the impact angle struck from below the rotor disc. As the relative wind angle moves upward toward a level plane with the rotors, the wind velocity required to lift the aircraft increases.
