The Story and Lessons from a Dozer Tip-Over Incident

Narrative

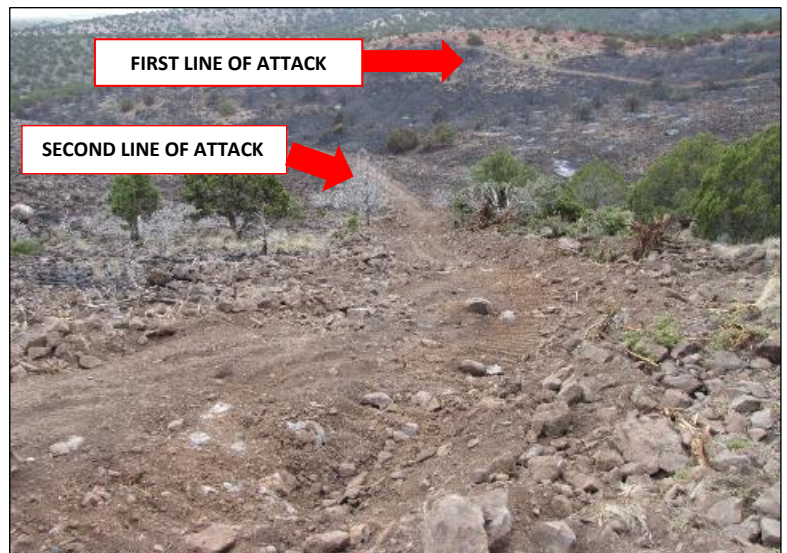
Photo shows the first and second fire lines ascending the ridge.

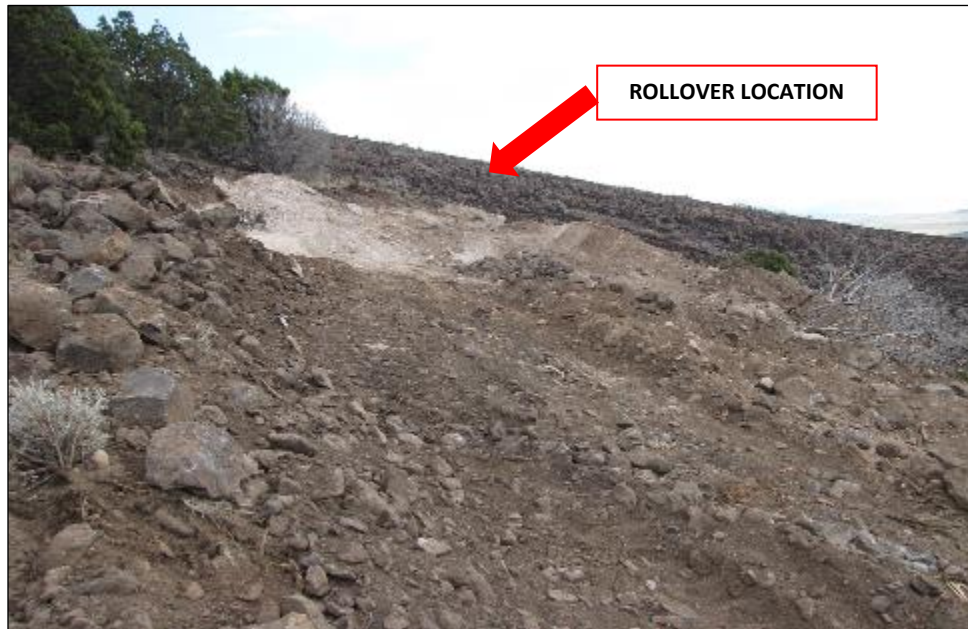
FIRE LINE AS THE OPERATOR BEGAN TO TRANSVERSE THE HILL

It was at this point the rollover incident took place. The operator reported: *"What happened was the fire line took a dogleg upslope. There was a tree in the bottom on the dogleg. I pushed this tree over, then backed up to pick my line back up and construct line uphill. I believe that with traveling on this section of line twice broke up the rock stability underneath me. As I started to push line where I had just drove twice, the rocks and the dozer started to slide. While starting to slide, I tried to turn downhill and was unable to. I continued to slide until I slid off the rocks and with that momentum it tipped the dozer onto the side."*

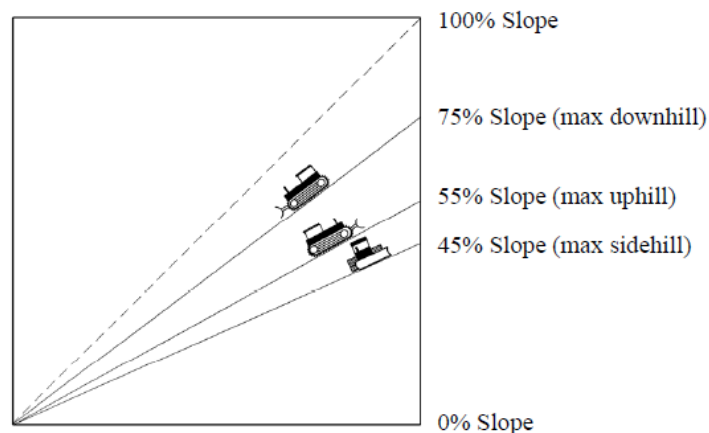
Figure 1 – Guideline for Maximum Percent Slope Dozer Operation

The U.S. Forest Service's Dozer Boss Pre-Course Work training course, Appendix D states: *"As with any piece of specialized equipment, the dozer has limitations. As a general guideline, dozers should not be operated across slopes (sidehill) greater than 45 percent, uphill slopes greater than 55 percent or downhill on slopes greater than 75 percent (see Figure 1)."*

All sections of dozer line were under these general guidelines for operation. However, the rock accumulation presented a hazardous situation and an angle beyond the stability point of the dozer as it slid off the rocky bed.

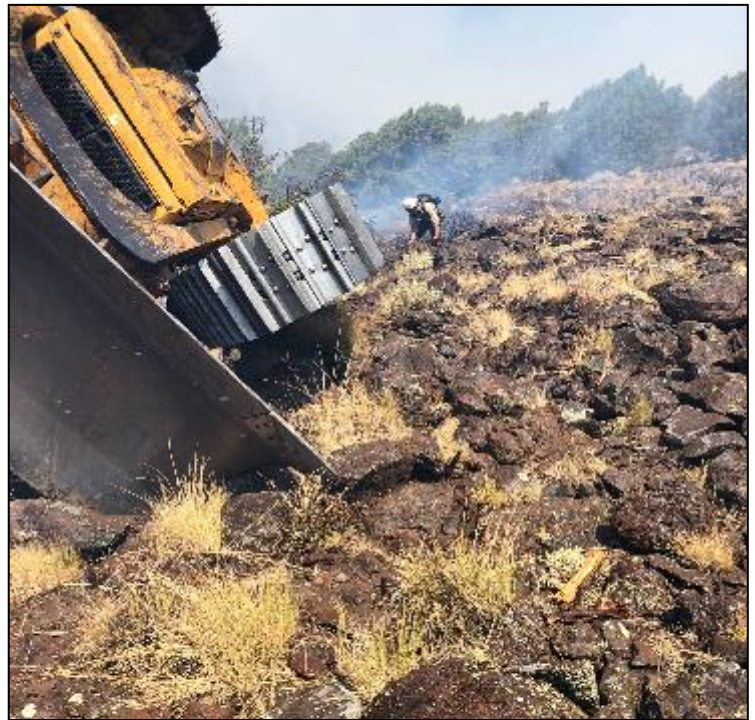
On August 23 at approximately noon, an agency owned and operated 486C Caterpillar dozer tipped over onto its side while constructing fire line on the Baboon Fire near Minersville, Utah. The operator was unharmed and able to safely exit the dozer after the rollover occurred. Damage to the equipment was mostly cosmetic, denting the side panel and diesel tank.

The overturned dozer.

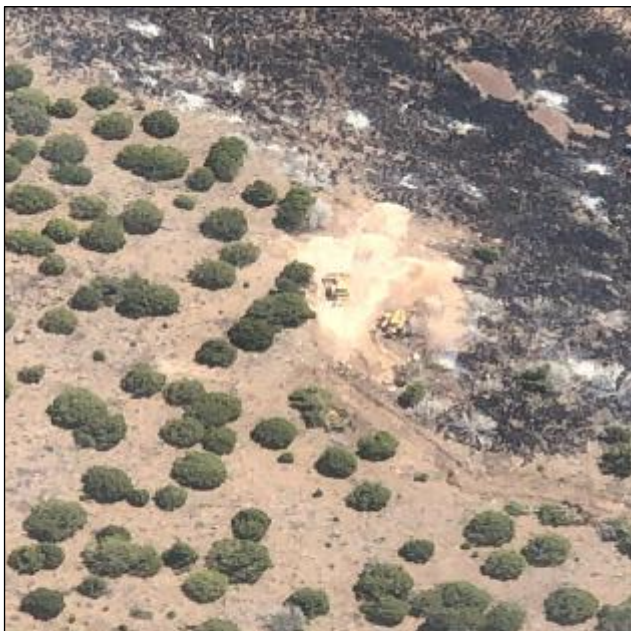
The county dozer responded to the agency dozer tip-over incident, created line between the overturned dozer and the fire, then up-righted the dozer.

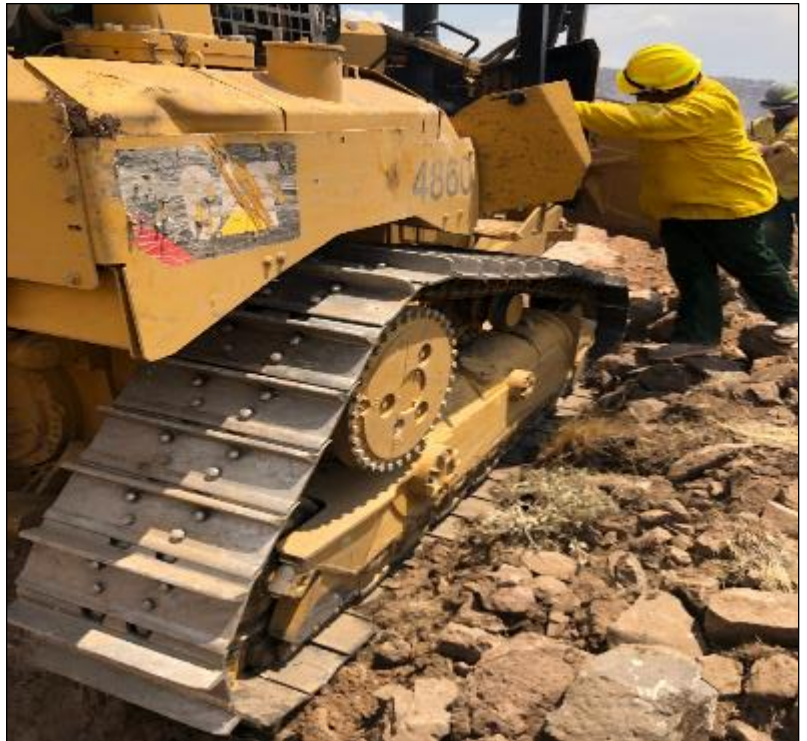
The up-righted dozer.
