BUREAU OF INDIAN AFFAIRS

Incident within an Incident, (IWI) *Lessons Learned Review*

Silver Creek Motor Vehicle Accident

Williams Flats Fire - August 12, 2019

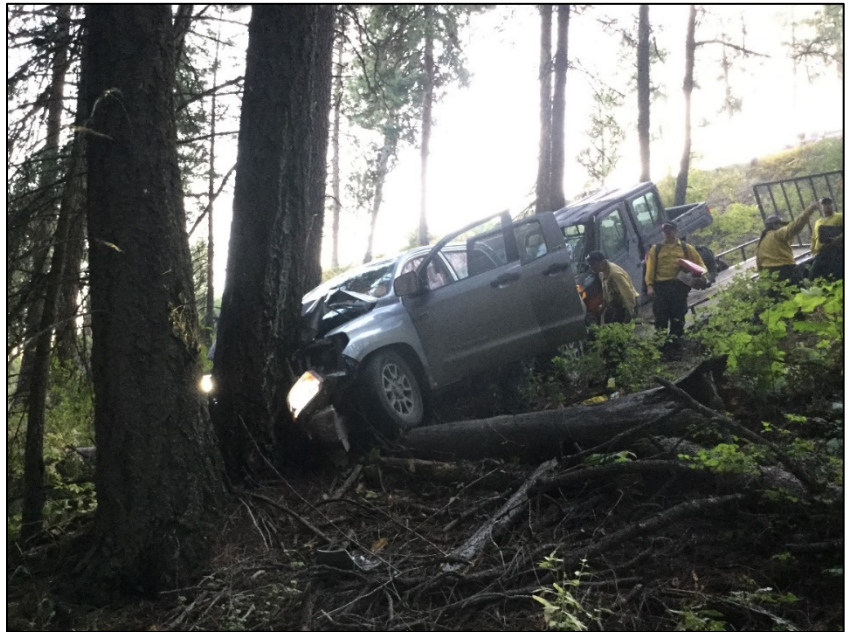
*Vehicle traveled 125 feet before impacting a large tree at the bottom of a drainage.
Photo by: BIA*

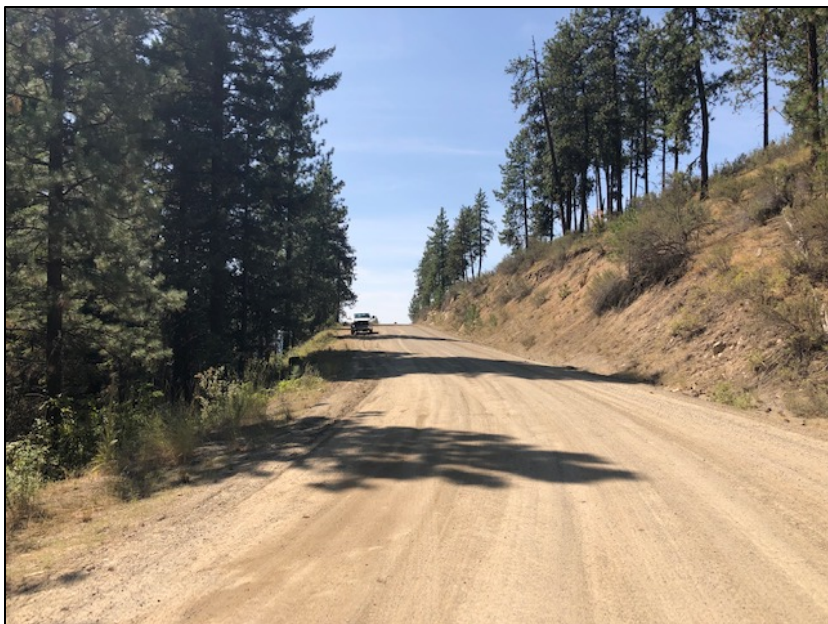
Photo shows the direction the vehicle was traveling prior to the accident.

The parked truck shows where the vehicle left the roadway.

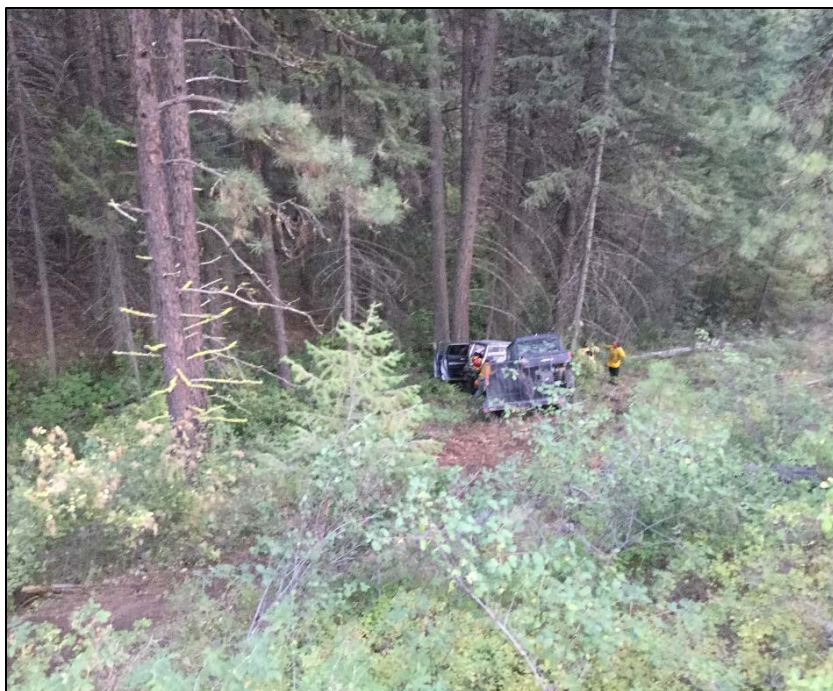
Visual from roadway overlooking the drainage the vehicle traveled down.

Notice the slope steepness (~50%) and the direction of travel.

Also visible is the hand line the fire crew constructed to assist with packaging and transporting the firefighter 125 feet up to the roadway.

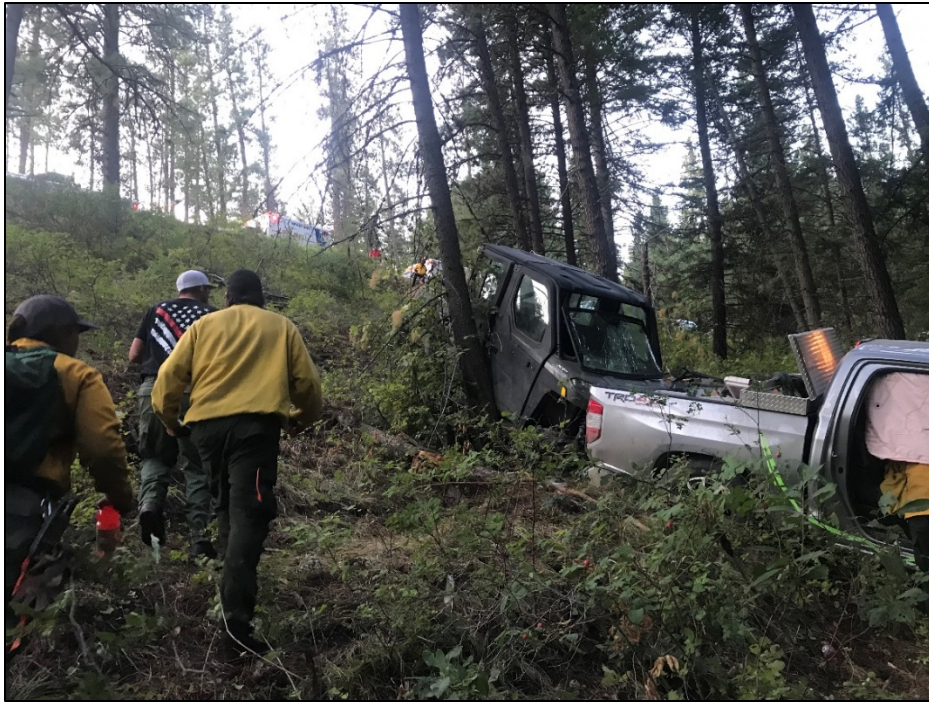
The UTV impacted the rear of the pickup truck.

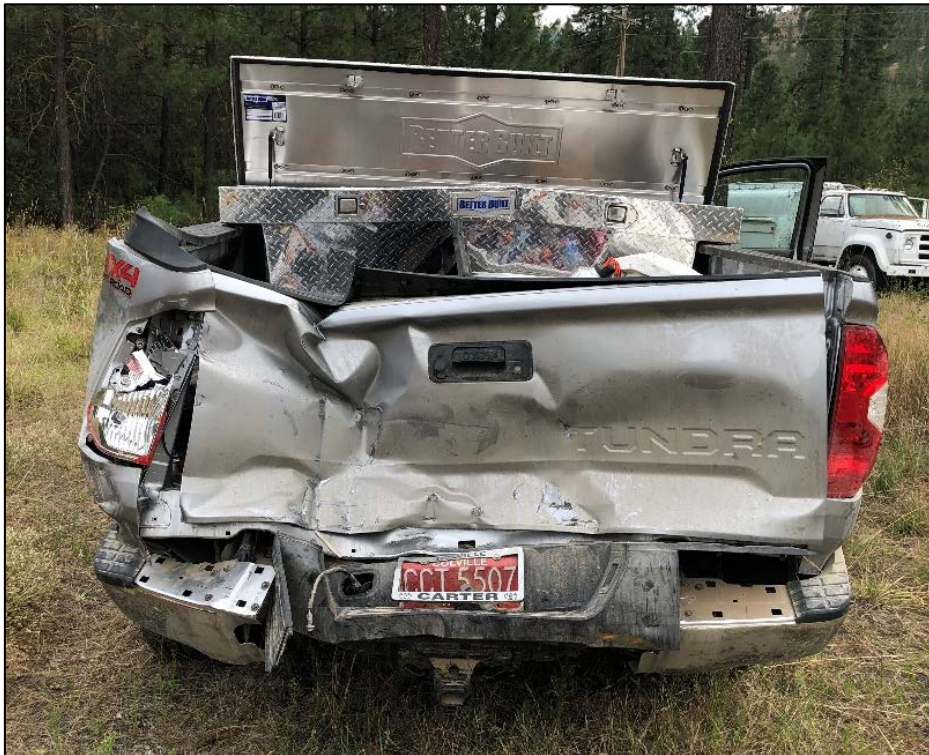
Damage to the rear of the pickup truck showing where the UTV impacted after departing trailer.

Gear in the bed of the truck damaged the truck box upon impact.

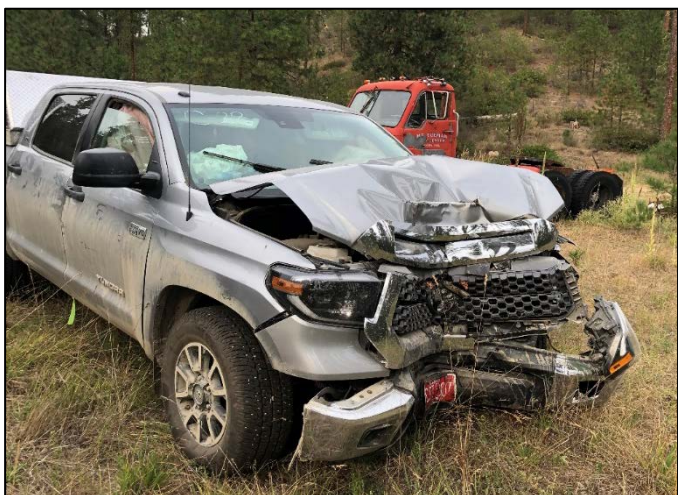
Damage resulting from impact to tree, which was approximately 28" diameter at breast height (DBH).

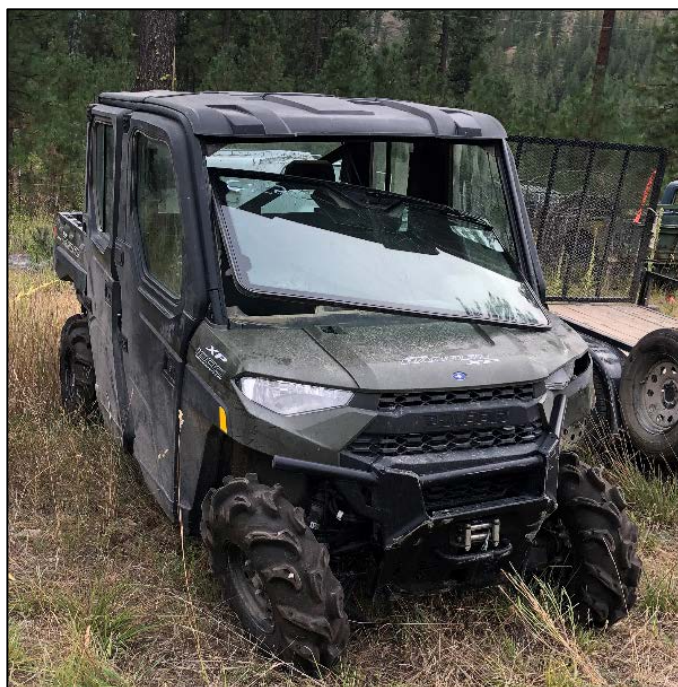
1. The four-passenger UTV was secured to the trailer utilizing only the front winch of the UTV. No other tie-down straps were used to secure the UTV to the trailer.
2. Three of the four passengers were wearing seatbelts.
3. No documentation regarding UTV training or trailer towing was available for review and "UTVO" UTV Operator was not listed on red cards. Individuals involved were not aware of the requirement to complete UTV training.
4. Multiple vehicle occupants stated that speed, complacency, and fatigue may have been contributing factors.
5. The road was well maintained; however, the road was "wash boarded" when accident occurred.
6. The crew traveled this road multiple occasions prior to the accident occurring.

Damage to UTV.

NOTE the winch cable, only mechanism utilized to secure UTV to trailer, snapped on impact.

1. Implement programmatic trailer towing training annually to all drivers who will tow a trailer, with emphasis on how to secure loads.
2. Implement annual driving policy, per BIA Driving Policy, and ensure all drivers are approved to operate a vehicle. Ensure all training is documented and documentation is available for compliance review.
3. After successfully completing UTVO training, document it and ensure it is listed on individuals red card, per Chapter 14 of the Interagency Standards for Fire and Fire Aviation Operations.
4. Ensure medically trained personnel are equipped with the appropriate gear, commensurate with the training and scope of work. Backboards are not required gear, but many crews elect to carry a type of backboard to assist with patient transport.

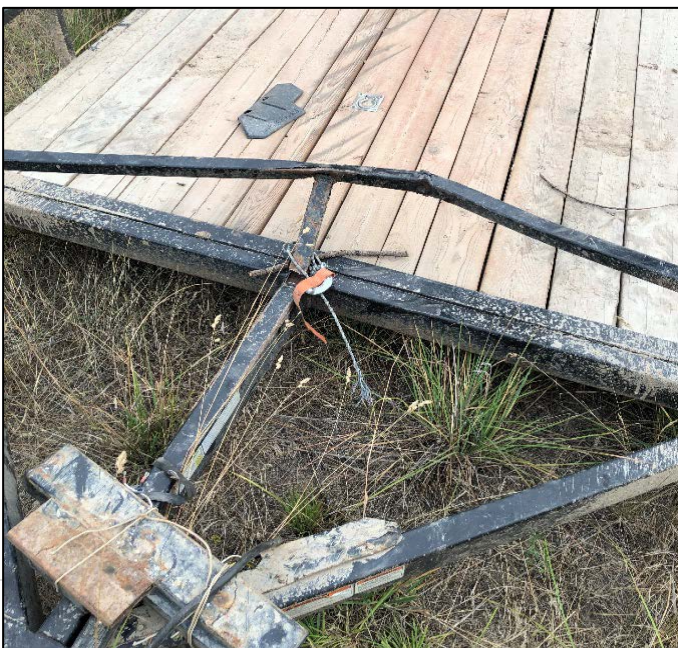
Damage to trailer.

NOTE the winch hook and remaining section of snapped cable.

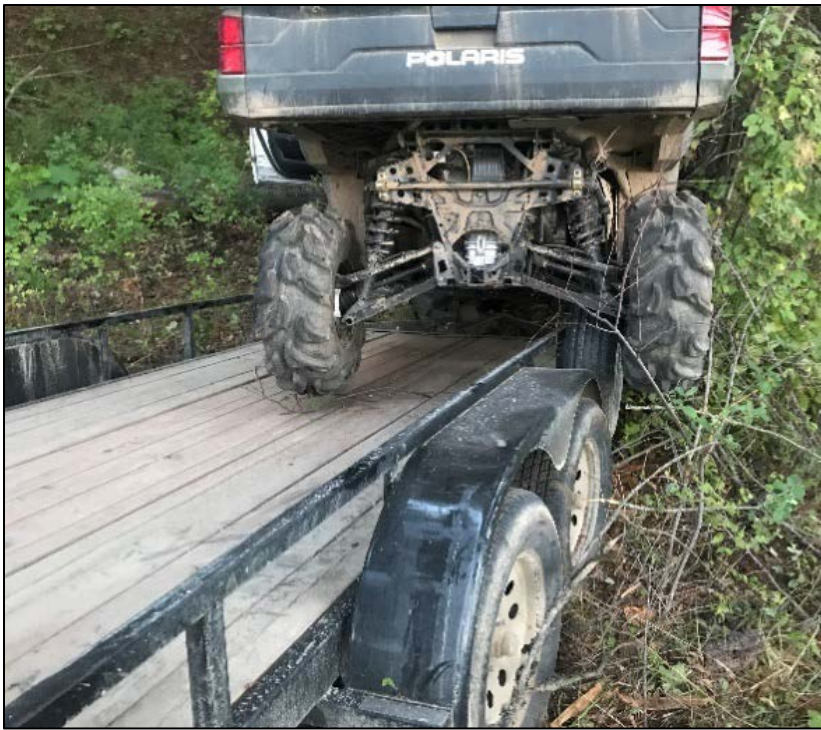
Movement of UTV upon impact.

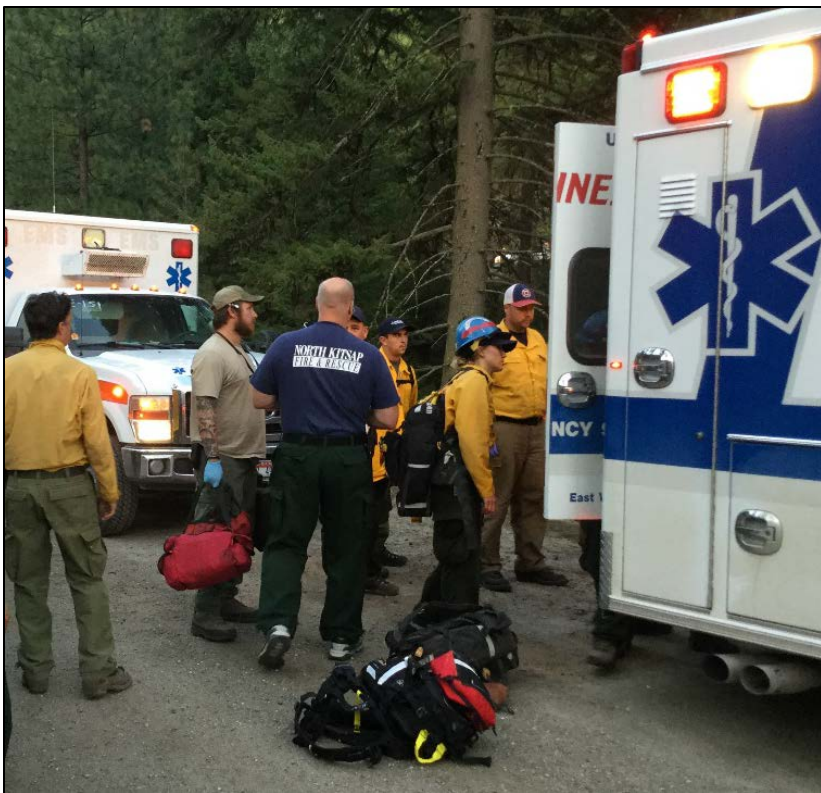
Medical and fire personnel on scene.

NOTE the condition of road near the time of incident.
