The Fire at Sperry Chalet

Fire Investigation Report

April 2018

Sperry Chalet
Glacier National Park
West Glacier, Montana 59936

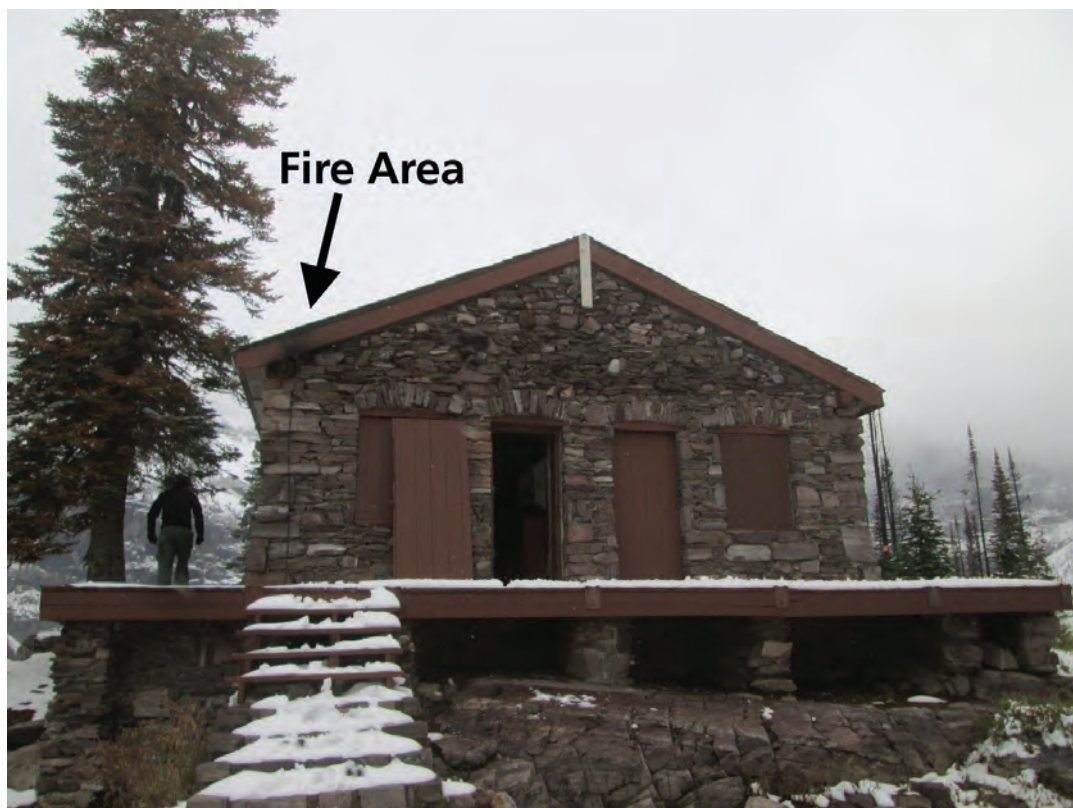
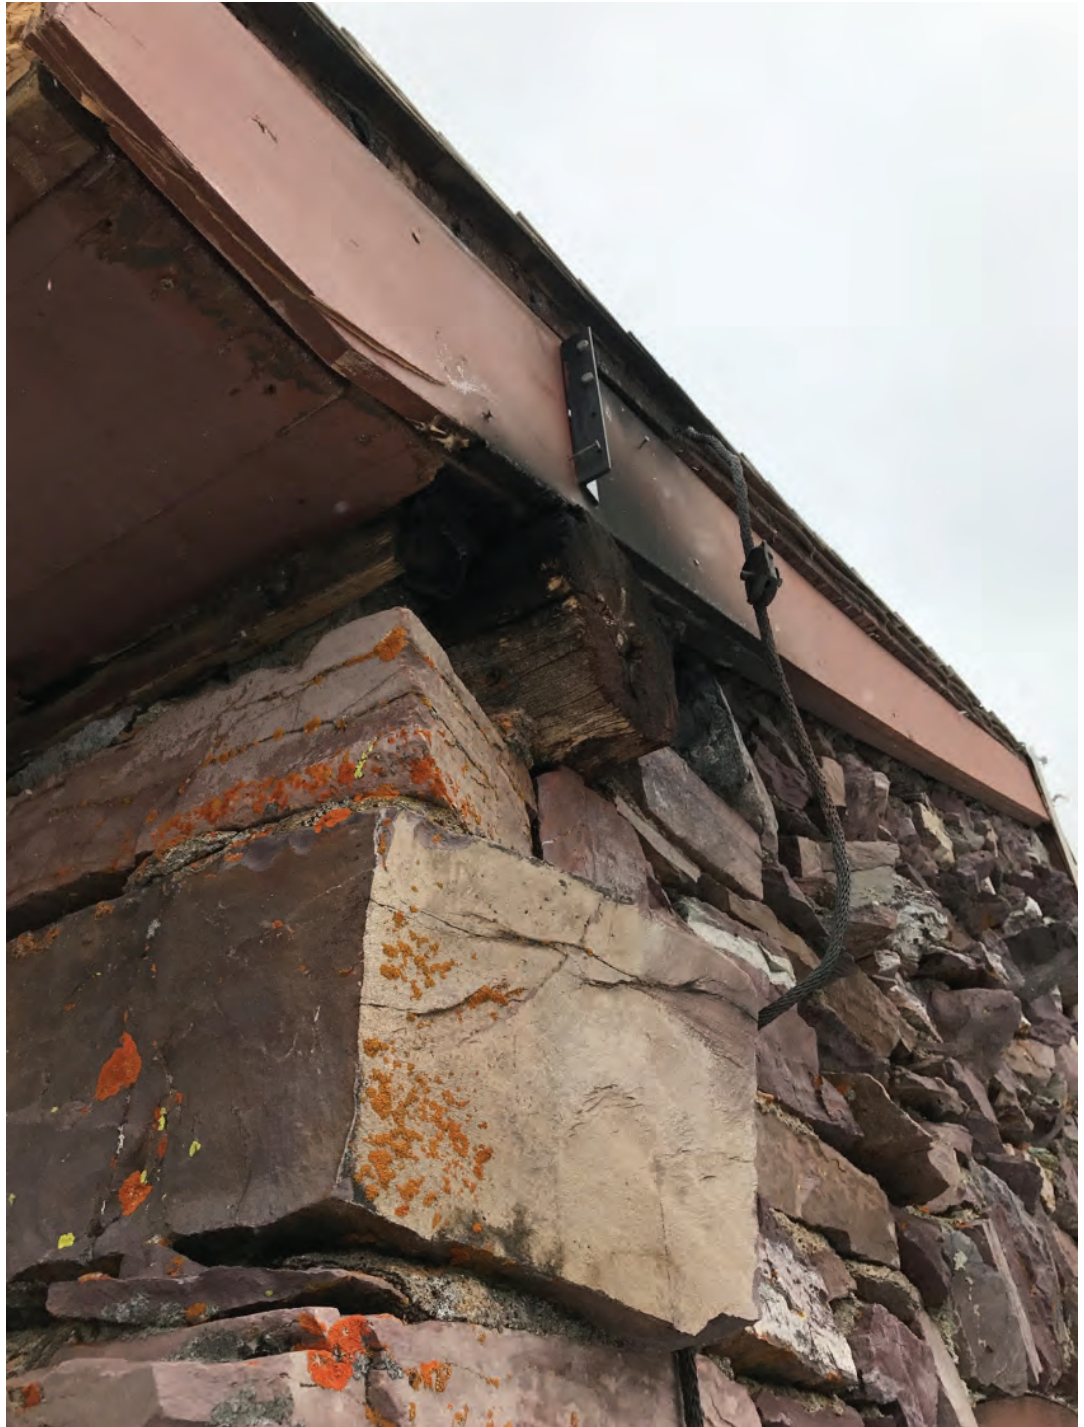
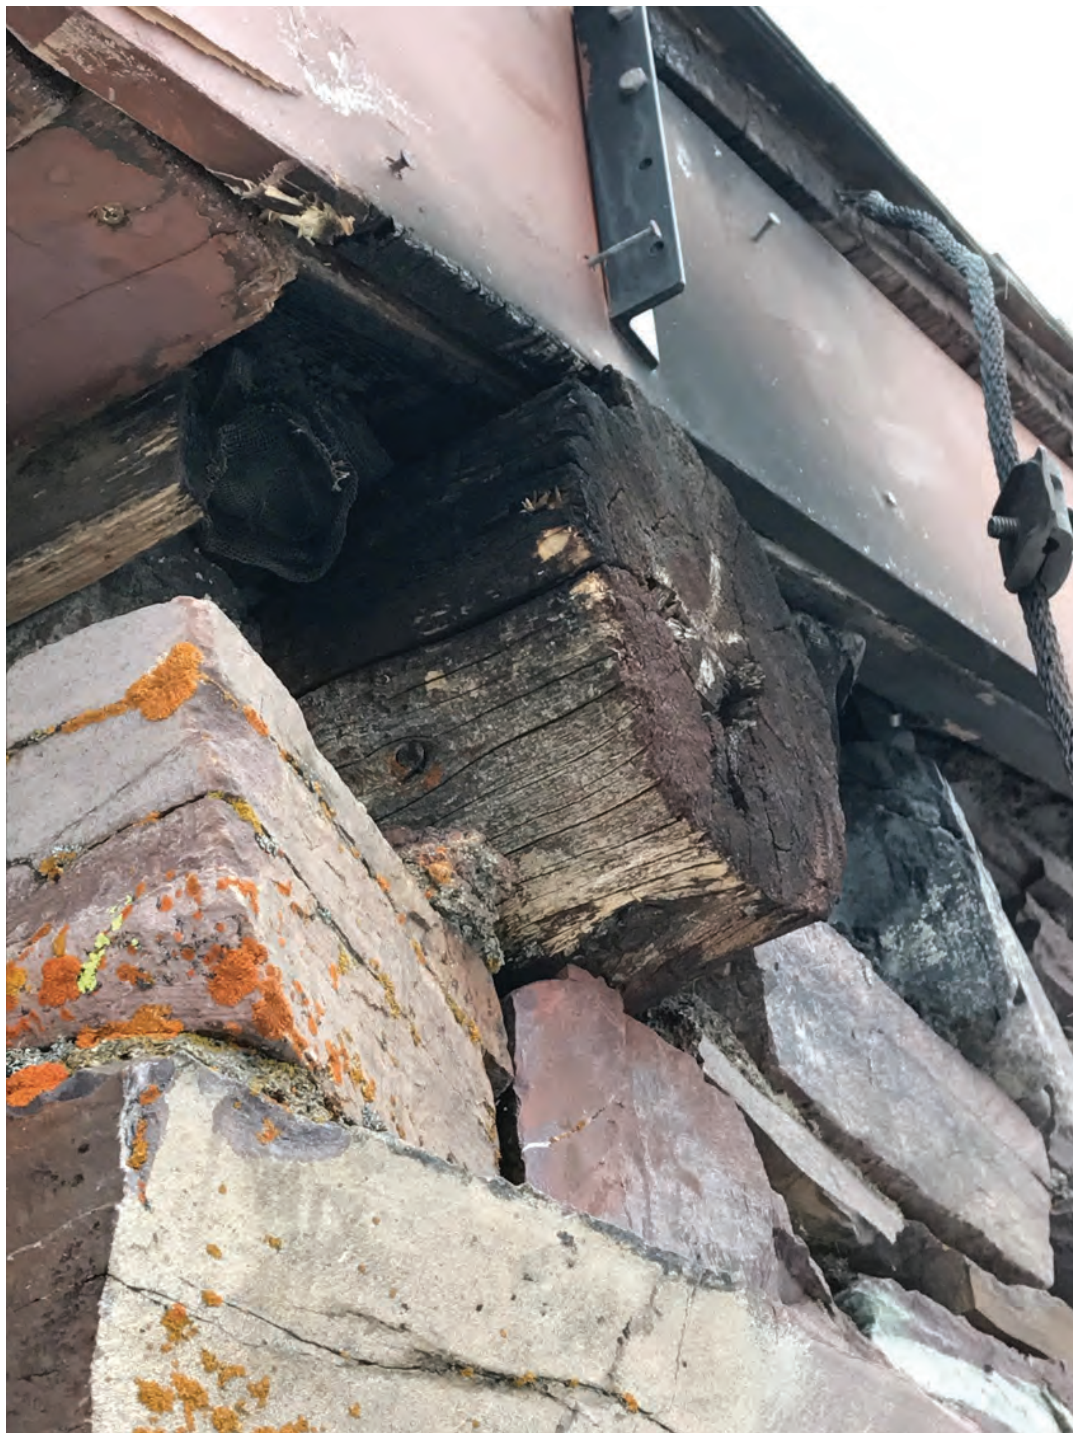
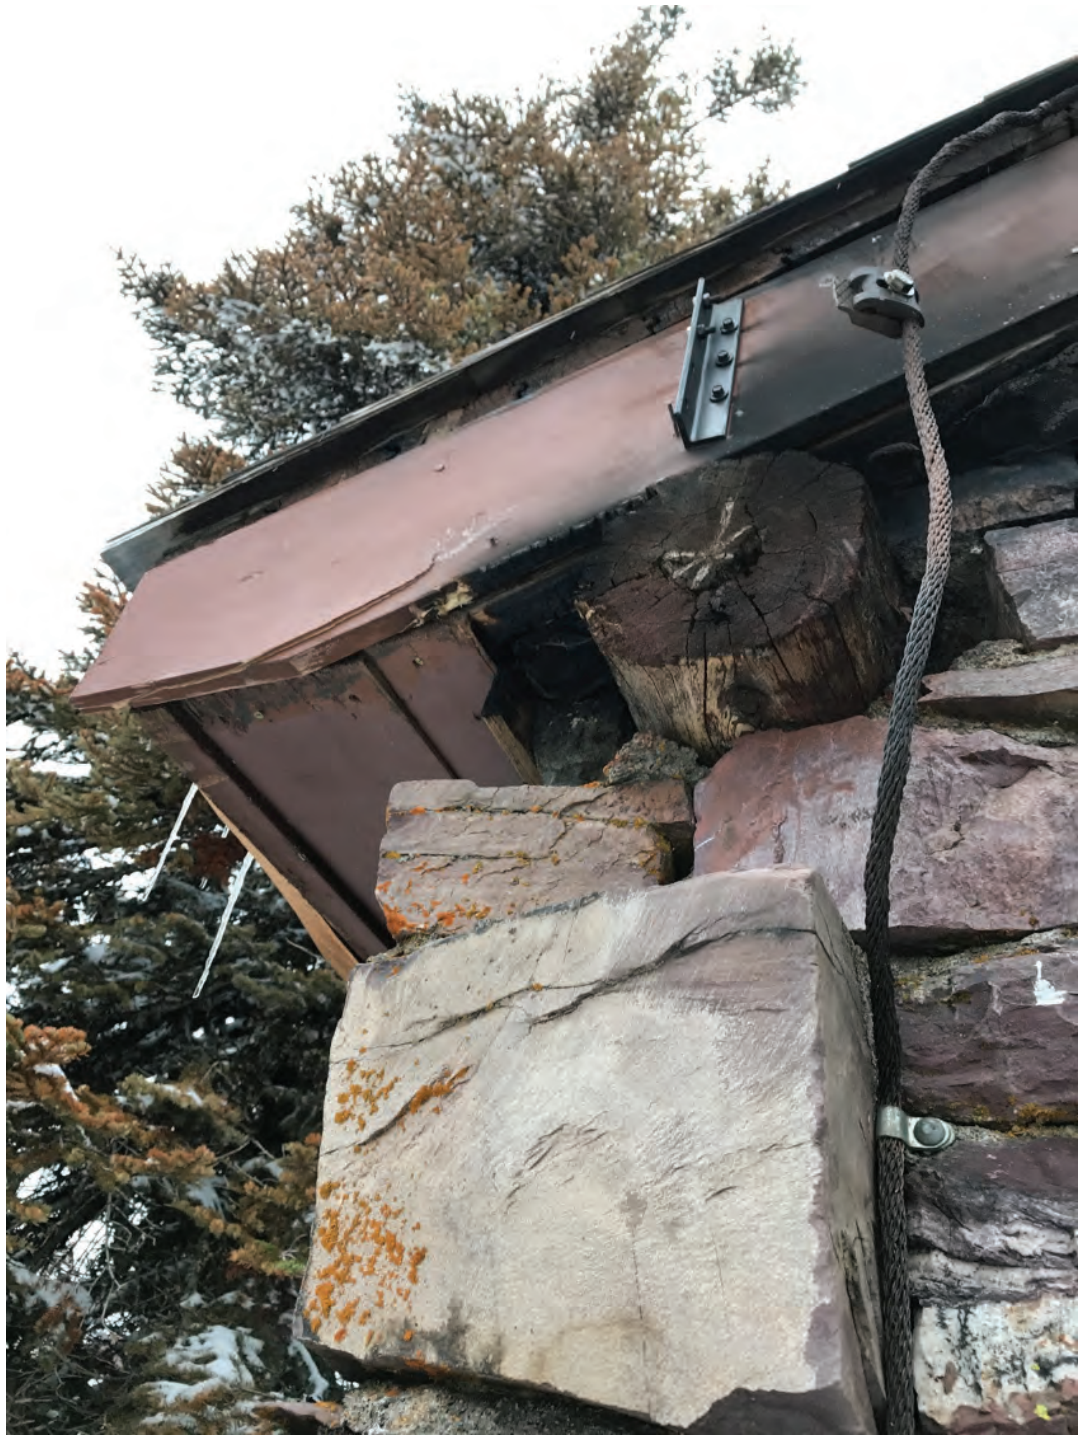
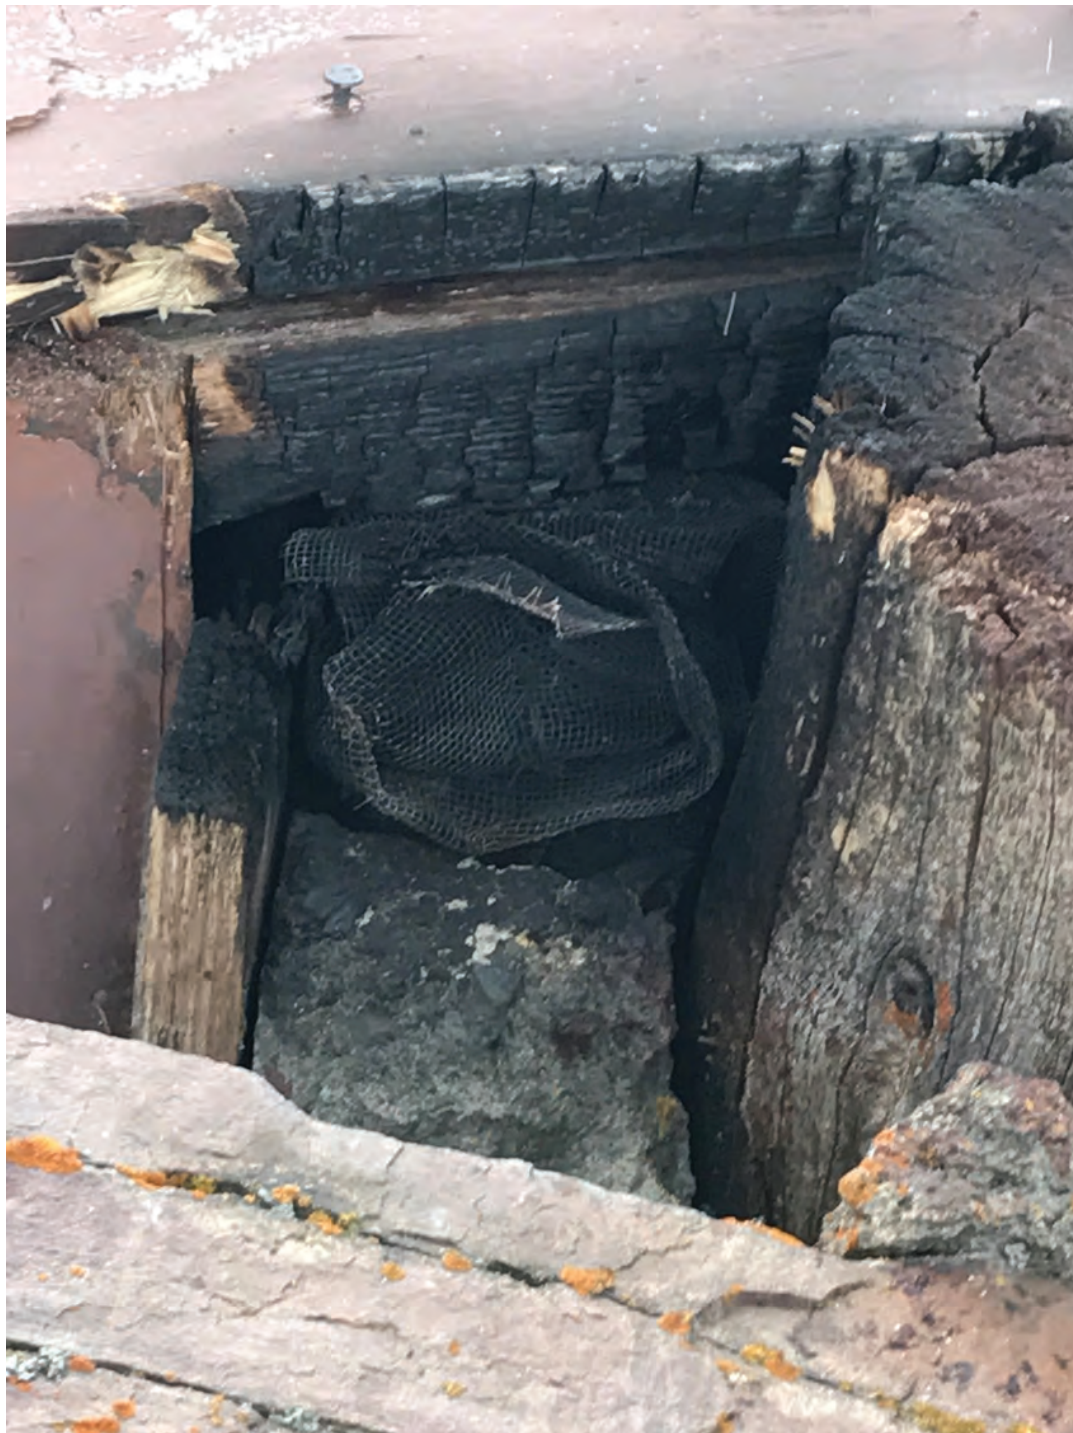
Taken from southwest corner
of exterior dining/kitchen deck.
Shows fire damage at eave/
soffit/timber.

The fire in the Dining/Kitchen building eave was located in a concealed combustible location. Soffit boards enclosed the eave along the entire length of the dining/kitchen west wall. Firefighters opened the combustible soffit with a pulaski and found flaming combustion with flame lengths approximately 6" to 12" in length. During my investigation of the exterior and interior of the southwest room of the dining/kitchen on September 23, I found charring of combustible construction material in the upper corner of the sleeping room, corresponding to the exterior eave/soffit fire that had been extinguished on August 31.

The area of origin of the Dining/Kitchen building fire was determined to be the concealed combustible space above the wooden eave soffit at the southwest corner of the building. During suppression activity firefighters noticed combustible "nesting" material similar to a rat's nest that fell out of the burning area when the soffit board was forcibly removed. This finely divided combustible material creates an easily ignitable combustible fuel. The concealed combustible area of the exterior eave communicated with the interior sleeping room, which provided an avenue for fire travel. During my site

Dining/Kitchen building – The first fuel ignited in the Dining/Kitchen building was determined to be either concealed combustible construction material or concealed nesting material in the southwest eave area. Firefighters found flaming combustion inside the soffit area and also found nesting material similar to a “rat’s nest.” Both were found actively burning when firefighters opened the soffit with a pulaski.

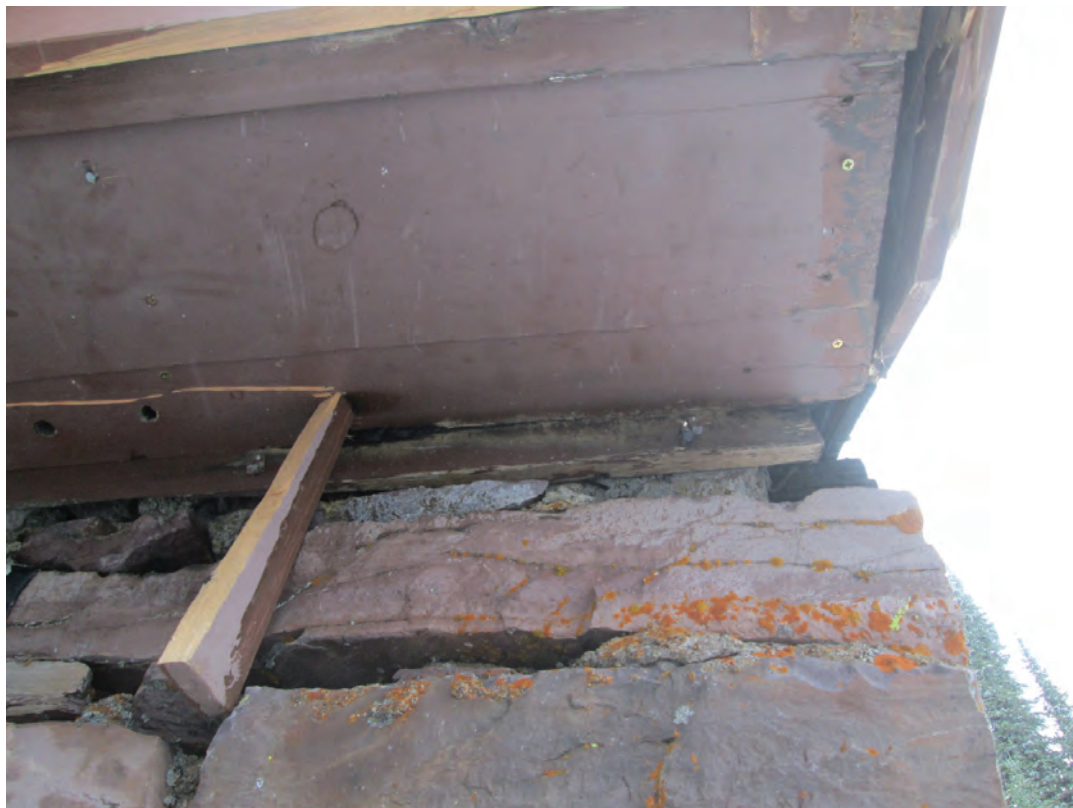
I began my site investigation by conducting an exterior walk around of the Dining/Kitchen building. I observed snow covering the roof, decks, and ground surrounding the building. Photographs were taken of the building exterior, including multiple photographs of the southwest corner eave, soffit, and beam end (timber). The wooden soffit pieces that were broken during the fire had been reinstalled. Smoke staining was visible along the eave and charring was noted on the south fascia board and also on the upper portion of the timber beam end. A small hole was observed in the soffit board with smoke staining that appeared to be pushed outward through the hole on the underside of the painted soffit board. A splintered portion of the soffit board had been placed into the hole after the soffit was reinstalled, possibly to preserve the splintered piece or plug the hole.

Taken from southwest corner of exterior dining/kitchen deck. Shows soffit board that was reinstalled by firefighters after the fire.

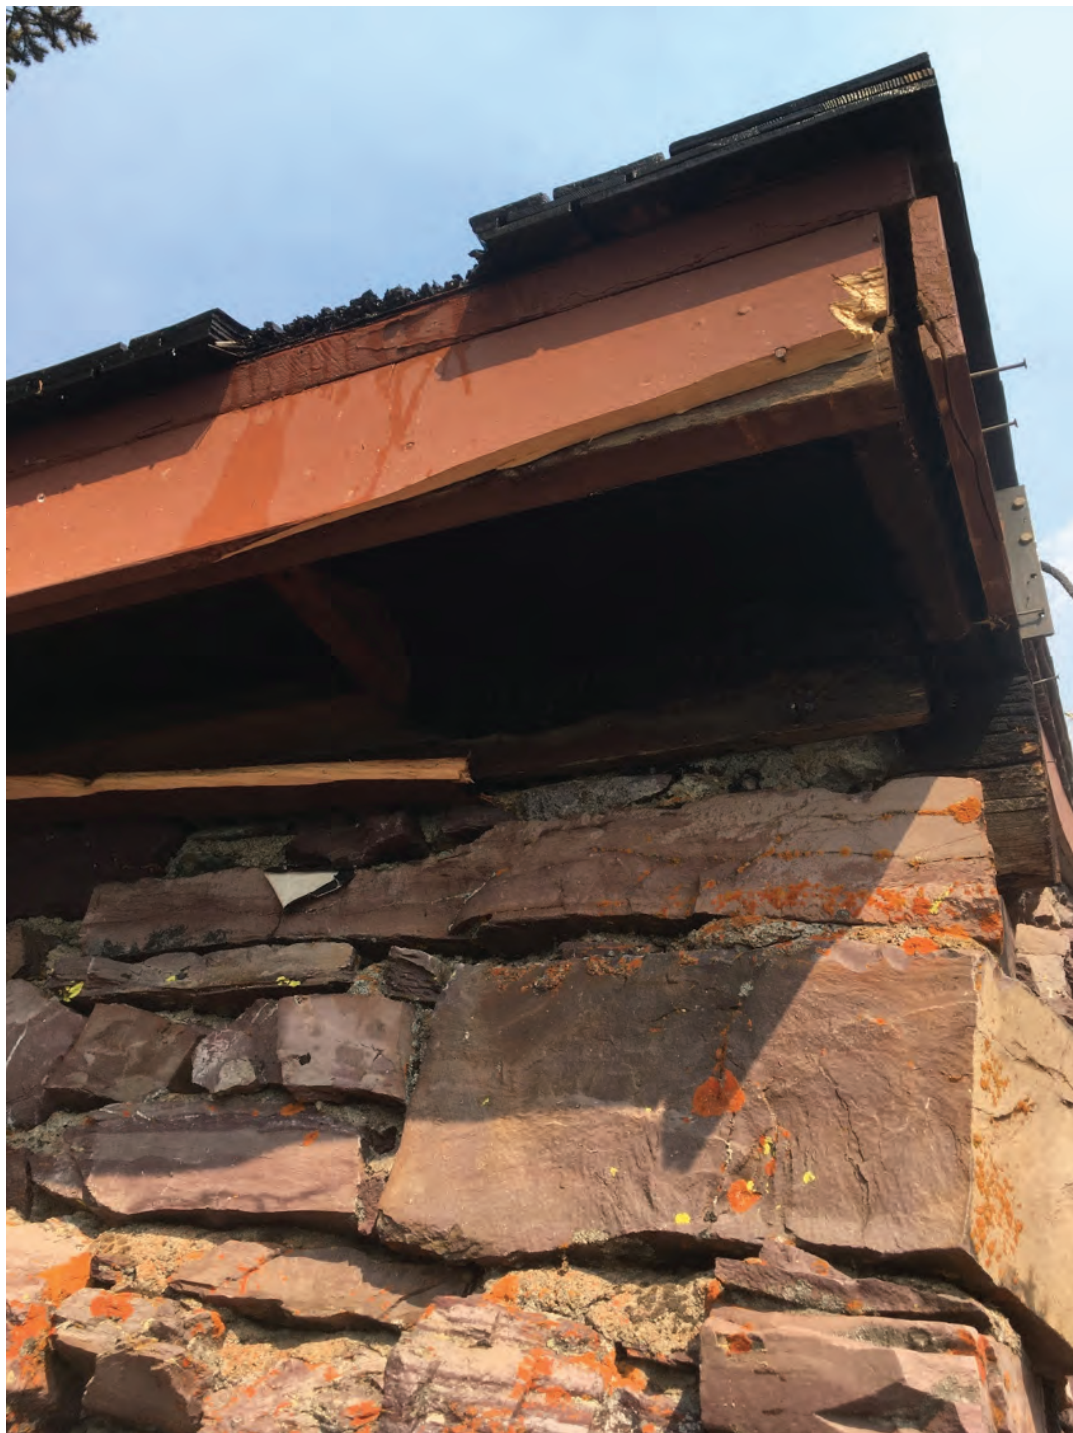
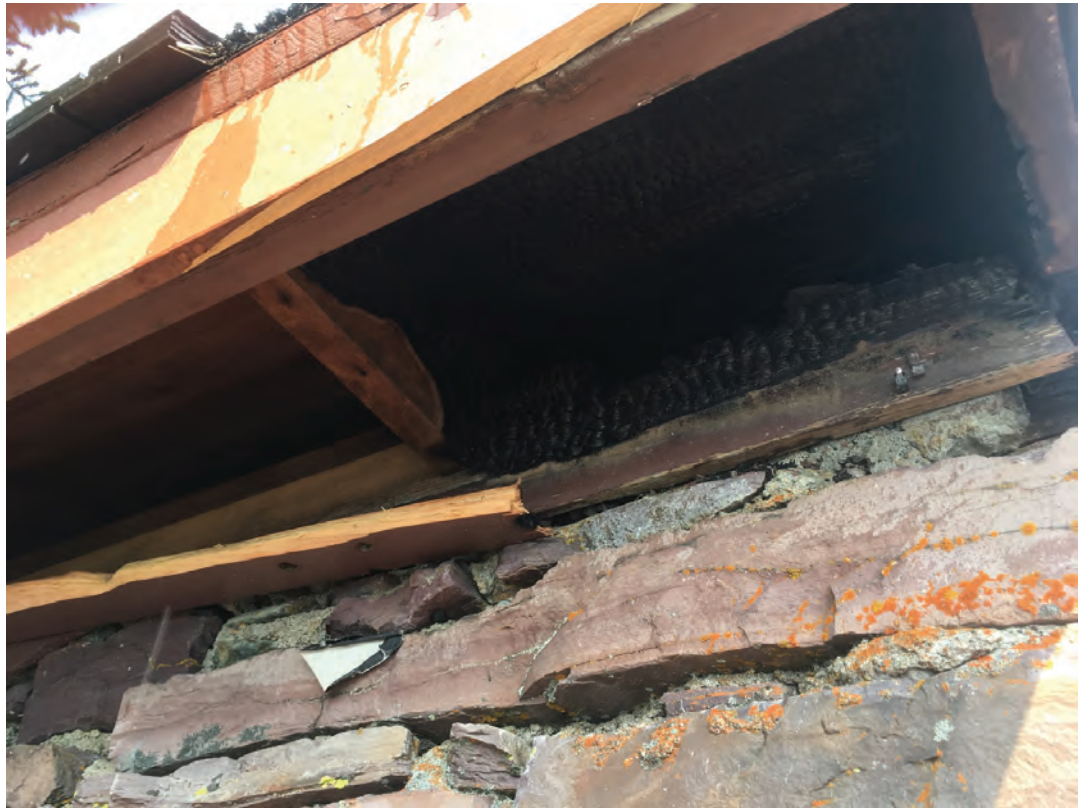
After completing the interior examination, an area of potential fire damage along the southwest corner edge of shingles was noticed by the FLA team lead, Miranda Stuart. The area was approximately 1" deep by 12" wide. Dark areas resembling charring were observed, however I was unable to visualize the top of the shingled area due to the height above the deck. Suitable ground ladders were not readily available. Access to the roof was not possible due to safety concerns. Refer to photos on Slide #15 and #16 for detail.

Additionally, I asked the personnel on site if the shingle damage on the southwest corner of the Dining/Kitchen building (Slide #15) was preexisting, caused by a spot fire, or damaged during suppression. The division supervisor was not sure if it was there before the fire, part of the fire damage, or if a firefighter might have hit it during suppression. The maintenance person indicated the shingle damage was not there prior to the fire, but was not sure if it was fire damage or suppression damage. The firefighter indicated that he was pretty confident the shingles came off when they were removing boards at the eave during fire suppression.

Taken by personnel on site after the fire. Shows internal charring of the soffit. Also shows damage to shingle area.

the southwest corner of the dining/kitchen appeared to have damage. This section is approximately 1" deep and 10" to 12" wide. This damage area is in the same area as the fire that was extinguished inside the eave. Firefighters indicated that they did not see this damage prior to the fire and believe it was related to suppression activity.

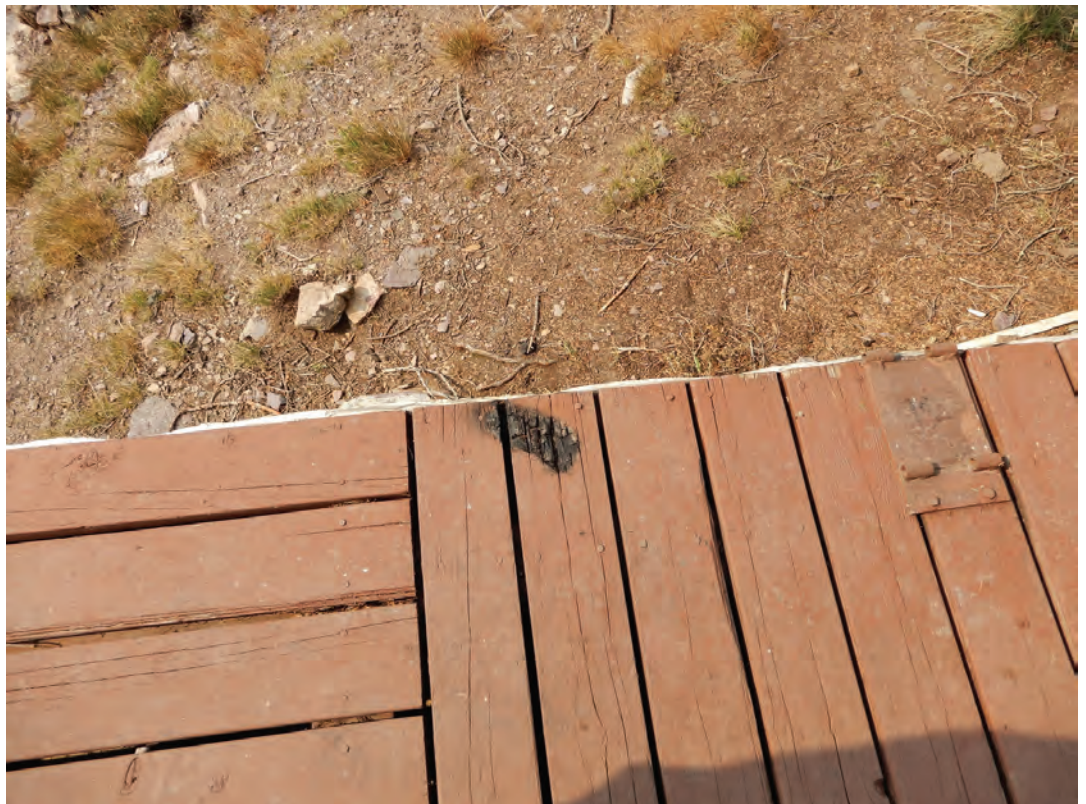
Taken by personnel on site after the fire. Shows spot fire on deck.

The ignition of the fires in the Dining/Kitchen building and the dormitory are hypothesized to be ignited by wind-driven embers that were present throughout the Sperry Chalet complex at multiple times on the afternoon and early evening of August 31. Windborne embers (firebrands) from wildland fires are recognized as a competent heat source. Embers started numerous fires throughout the Sperry Chalet complex on vegetation and in trees before and after the two building fires. Additionally, an area of char related to a small ember-caused fire on the exterior deck of the Dining/Kitchen building was noticed by personnel on scene and photographed by them on August 12 (Slide # 17).

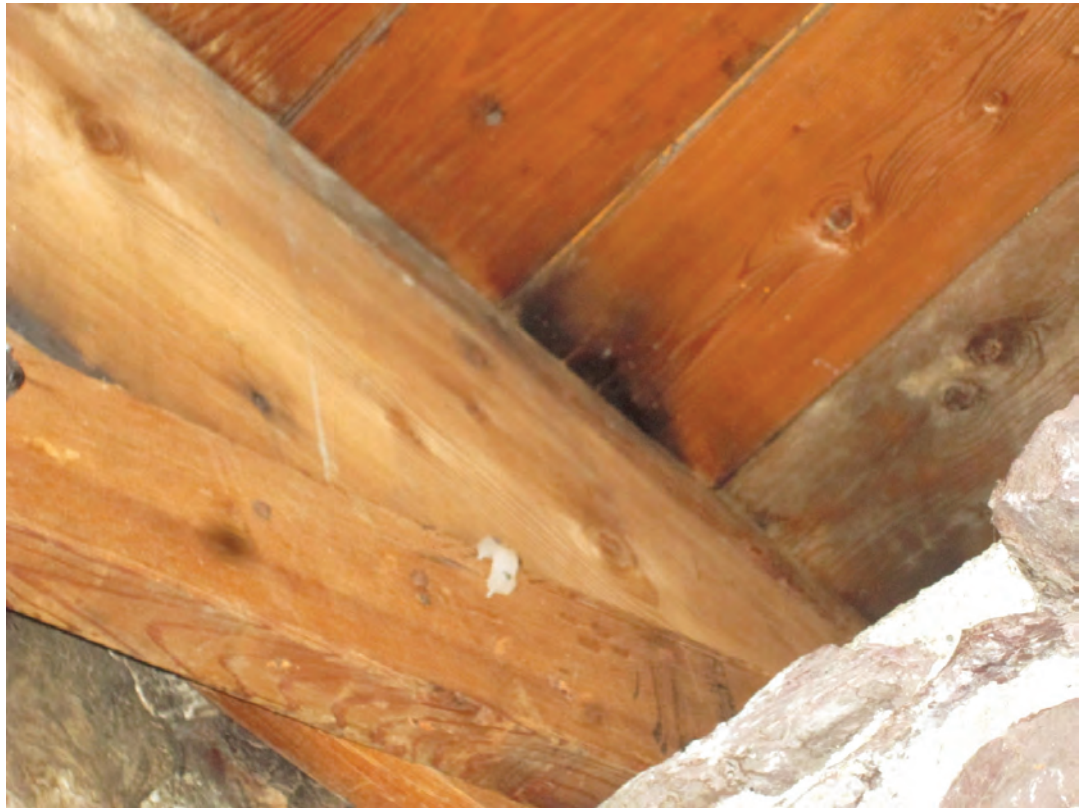
The interior sleeping room was entered by removing the shutter and accessing the locked entry door with a key. I examined this room for smoke and fire indicators. Smoke staining and charring of combustible building materials was observed in the upper southwest corner of the room. Two smoke alarms were observed in the room. Photographs were taken of the smoke/char area.

Taken in the interior of the southwest sleeping room. Shows fire progression into the building.

investigation on September 23, I observed smoke staining and charring inside the Dining/Kitchen building in the upper southwest corner of the sleeping room.

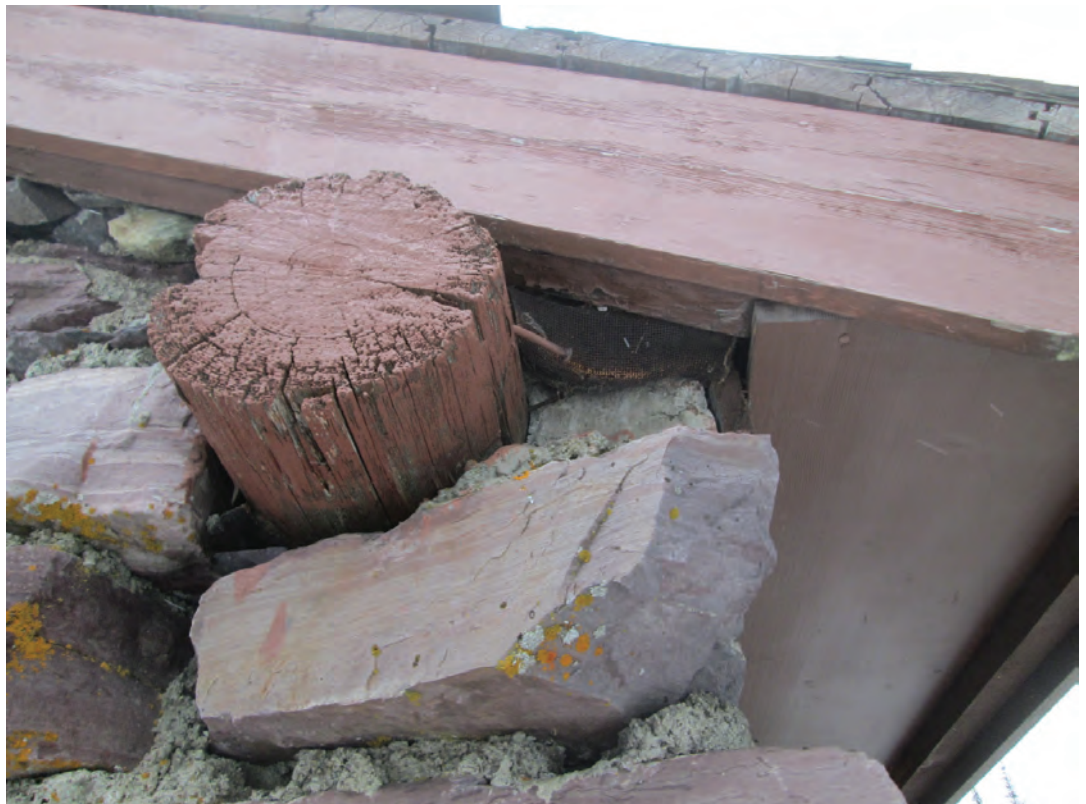
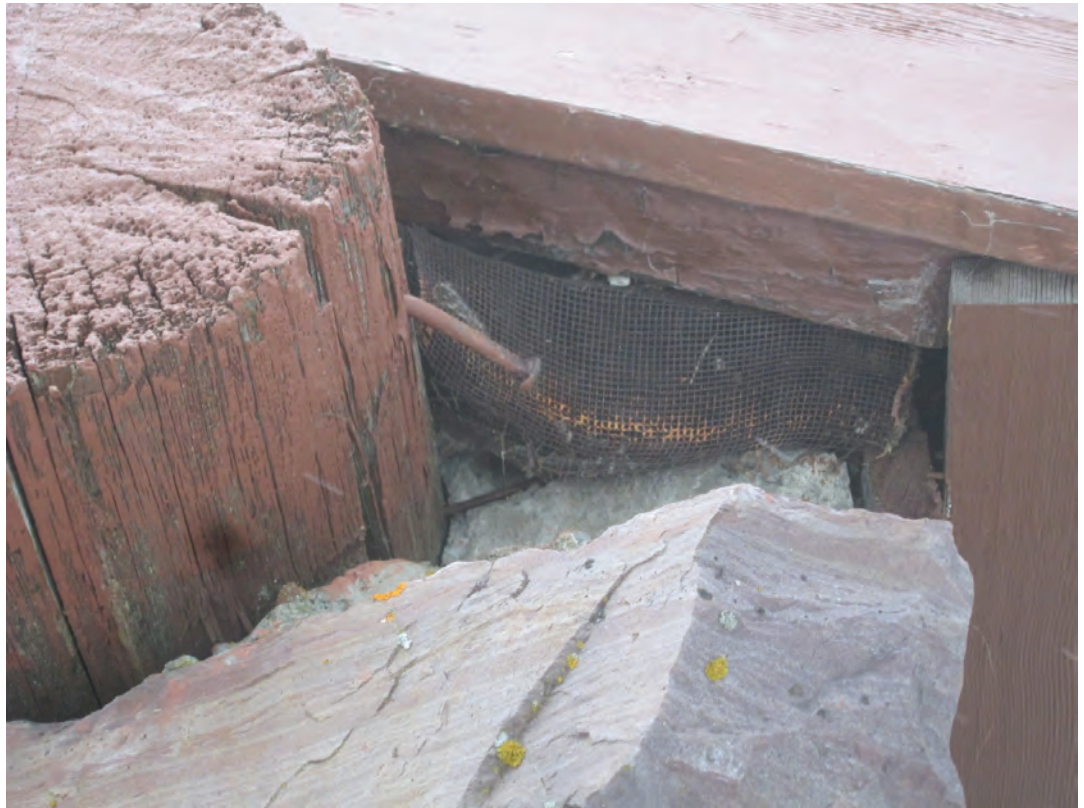
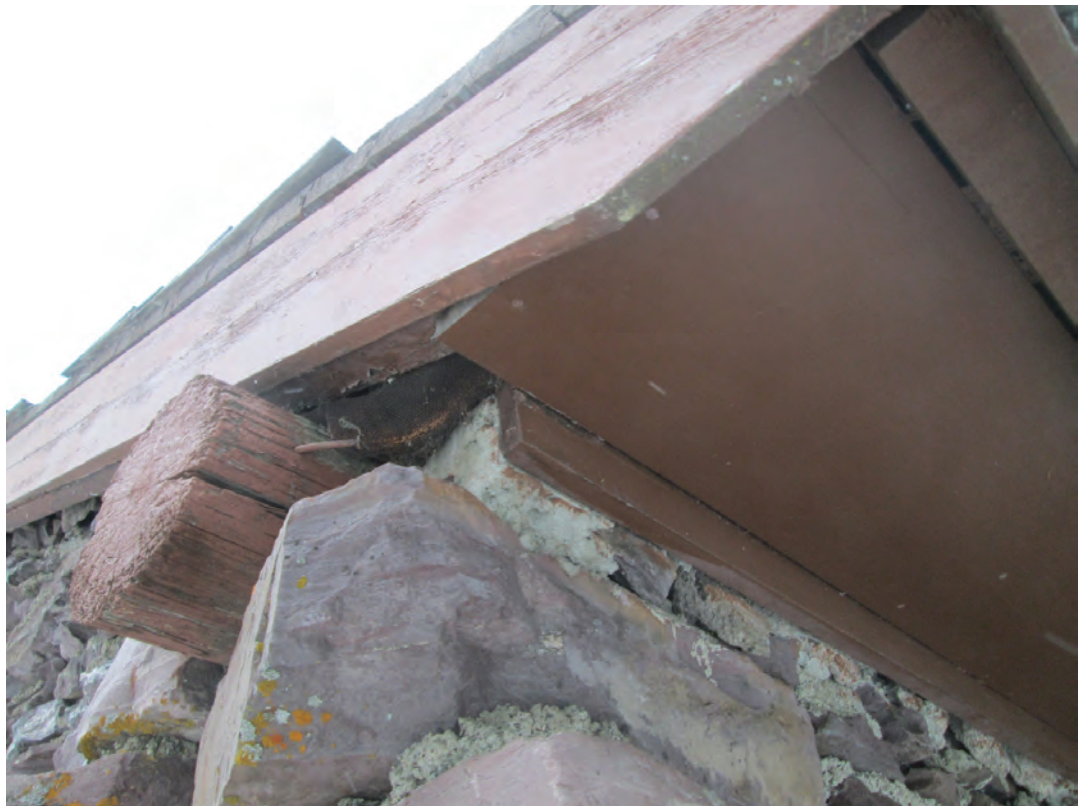
Taken from the southeast exterior deck of the dining/kitchen building. Shows comparison eave on east side of building.

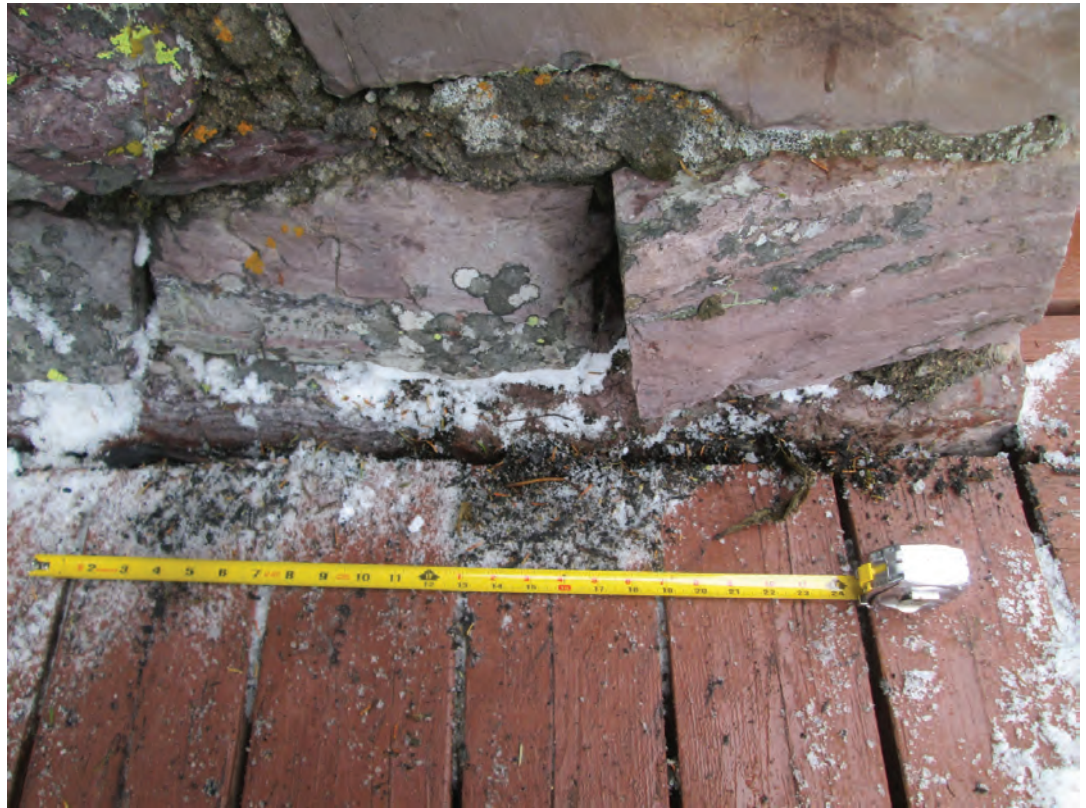
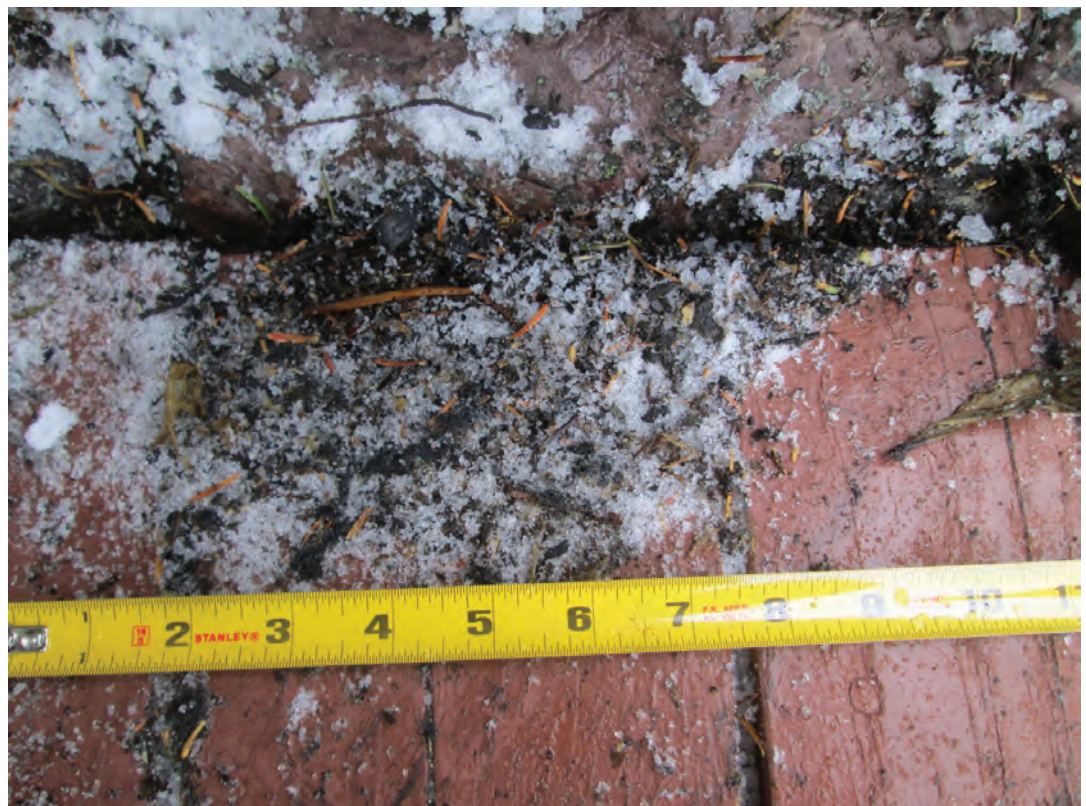
Taken from the southwest exterior deck of the dining/kitchen building. Shows nesting material that dropped from the soffit onto the deck during fire suppression.

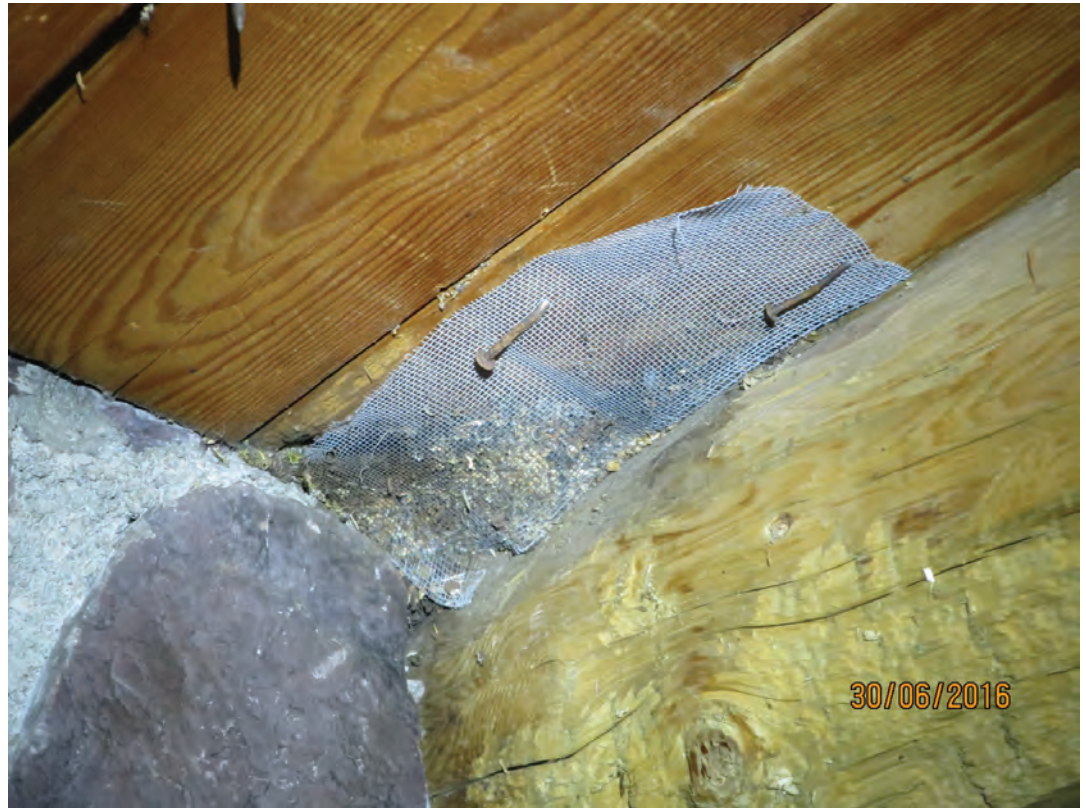
Close up of interior ceiling of second floor storage room, shows rodent nesting area.

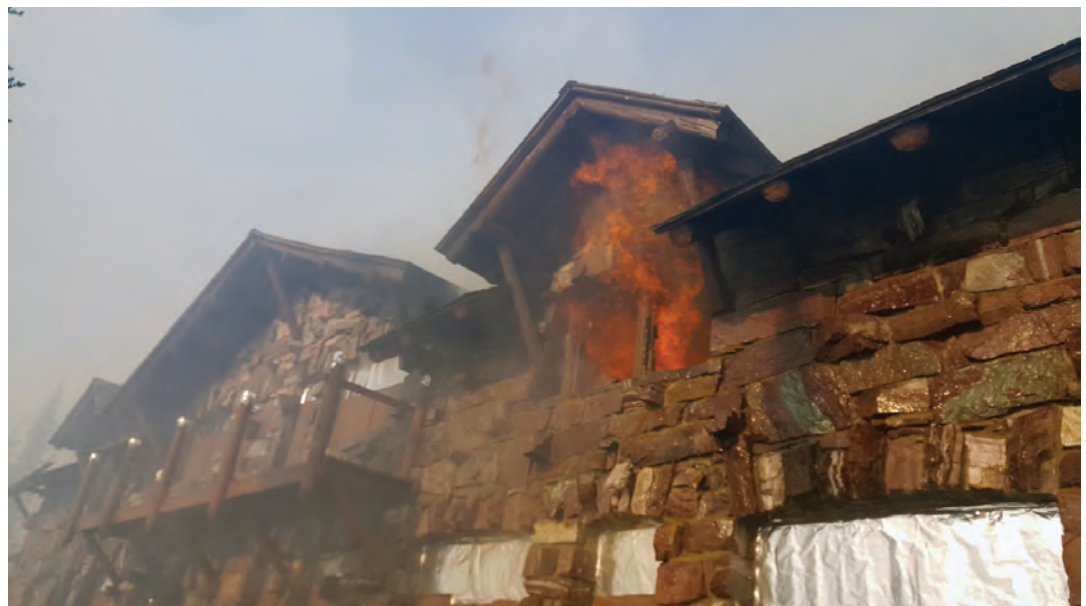
Taken from west side of dormitory, on the south end, adjacent to southwest corner of building. Shows relatively clean-burning flames coming from second story window of Room #15. Flames are observed covering the upper half of window opening. Flames are also shown reaching the underside of the dormer. The shutter from Room #15 is completely gone. It appears that possible window glass is remaining in lower right and lower left corners of the window opening. Charring of the exterior side of center window frame is noted. The first floor entry door shutter is in place over doorway.

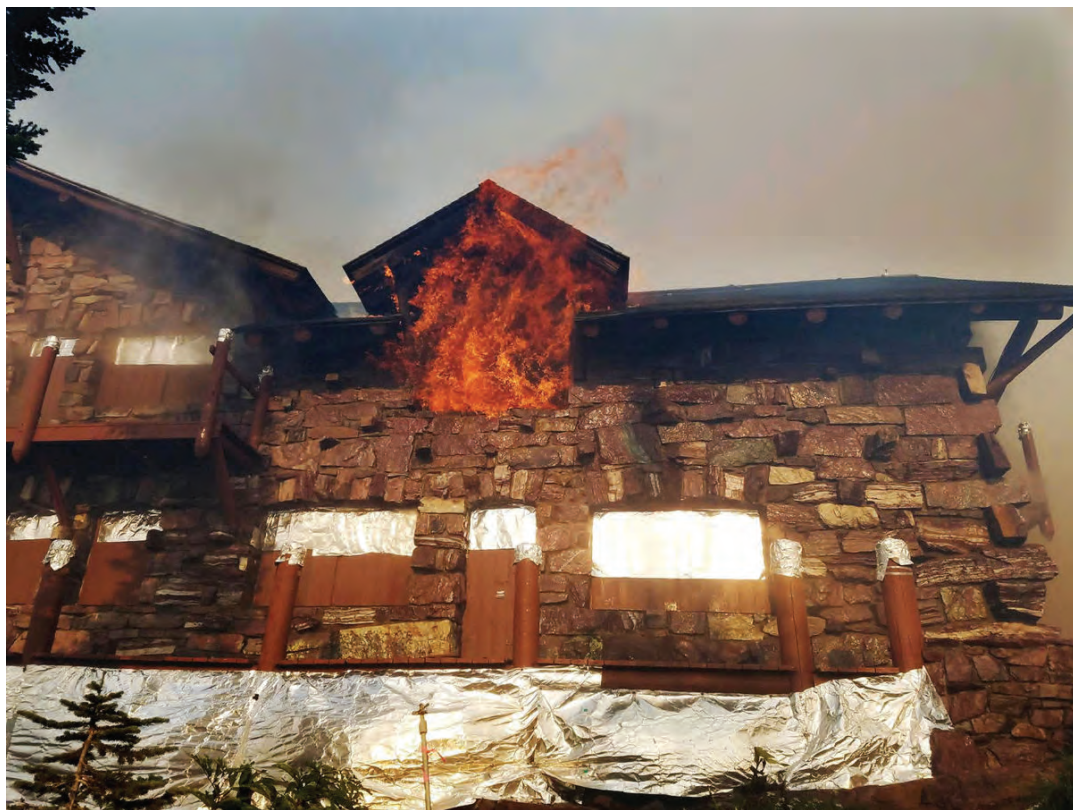
In reviewing the photographs of the dormitory fire (Slide #55 and #56) I observed the first floor door shutter was back in place over the front of the entry door. This shutter was reported to have been removed by personnel on site during the fire to investigate smoke in the dormitory. I contacted personnel that were on site during the fire and asked about this shutter being reinstalled.

Taken from west side of dormitory directly in front of the south lobby entry door. Shows full involvement of Room #15 with flames completely filling the window opening and appearing relatively clean burning with light smoke production. Flames are seen on the dormer and also appearing on the shingles located on the right and left side of the window. Smoke development is seen below the larger dormer located to the left side of Room #15 and heavy smoke development is seen on the right side of the building. The entry door shutter is in place at the south lobby doorway.

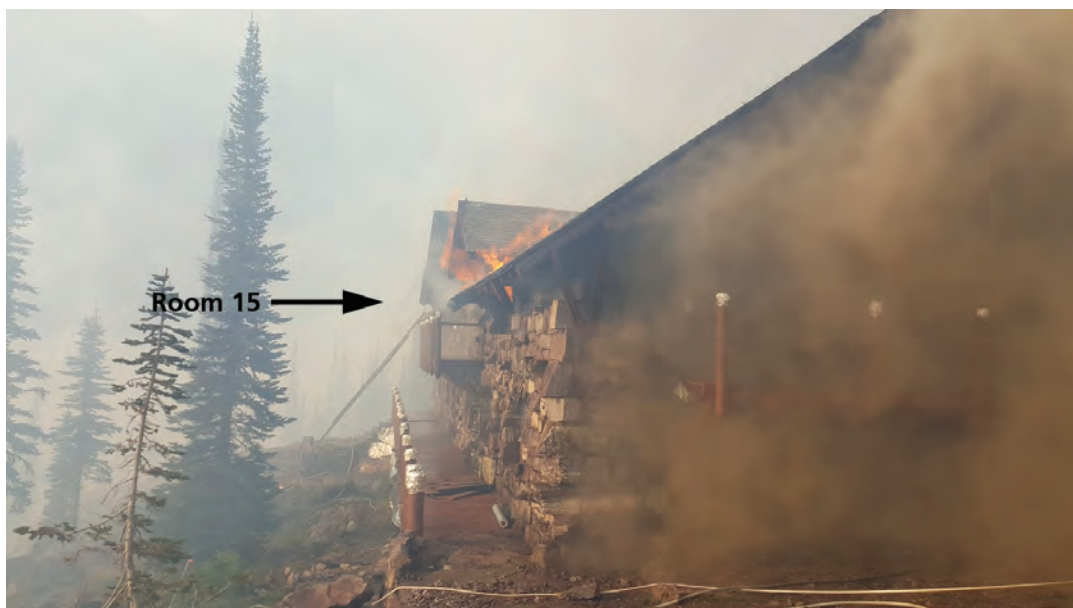
Taken from southwest corner of dormitory, shows the west side and the west half of the south end. Shows heavy fire involvement of the dormer above Room #15. Flames appear relatively clean burning, producing light-colored smoke. Flames are observed involving roof shingles. The west deck appears very wet in the photo. Remnants of the shutter from Room #15 are visible on the deck. Heavy smoke conditions are visible issuing from the south side.
