The Fire at Sperry Chalet

Fire Investigation Report

April 2018

Sperry Chalet
Glacier National Park
West Glacier, Montana 59936

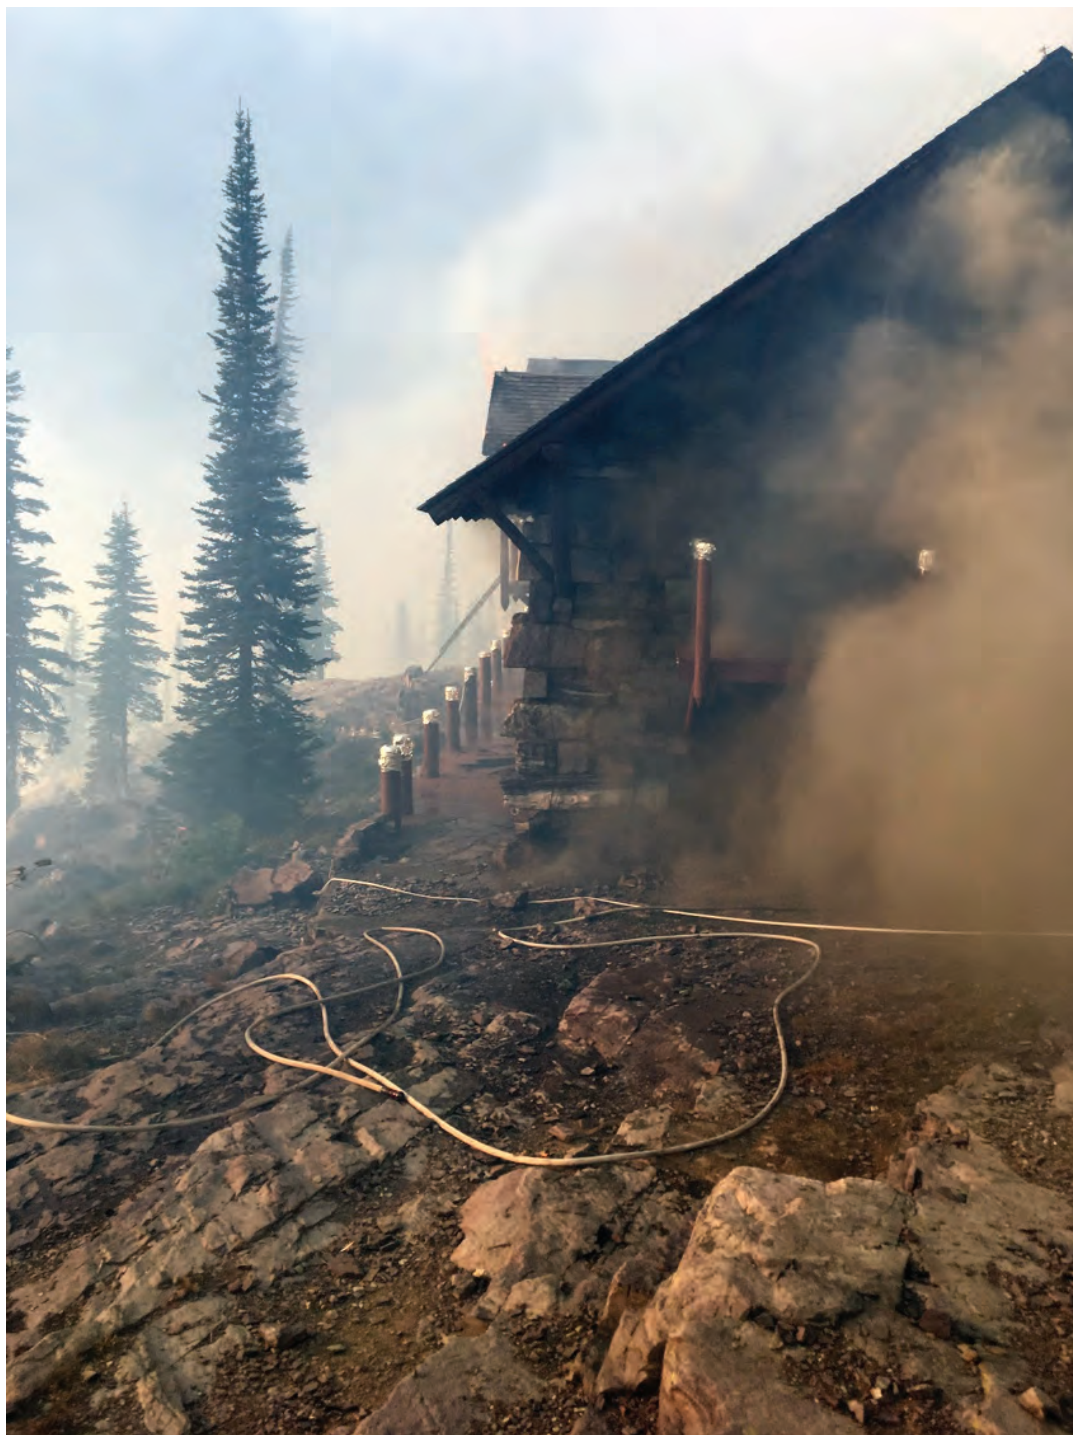
Taken from south end of the dormitory. Shows light smoke and thin flame showing from Room #15 dormer/window. Shows heavy smoke development on the south end.

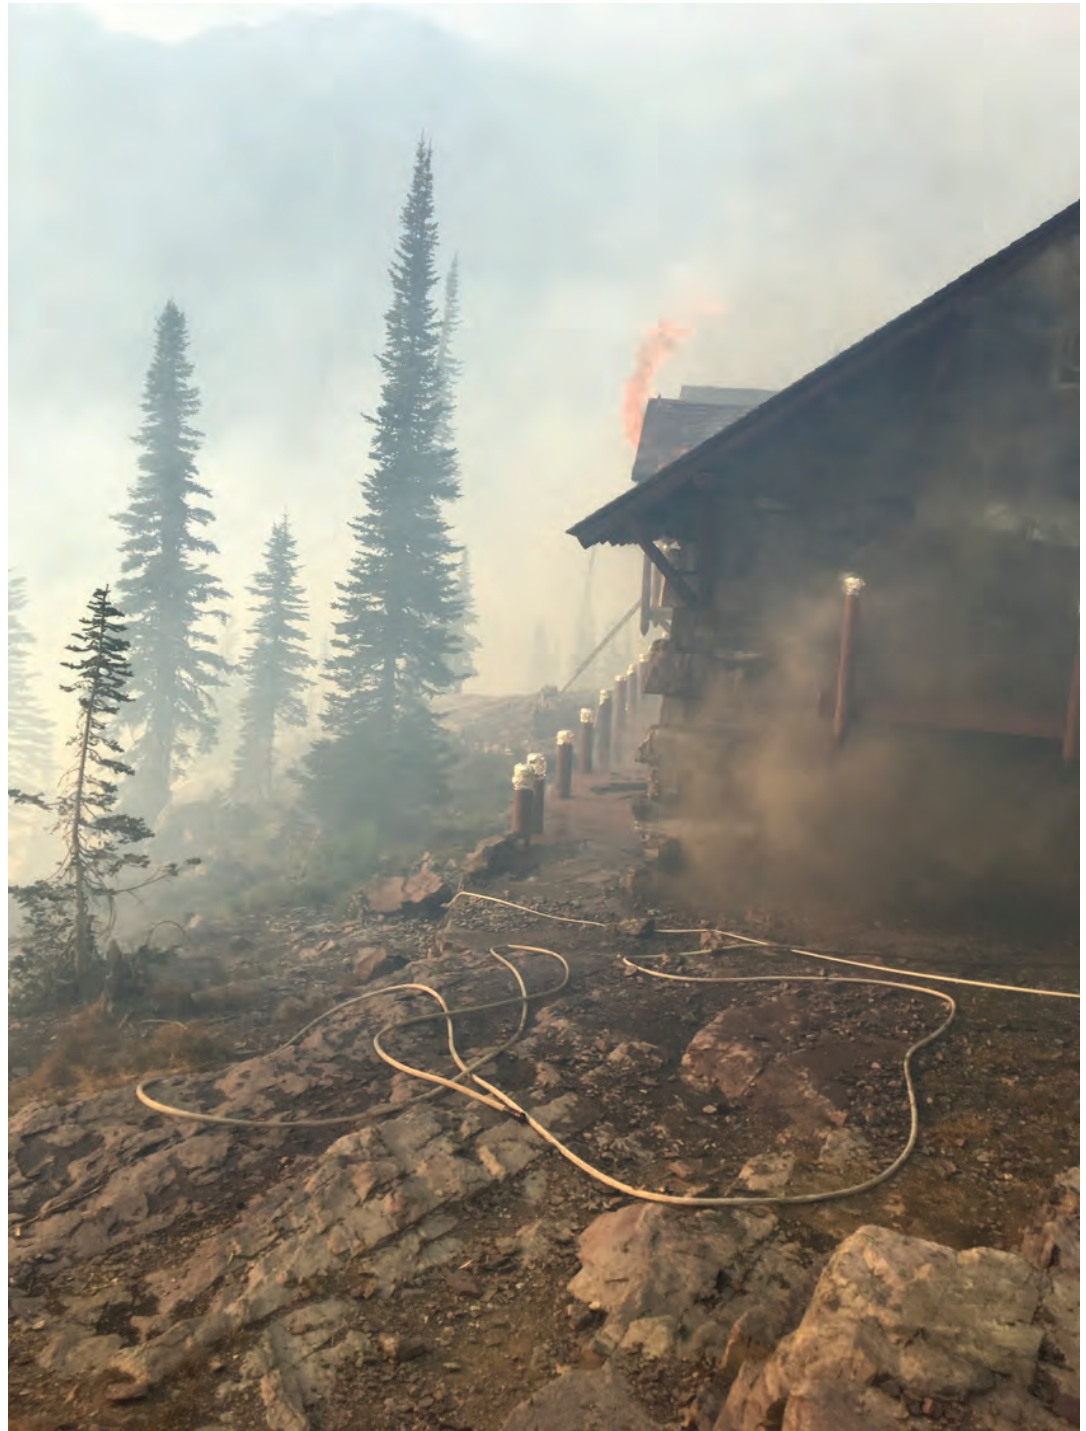
Taken from south end of the dormitory. Shows more flame length coming from Room #15 dormer/window.

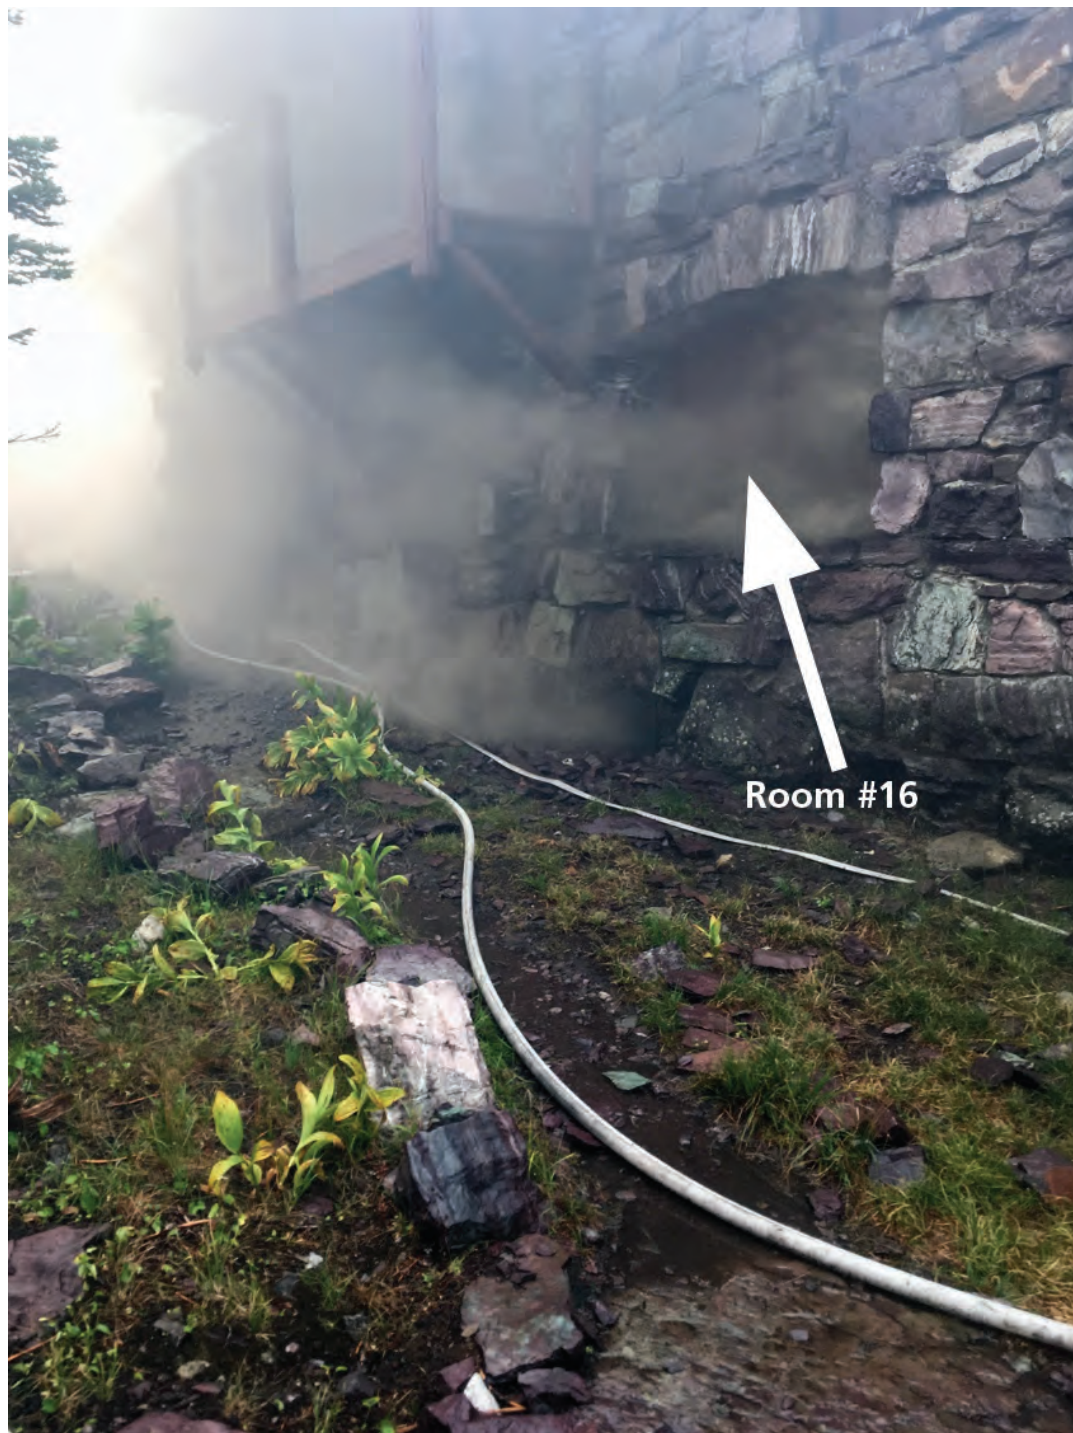
Taken from east side of the dormitory adjacent to Room #16. Shows moderate smoke production from the first floor.

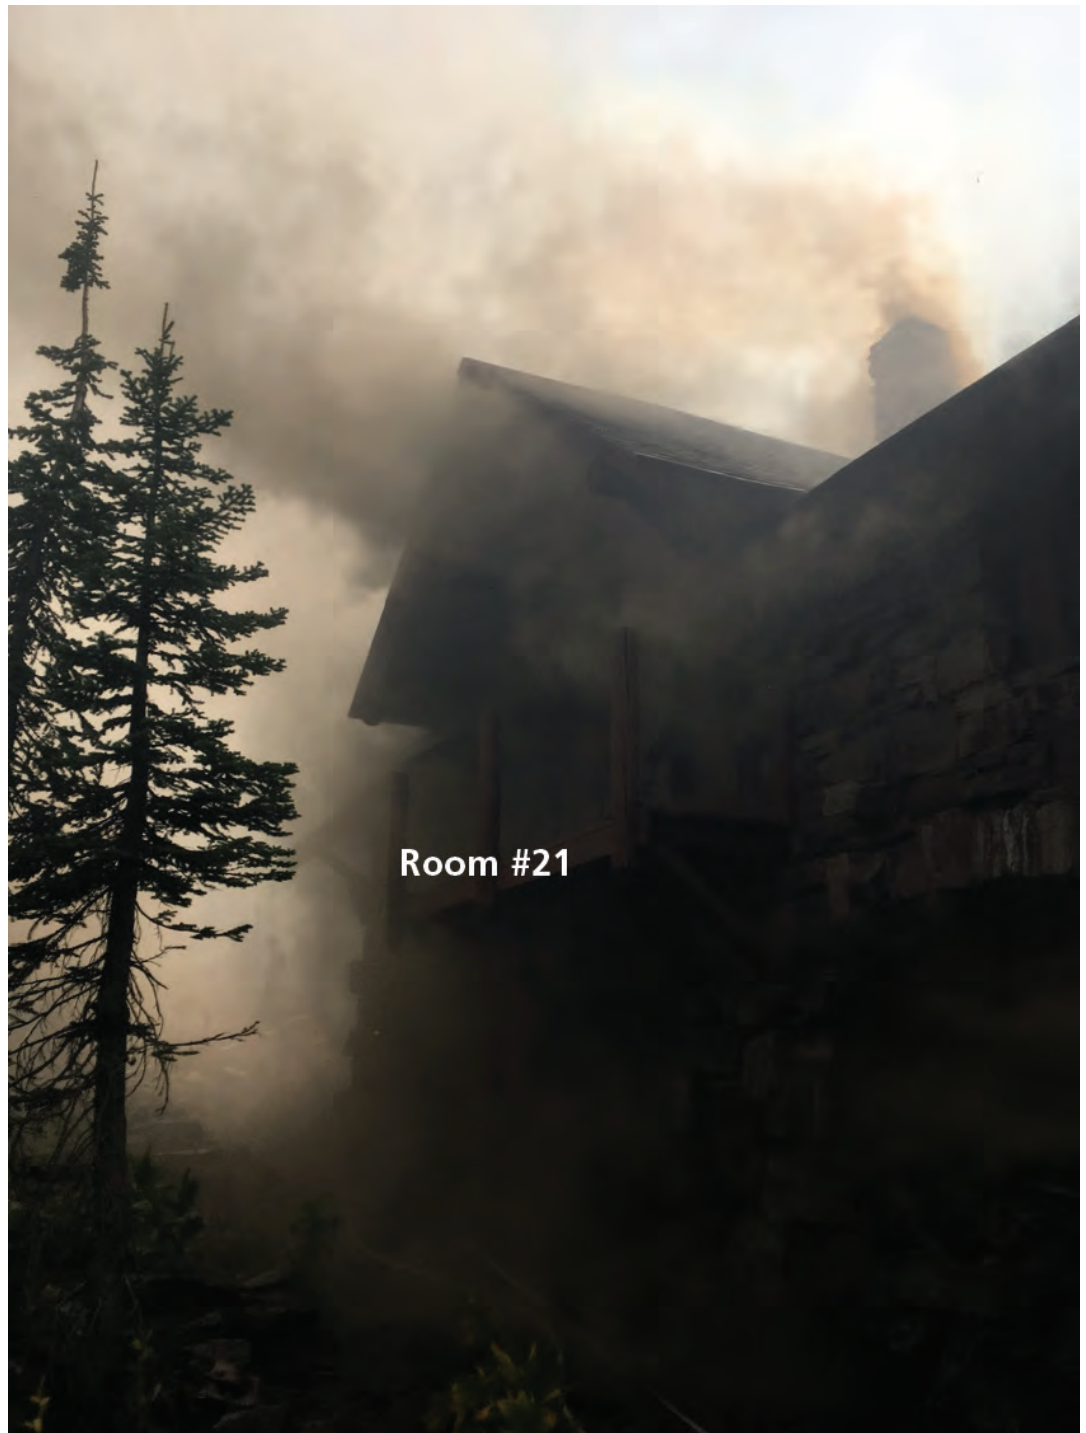
Taken from east side of the dormitory, north of the exterior porch (Room #21). Shows heavy smoke production from the second floor and smoke production near the chimney area.

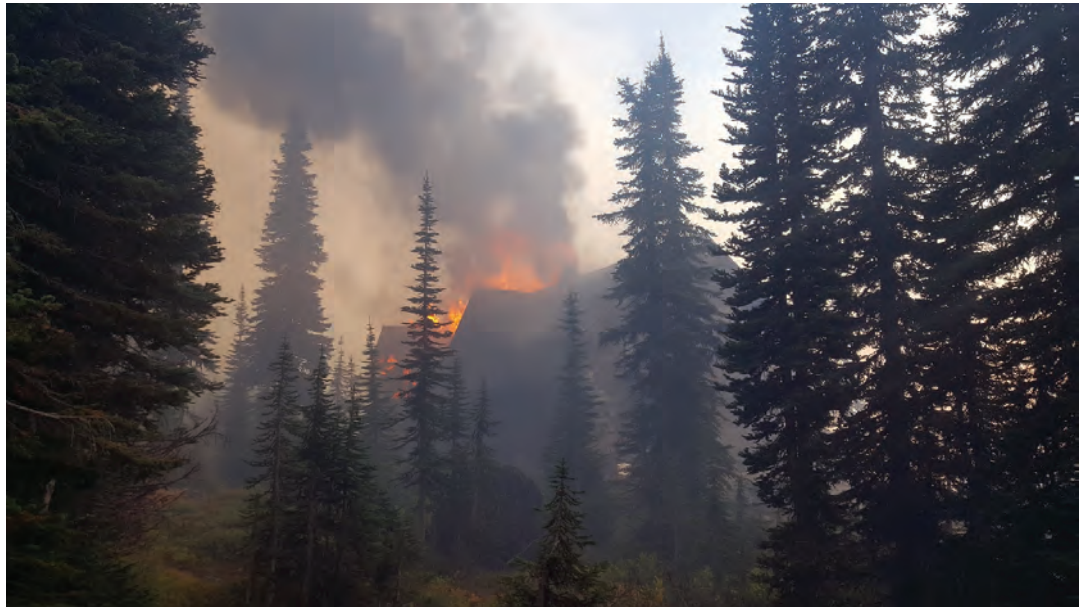
Taken from northeast area, long distance from dormitory. Shows heavy fire involvement on the south half of dormitory with fire through the roof.

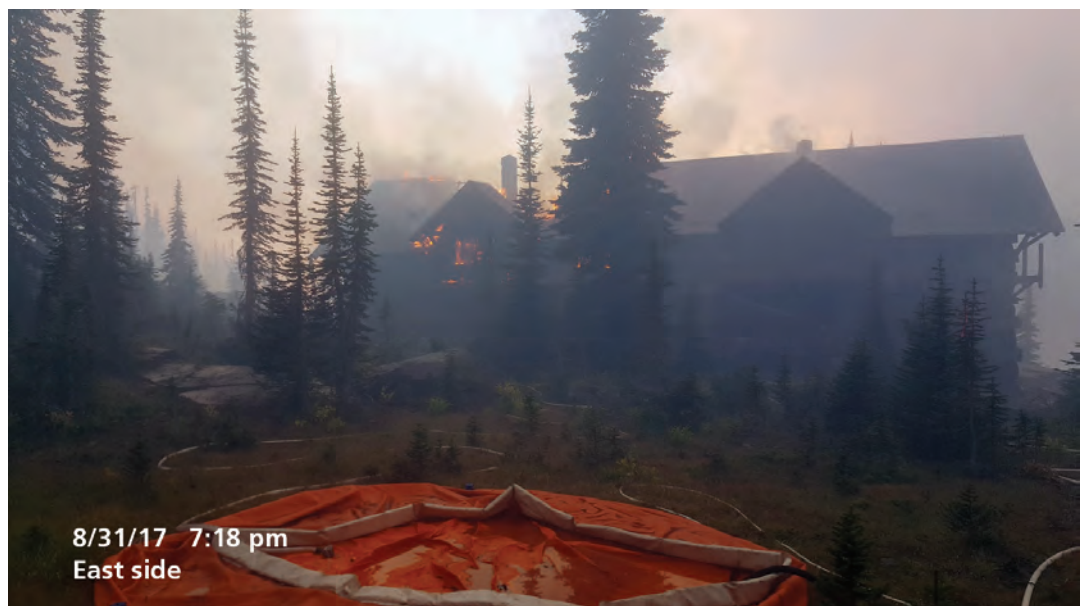
Taken from east side of dormitory, long distance from the dormitory on the east side of the empty water supply bladder (pumpkin). Shows fire decay on the south end of the dormitory and the south roof structure 50% or more consumed by fire. No flames are visible through the north roof structure.

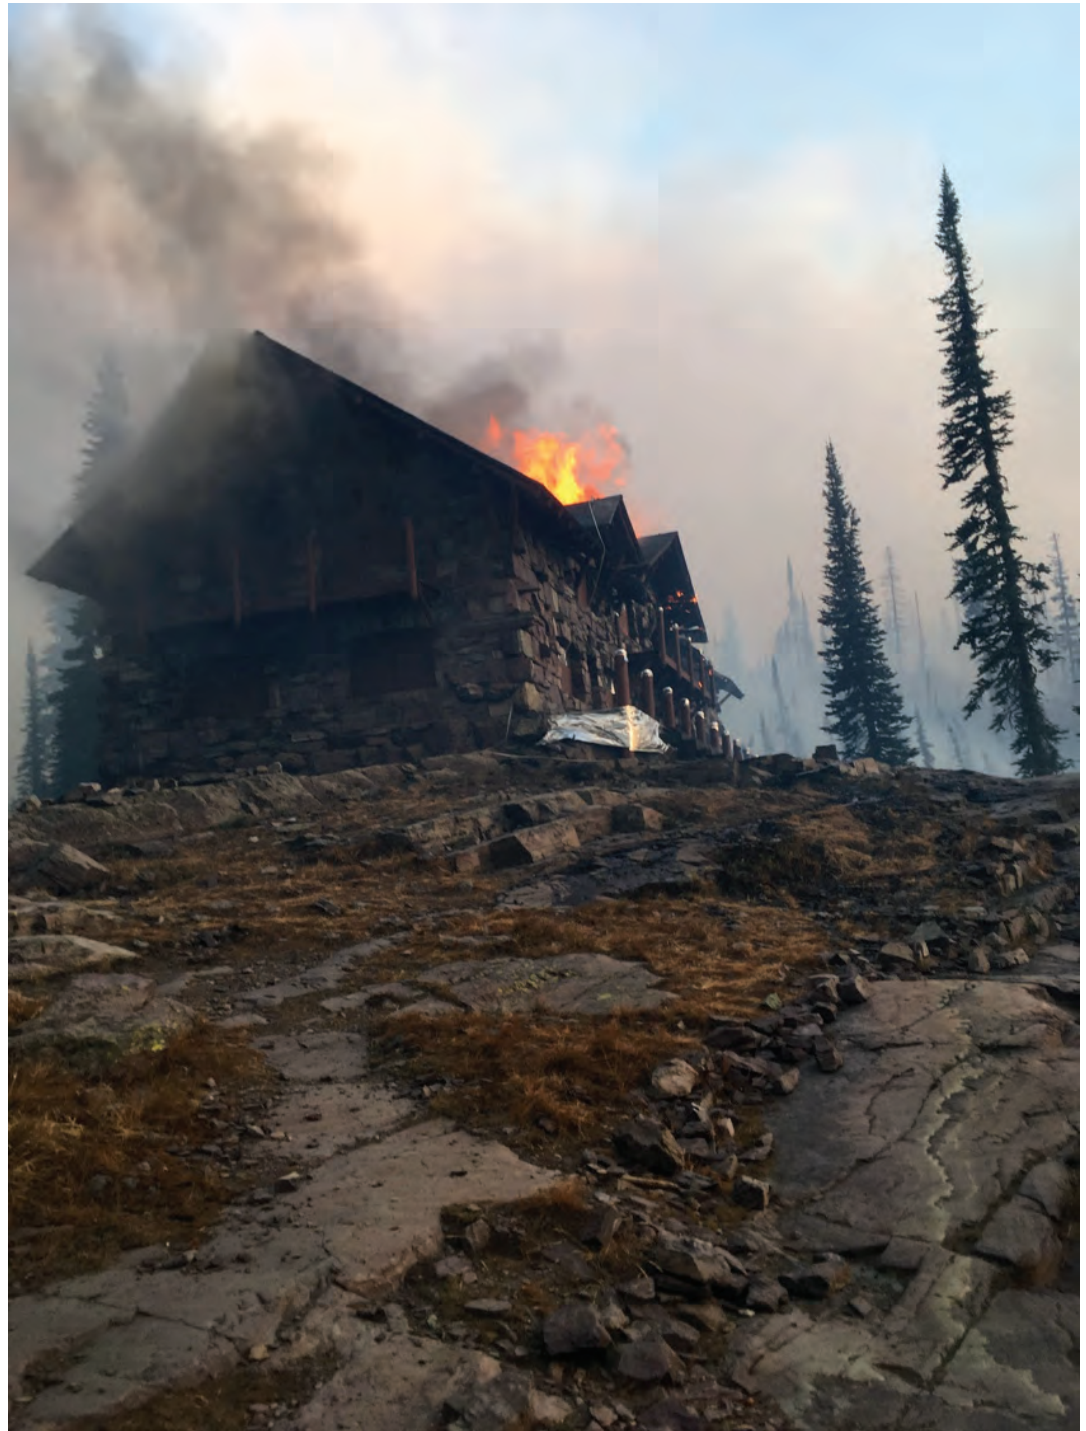
Taken from northwest corner of dormitory from a distance. Shows fire through the roof structure with heavy smoke conditions on the north end of the dormitory.

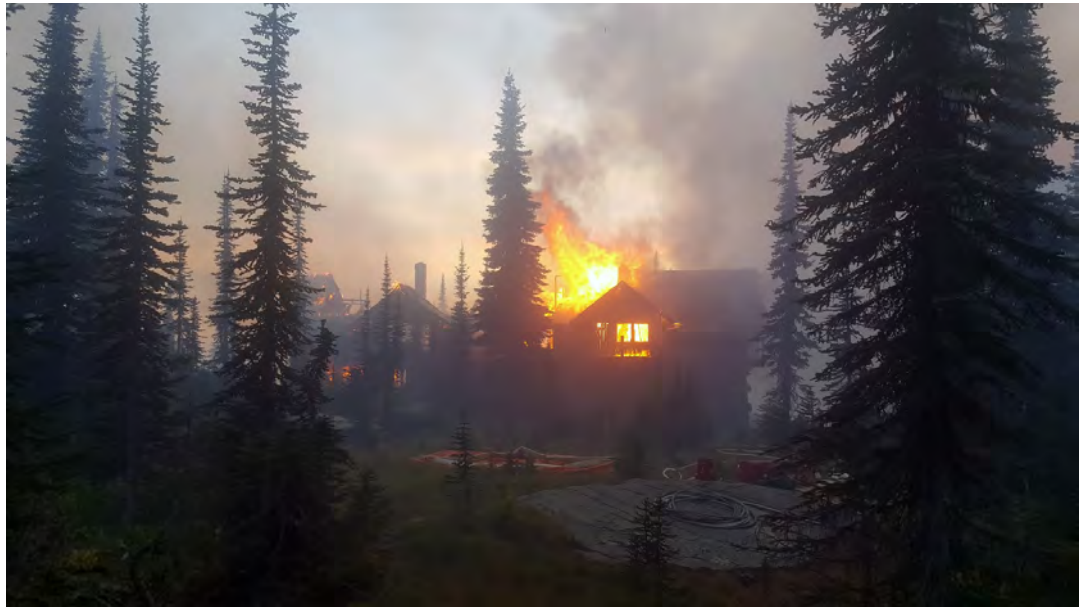
Taken from east side of dormitory, long distance from the dormitory on the east side of the empty water supply bladder (pumpkin). Shows 90% or more fire consumption of the south roof structure. Heavy fire involvement of the north roof structure is seen, with the second floor of the dormitory heavily involved in fire.

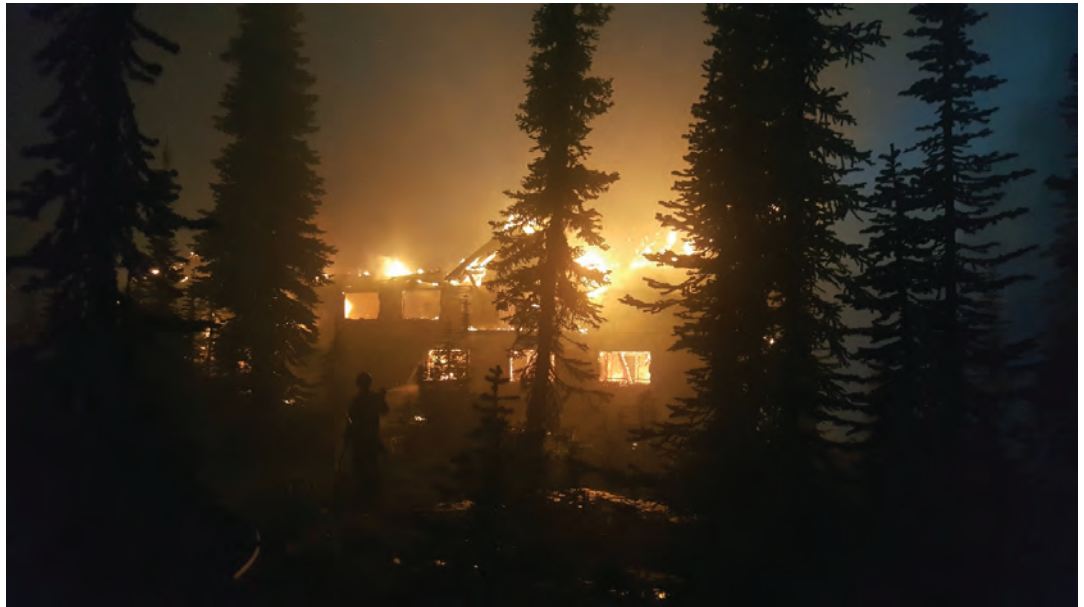
Taken from the northeast side of the dormitory, long distance from the dormitory. Shows full involvement of the entire building with fire decay noted in the south end and the majority of the north roof structure consumed by fire.

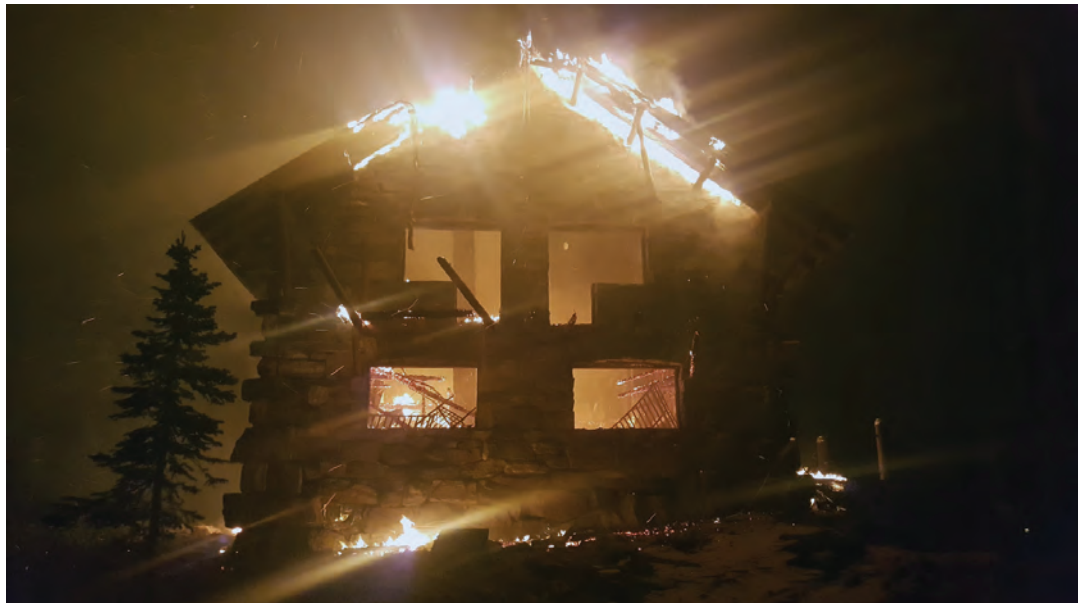
Taken from north end of the dormitory. Shows fire decay occurring inside the dormitory with fire still showing along the north gable eaves.
