Event Type: Defective Fusee Striker Caps

Date: September 19, 2019

Location: S-390/190 Field Day – Kansas National Guard Training

Firing Device Demonstration Incident

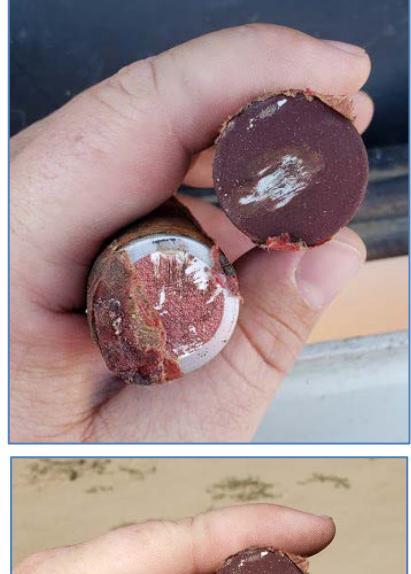
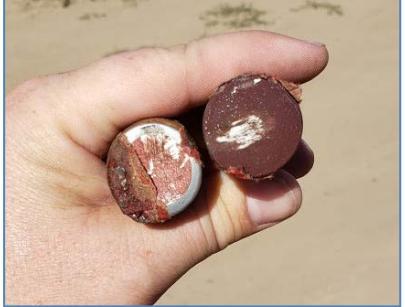
Neither the original cap or other identical caps would light any of the defective fusees. However, all defective fusees that were tested successfully ignited on the first attempt with a different style of striker.

Some fusee caps have less striking surface on them than what is common. These fusees may pose a risk to crews if they are unable to ignite them in an emergent situation, such as to burn out a safety zone or deployment site.

Two different striker caps are shown in these two photos. In both photos, the cap in the lower left position would not ignite any fusee that was struck, even after multiple strikes. This was also the case with all caps of this style that were tested. The cap in upper right in both photos ignited every fusee it struck on first strike, including those fusees that would not light with the other style of cap.
