**Skyline Road Vehicle Accident
Accident Investigation Report
Bureau of Indian Affairs, Warm Springs Agency**

July 18, 2014

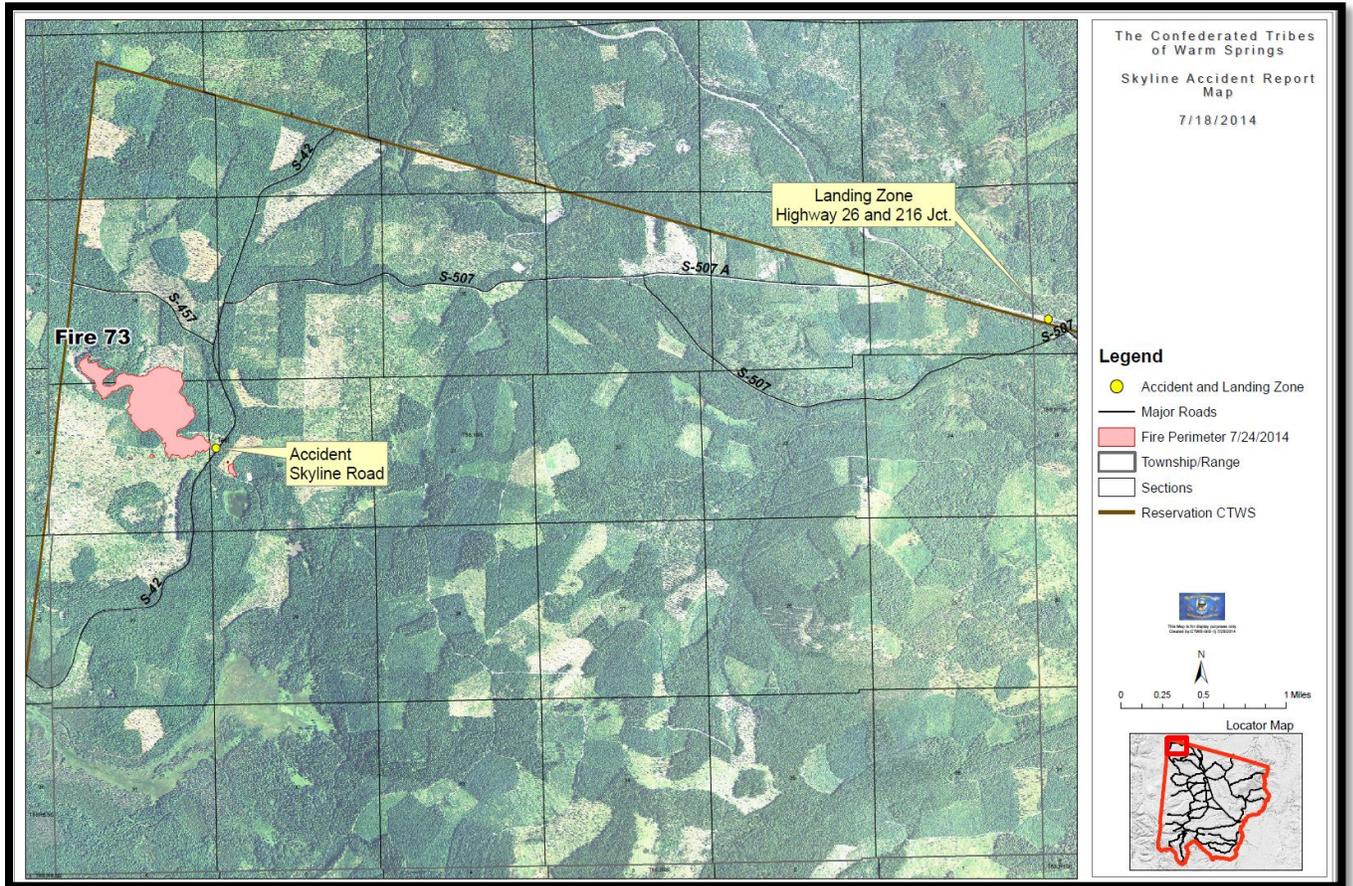
Engine 38 Motor Vehicle Crash Photo 029. Passenger Side of engine
