Rapid Lesson Sharing

Event Type: Tree Felling Mishap

Date: March 6, 2022

Location: Yellowpine Burn Unit, Angelina/Sabine National Forests, National Forests and Grasslands in Texas

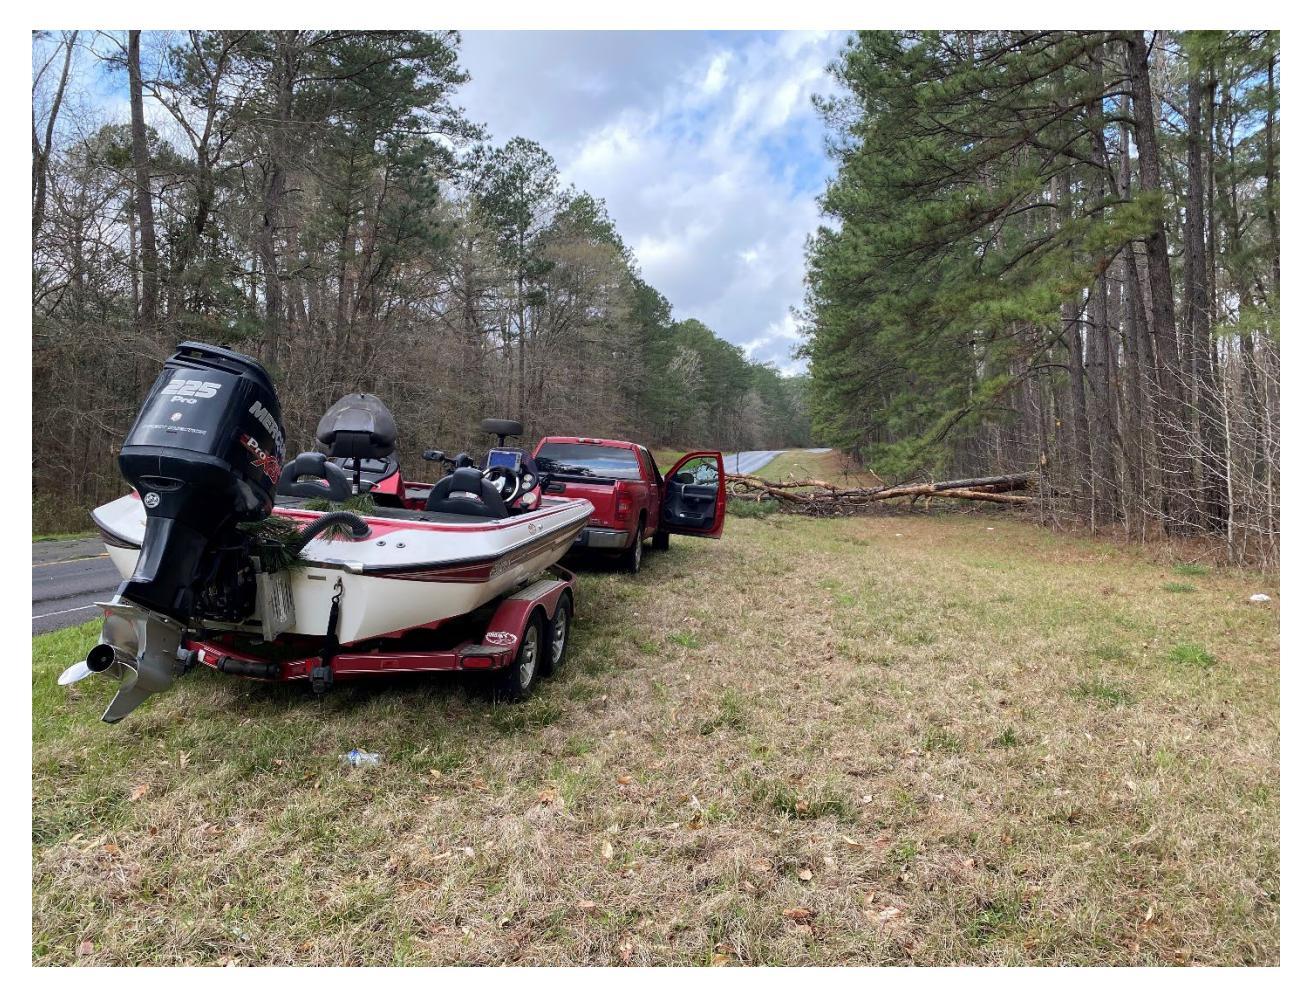
Texas Highway 87, looking west. Truck and boat with damage in foreground, trees at cutting site in background.

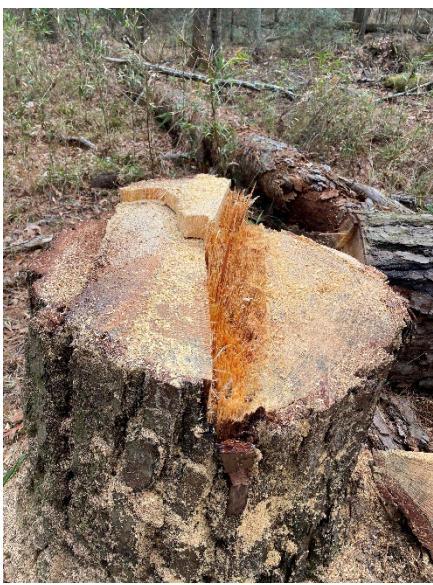
He selected what he felt was a narrow but adequate lay for the tree, which would impact the road but only the near lane. He predicted his lay would hit a 12" oak about 15' in front of the primary tree, but believed it would clear the pine trees closer to the road and only brush or snap their small limbs. Because of the 30-foot grass buffer along the highway, he was not expecting those small limbs to impact the highway.

Stump of primary cut.

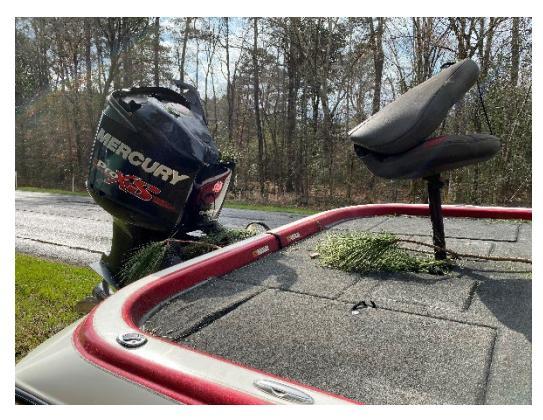
Once the trees were on the road, he quickly looked at his road guard and, as he approached him, said "that was a close call". The Engine Captain initially thought the trees had missed the red pickup and boat. The road guard also told him that while he was watching and listening for traffic in both directions, he did not see or hear the red pickup and boat until they were very near the trees' lay. The road guard stated that it was traveling so fast he didn't have a chance to signal for the truck to stop. The truck returned to the site, and it was determined that the driver was not injured, however there was damage to the boat being towed by the truck.

Damage to boat motor.
