Badger Fire Injury and Medevac

Accident Investigation Report
Bureau of Land Management, Phoenix District

05/24/2014

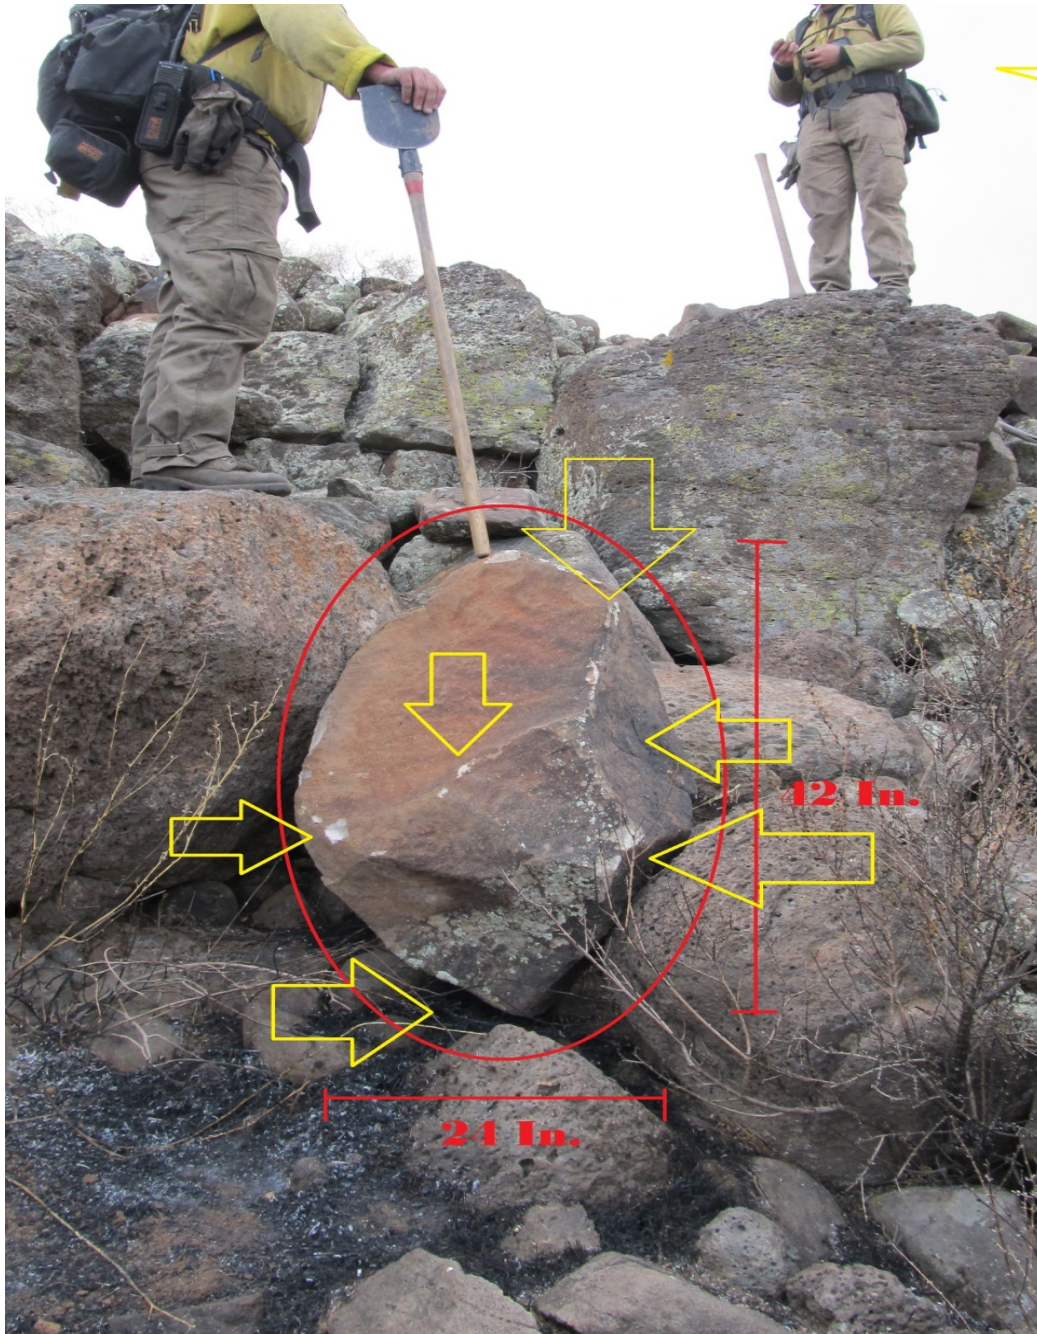
Cause of accident: The angle and nature of the terrain required three points of contact, which ultimately caused the boulder to be displaced , striking the crewmember and causing the injury.

PHOTO 1: Looking toward the mesa top from the estimated path of travel. The boulder that struck the crewmember is circled in red, in its resting position, after striking the crewmember. The approximate size of the boulder is 42" in length, by 24" wide. Yellow arrows indicate impact marks from the boulders travel from its original location, to this resting position; approximately 10 feet away and 4 feet below.

Recommendation: Rugged terrain remains one of the highest risks firefighters are exposed to in the performance of their duties. This hazard cannot be removed from the fireline environment and should be addressed through on-going field risk management process. If an area poses too much risk for mitigation, avoidance should be considered as an option.

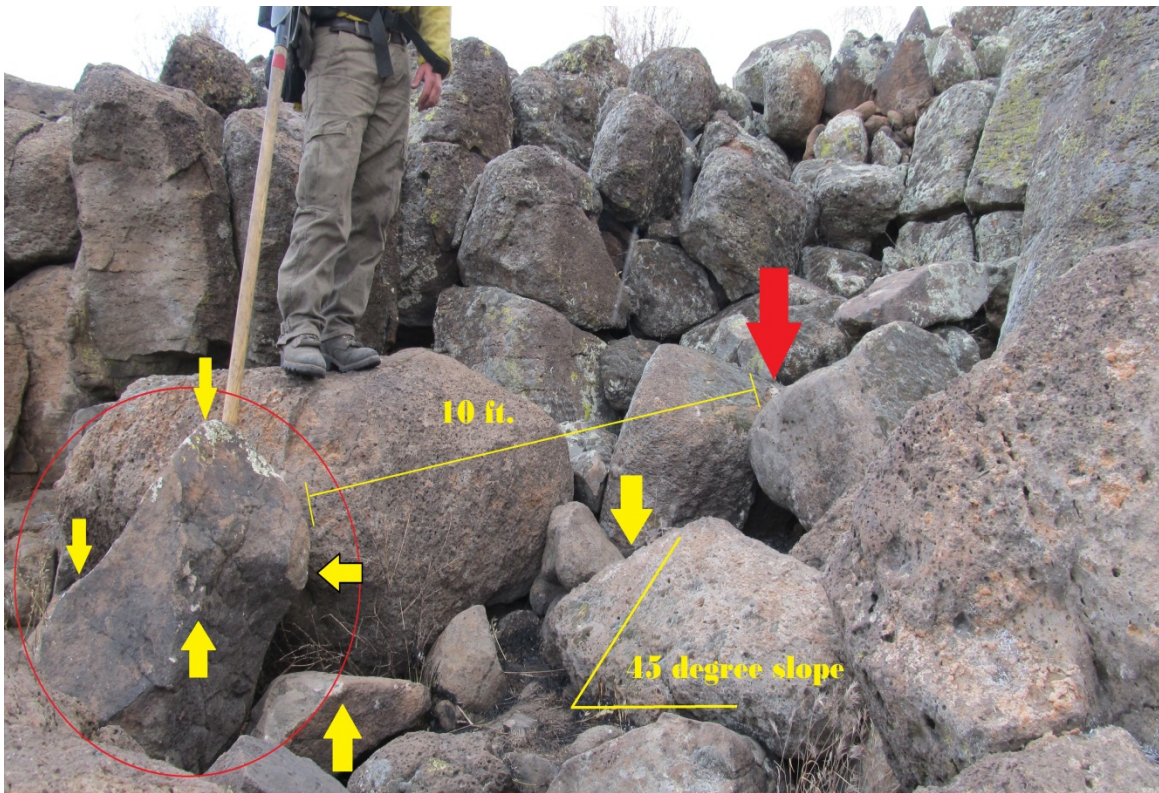
Throughout the hike, the team collected slope measurements; photographs observed environmental conditions and discussed fire behavior and crew actions. Arriving at the site, the team and local unit reenacted the accident using the facts available. The original orientation of the boulder is unknown. Slope angles in the area of the accident site ranged from 37-46 degrees, with large, stacked boulders. Many aspects of this area require 3 points of contact to maneuver. There was no evidence to support the burned vegetation compromised the stability of the boulder. Given the terrain constriction and adjacent cliffs, location of the fireline and fuel type, the path the crew member chose was determined to be appropriate, based on the assigned task.

PHOTO 2: Red arrow indicates the original location of the boulder. The red circle identifies the resting position of the boulder after striking the crewmember. Yellow arrows identify impact areas from the boulders travel. The slope directly below the boulder's original location was measured by clinometer to be 45 degrees. Other slope angles at the site were measured between 37-48 degrees.

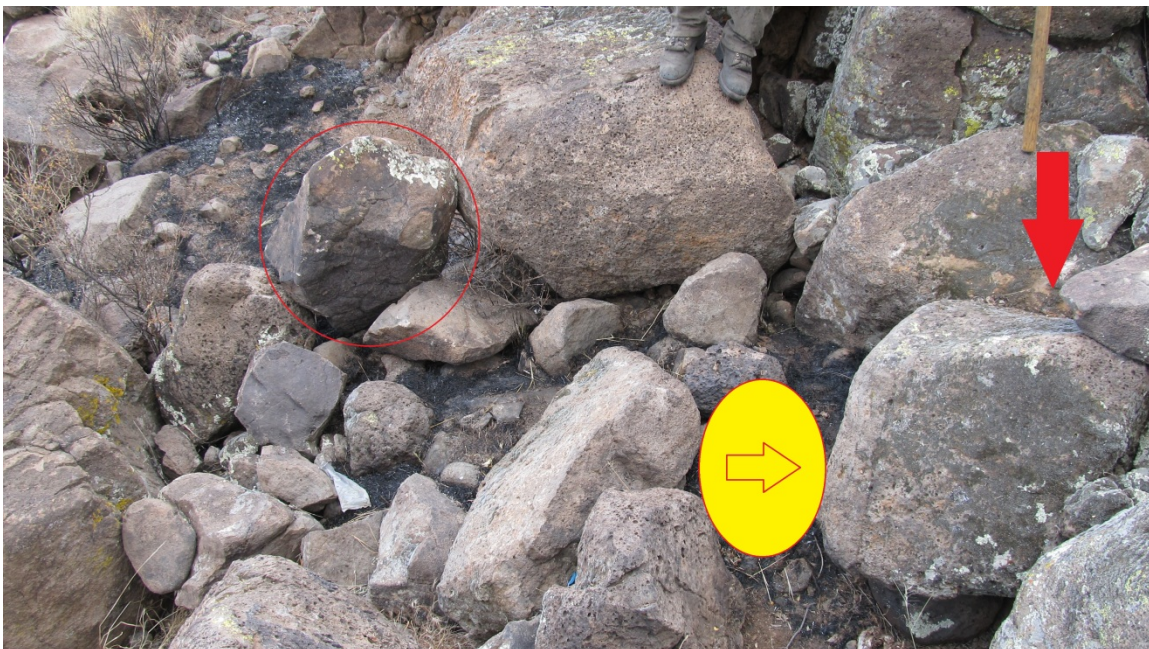
PHOTO 3: Solid red arrow shows original position of boulder and circled in its final resting position. Yellow circle shows approximate footing of crewmember and arrow indicates direction of travel.

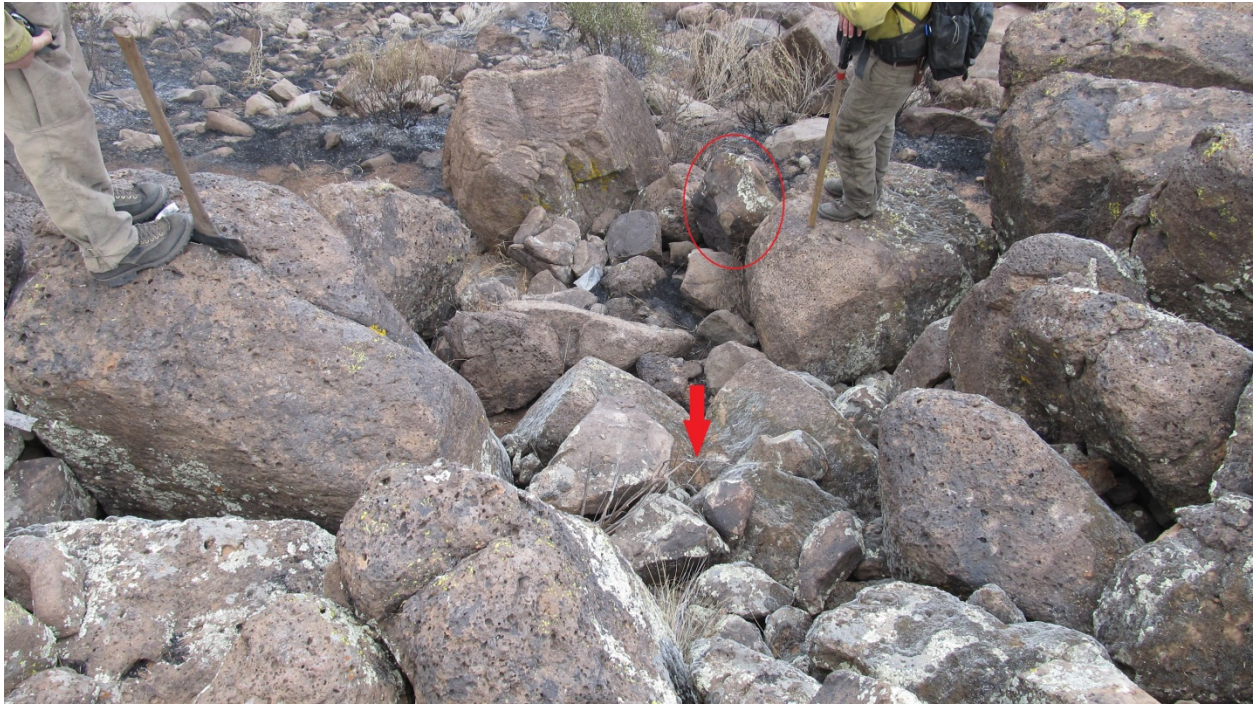
PHOTO 4: View from the top of the mesa, the crewmembers destination, looking down at the accident site. Red arrow is original position of boulder; circle is boulder in resting position.

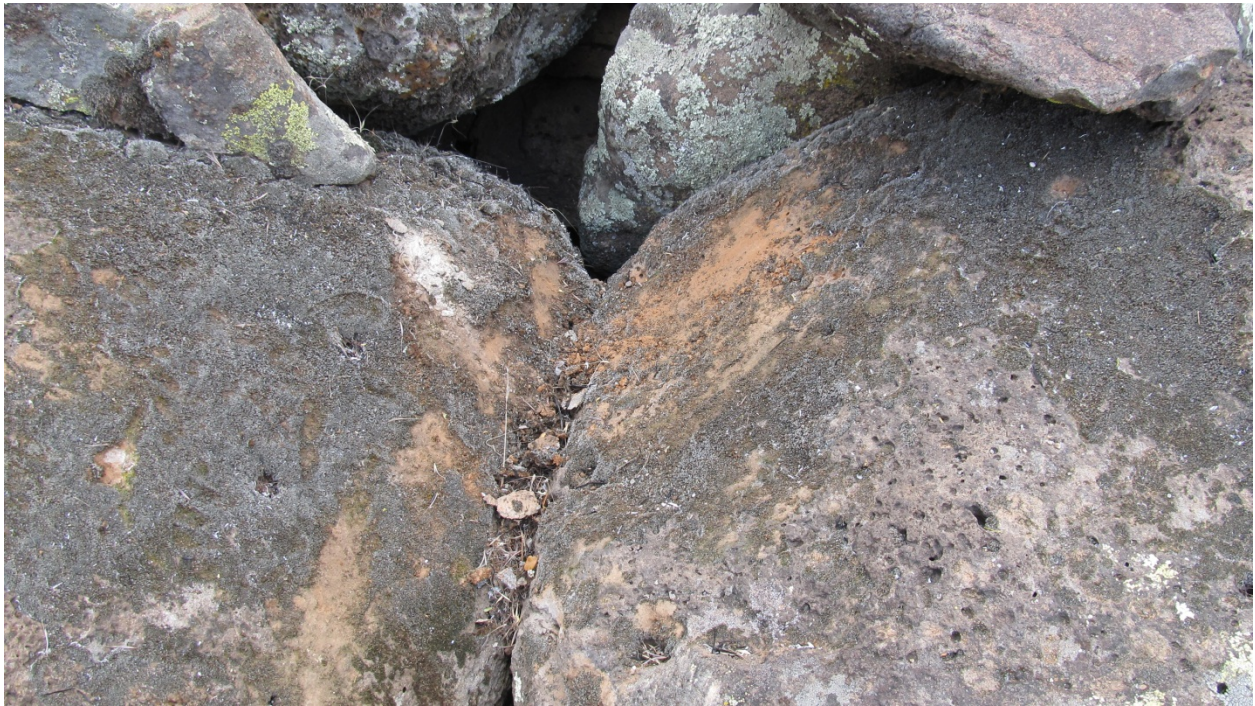
PHOTO 5: Original resting position of boulder. Burned vegetation not a contributing factor.

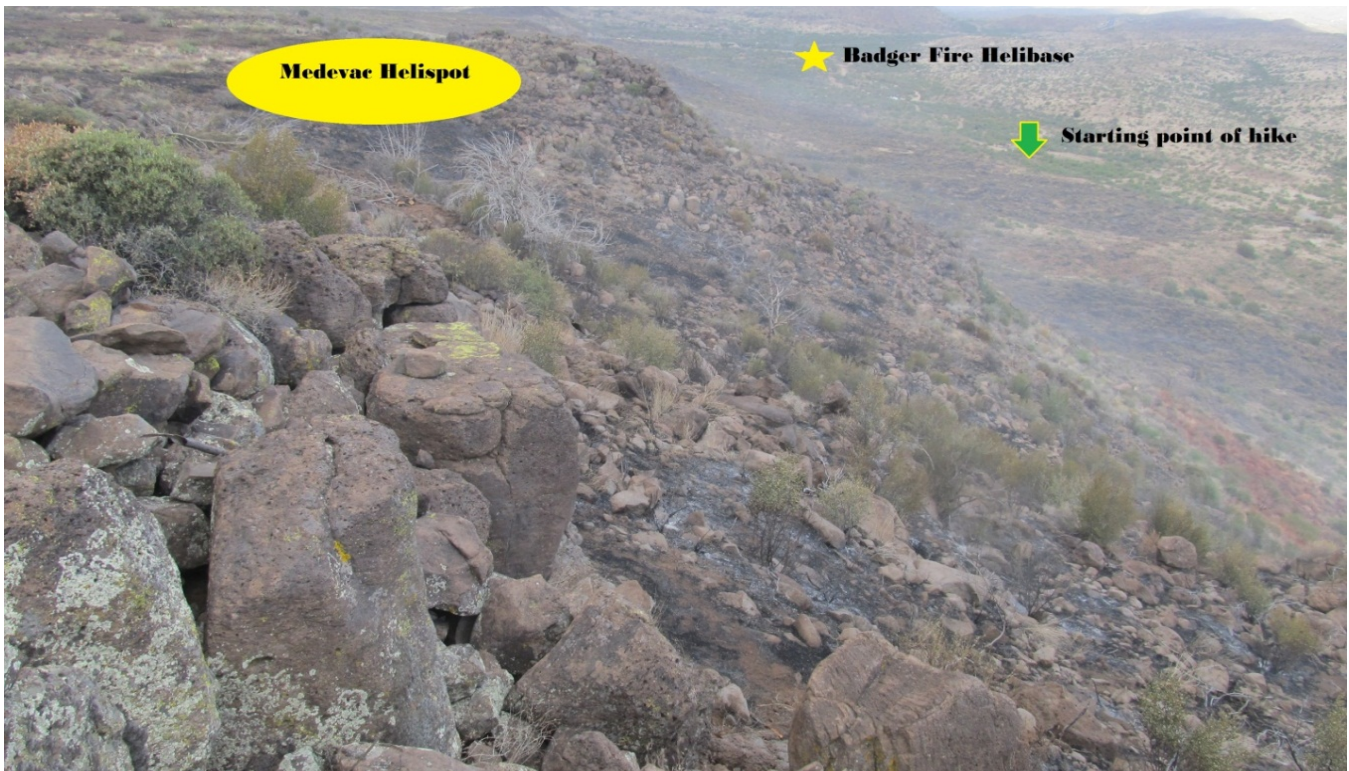
PHOTO 6: View from the top of the mesa, just above accident site, looking West/Northwest. The yellow circle identifies the location of the MEDEVAC helispot that the patient hiked to under his own power, with assistance from the crew. The yellow star identifies the location of the Badger Fire Helibase, near exit 256, Beaver Springs, on Interstate 17. The green arrow is the starting point of the crew's cold trailing operations.
