Event Type: Helicopter Rotor Strike Date: July 8, 2018 Location: North Spring Fire, Colorado

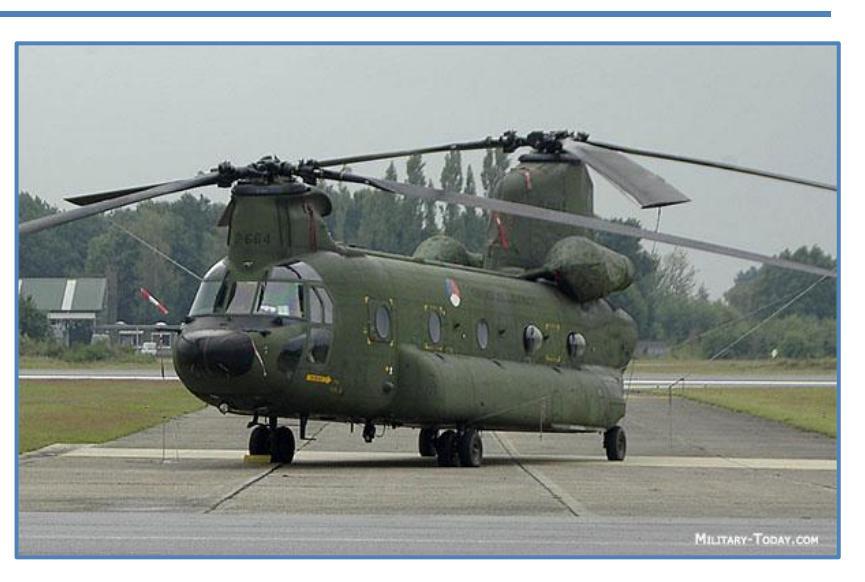
A Chinook Helicopter similar to the one on the North Spring Creek Fire incident.

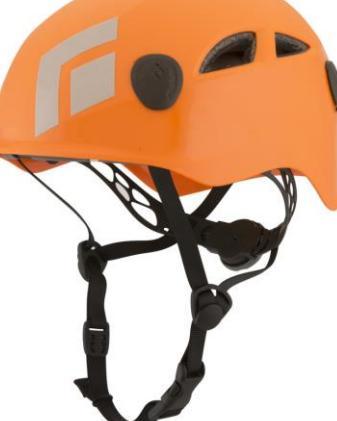
- Within the past year, the company has implemented a safety practice that requires all crew members climbing on the aircraft to wear safety helmets. Fortunately, the crew member during this accident was wearing the provided safety helmet which potentially prevented further injury.

Similar helmet to the one being used by the Chinook Helicopter crew.
