Rapid Lesson Sharing

Event Type: Forwarder Tip-Over

Date: August 29, 2014

Location: Deception Complex

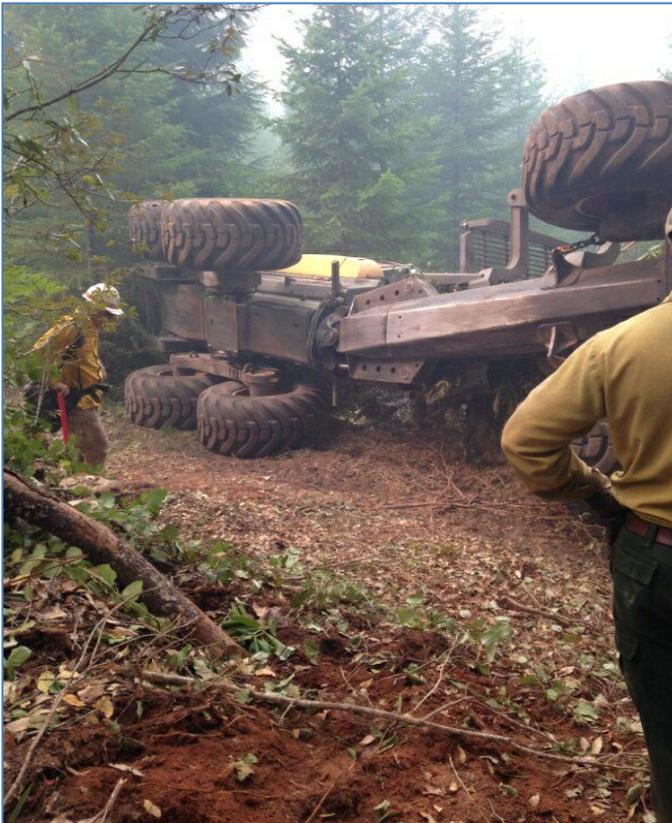
As the Forwarder came over the bump and made the turn, the load of logs began oscillating and tilted to the downhill side. The Operator—thinking that the load would settle—continued forward, knowing that it’s typical for the machine to tilt like this when loaded. Normally, the load would settle because of the self-balancing mechanisms built into the machine. However, unbeknownst to the Operator, one of the Forwarder’s tires under the load of logs had become flat. This allowed the load to tilt more than usual. As the load of logs slowly tilted more, gravity took over and pulled the entire machine onto its side.

- ✓ The contractor held an AAR after righting and getting the Forwarder out to the road to review what had happened. During this review it was determined that a tire had gone flat on the haul. Thus, when the Forwarder made the turn, this flat tire allowed for too great a lean to the downhill side. With that knowledge, they looked for any adjustments or changes that they could make to the operational plan.

- ✓ It was determined to adjust load sizes so that the grapple would ride lower, therefore keeping a lower center of gravity.
