## Accident Investigation Report

### Serious Injury Investigation Factual Report

#### Silver Fire Gray Water Truck Accident

Region 5, Plumas National Forest  
Quincy, CA

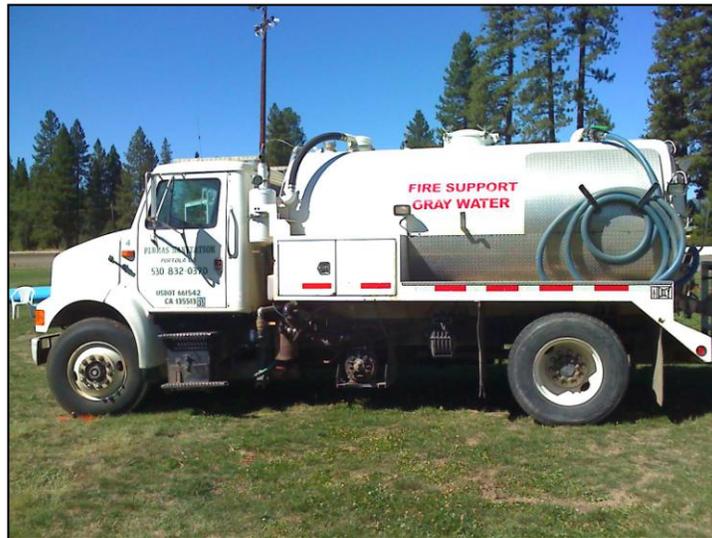
Gray water truck E-27

This truck, a 1990 International model 8100 gray water truck is a large commercial vehicle and weighs about 13,500 lbs. At the time of the incident, the driver told CHP he had just recovered about 1500 gallons of gray water from the shower bladder, which weighs an additional 12,510 lbs. The truck was scheduled to pump at night and after showers in the mornings to handle peak times. The operator usually does not have a spotter.

The truck was subjected to a Pre-Use Inspection on September 20, 2009, prior to its being placed into service. The truck passed the mechanical inspection; reported as satisfactory for use.

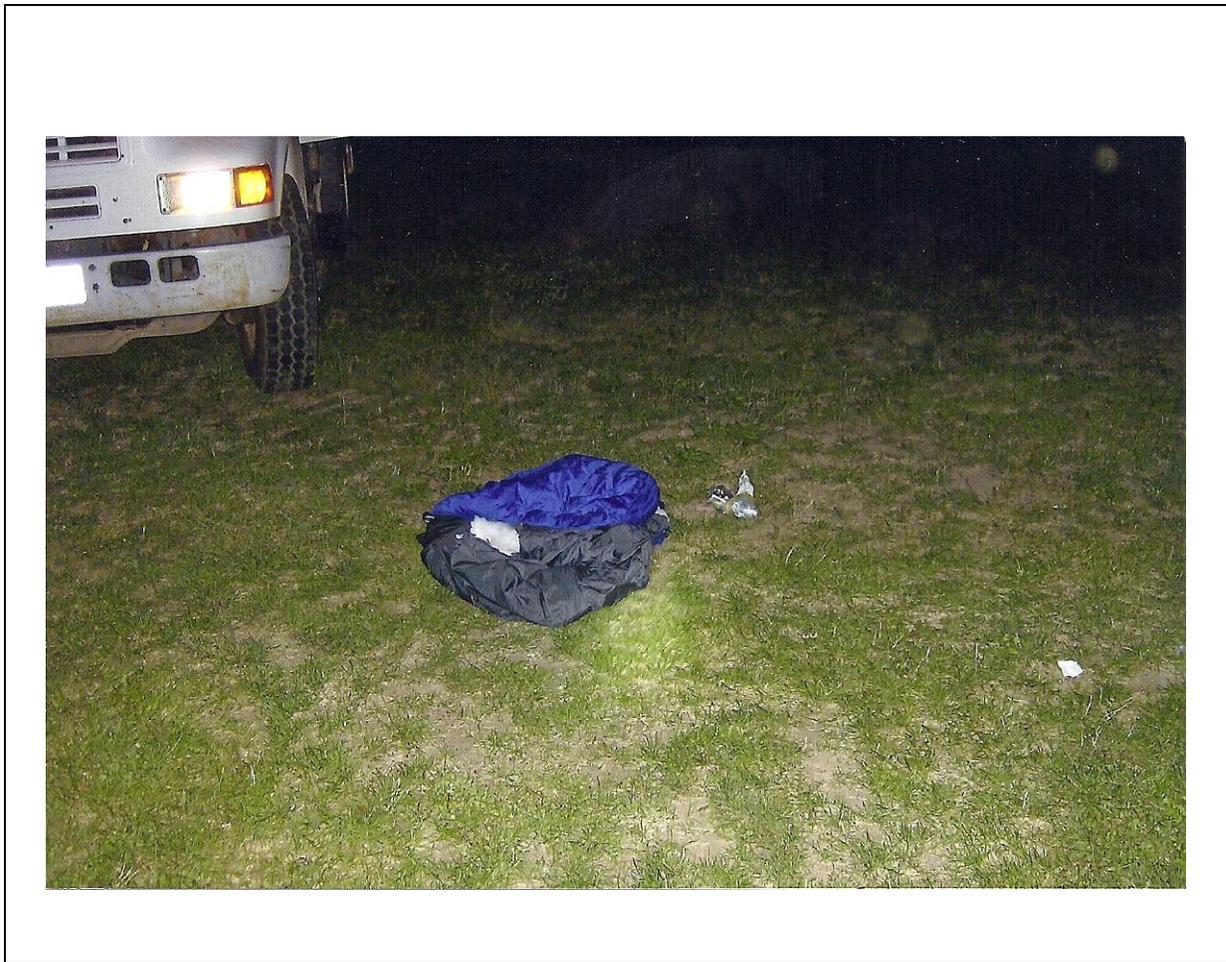
Gray water truck E-27 with sleeping bag in original position. Scene still secured.

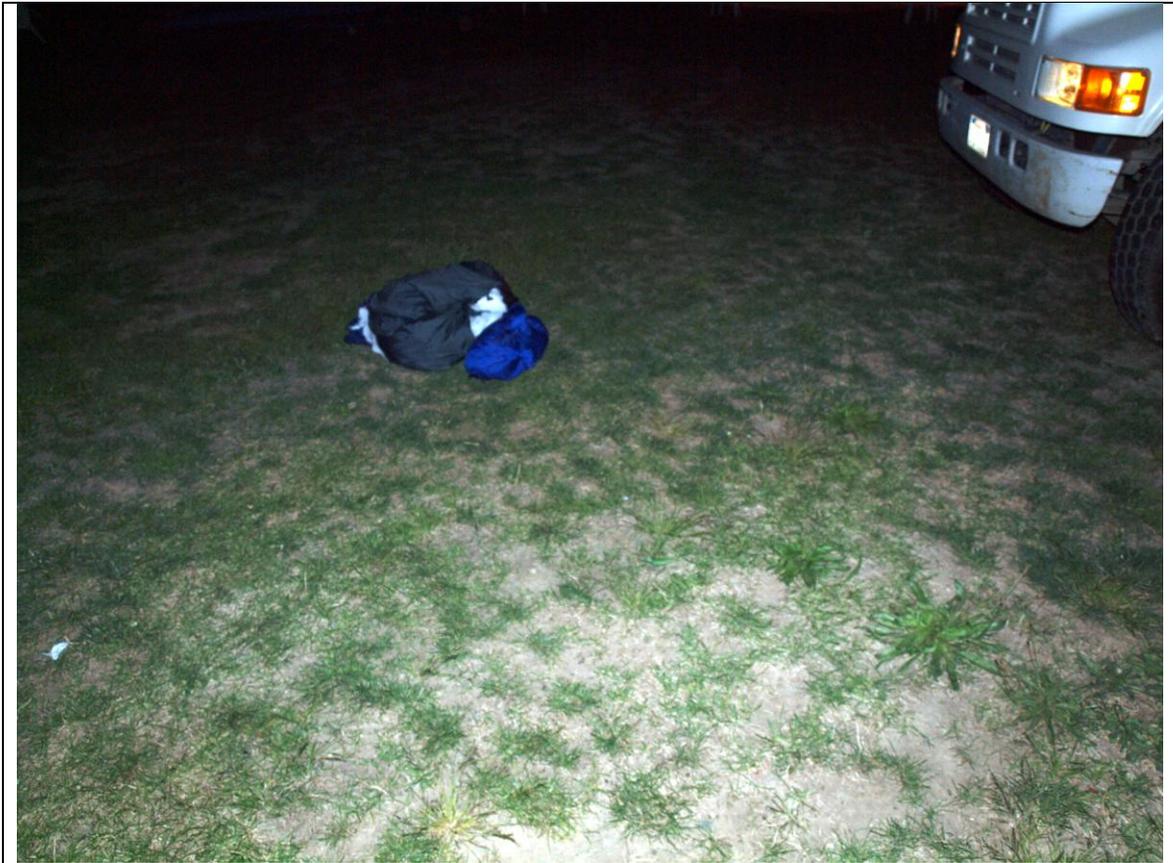
Gray water truck E-27 and sleeping bag in original position. Scene still secured.

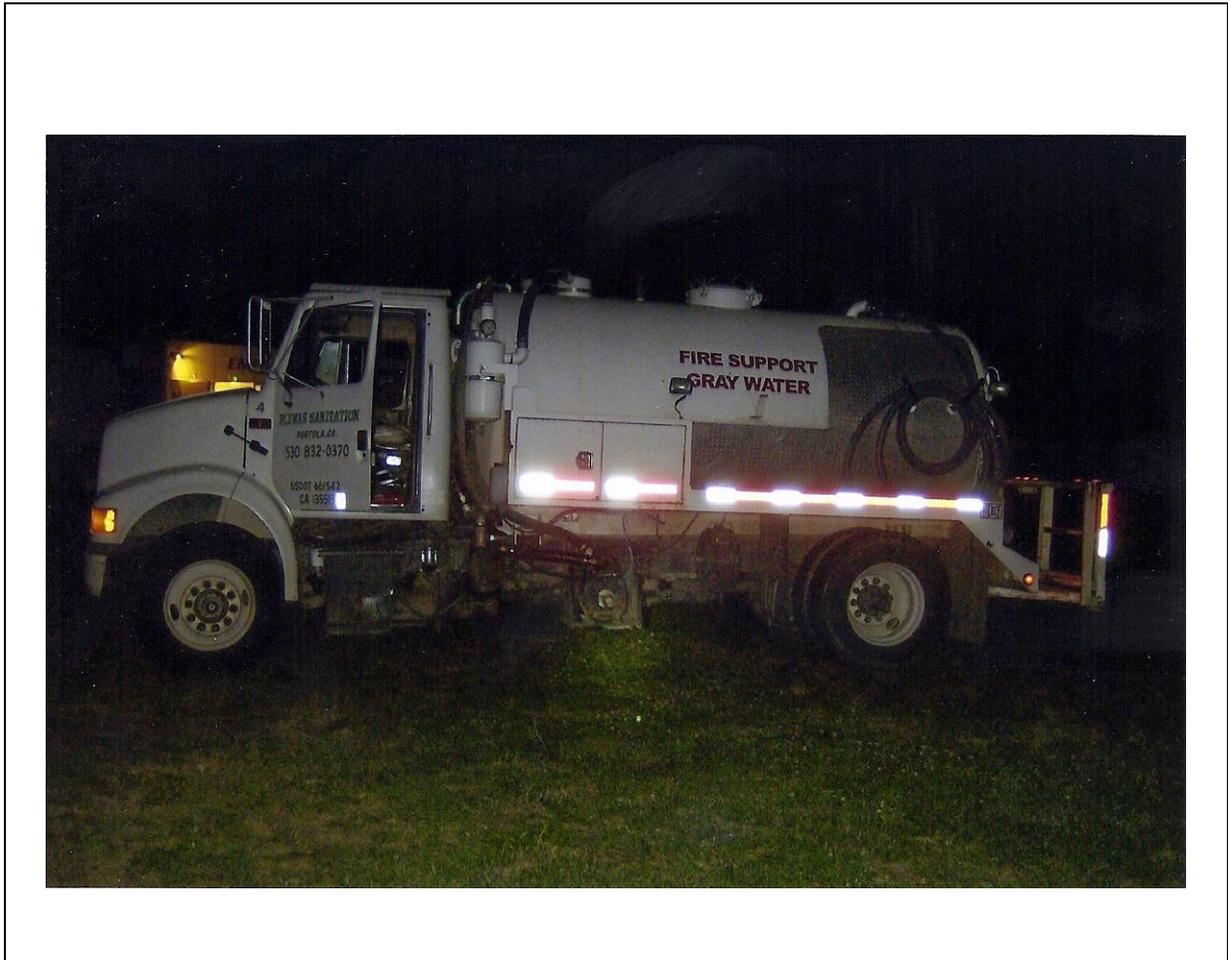
Gray water truck E-27 with headlights still on. Left view. Scene still secured.

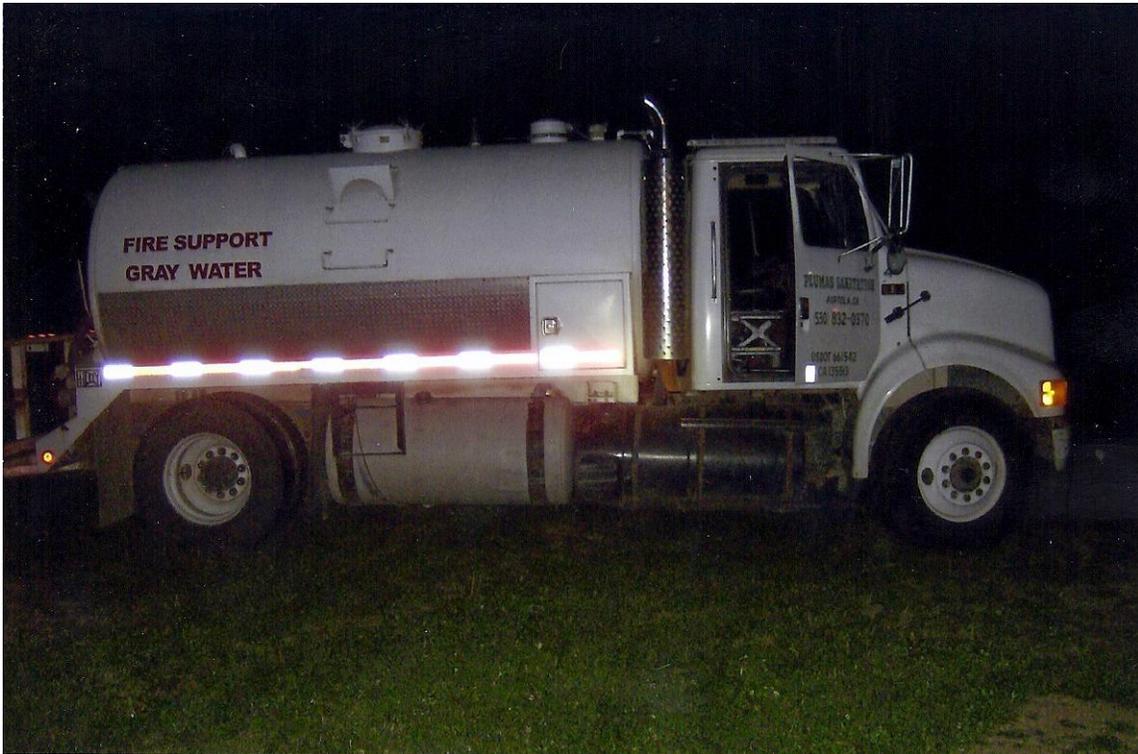
Gray water truck E-27 with headlights still on. Right view. Scene still secured.

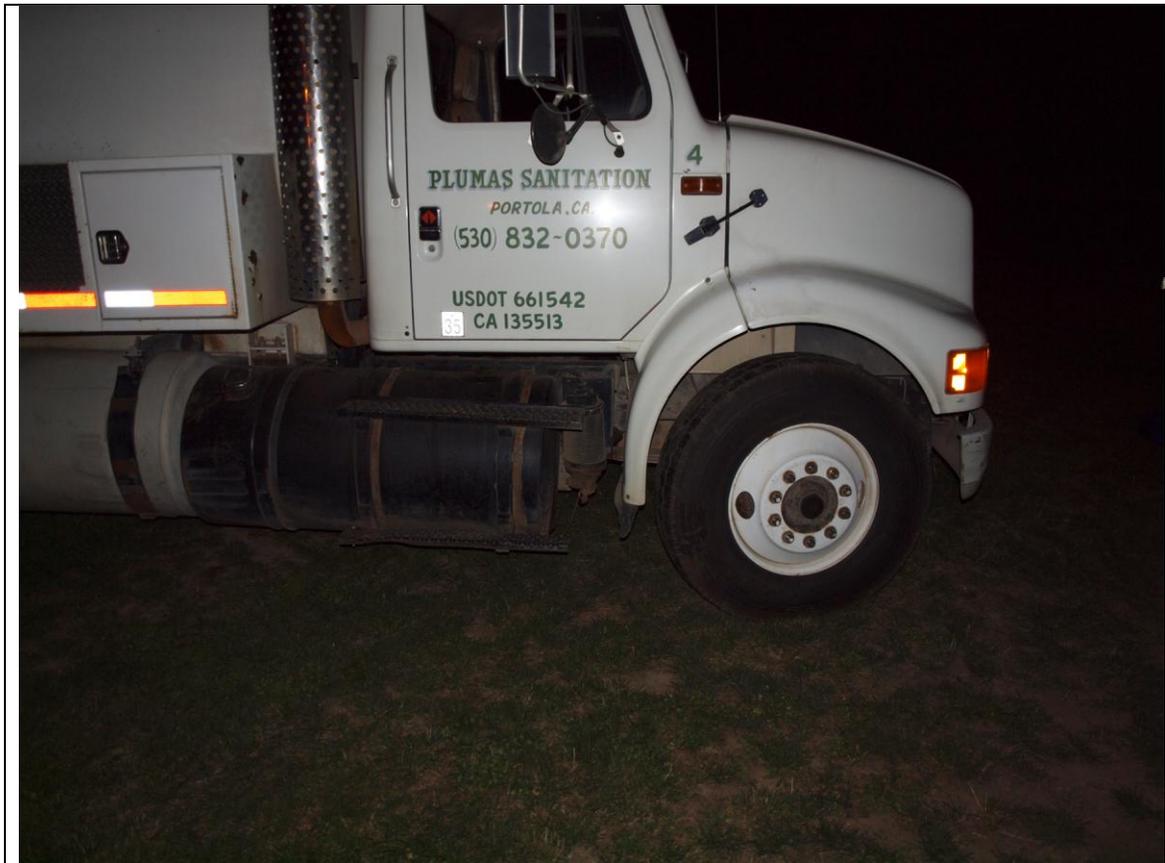
Gray water truck E-27 with headlights still on. Showing owner door info.

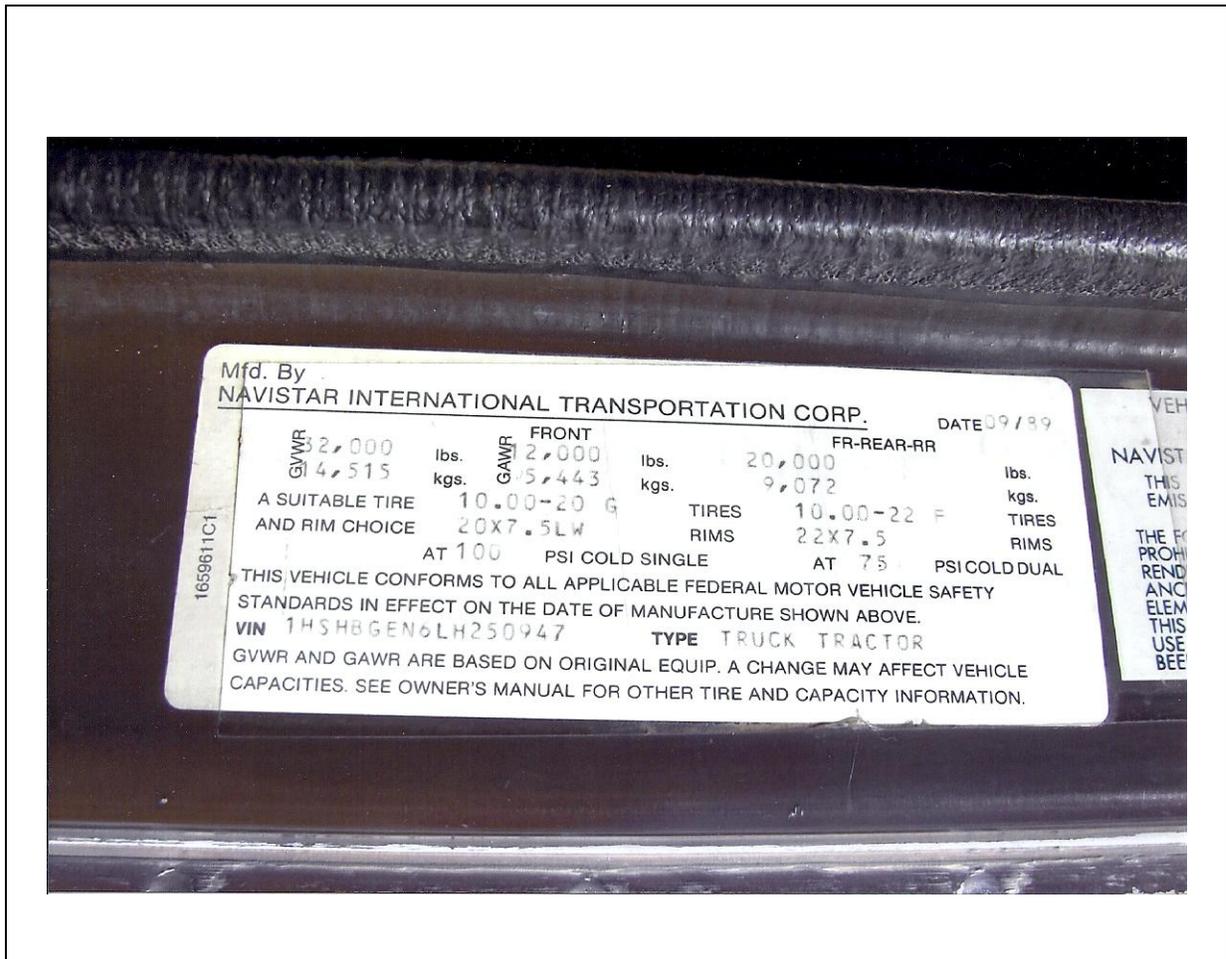
Description of photograph:  
Gray water truck E-27 mfg plate.

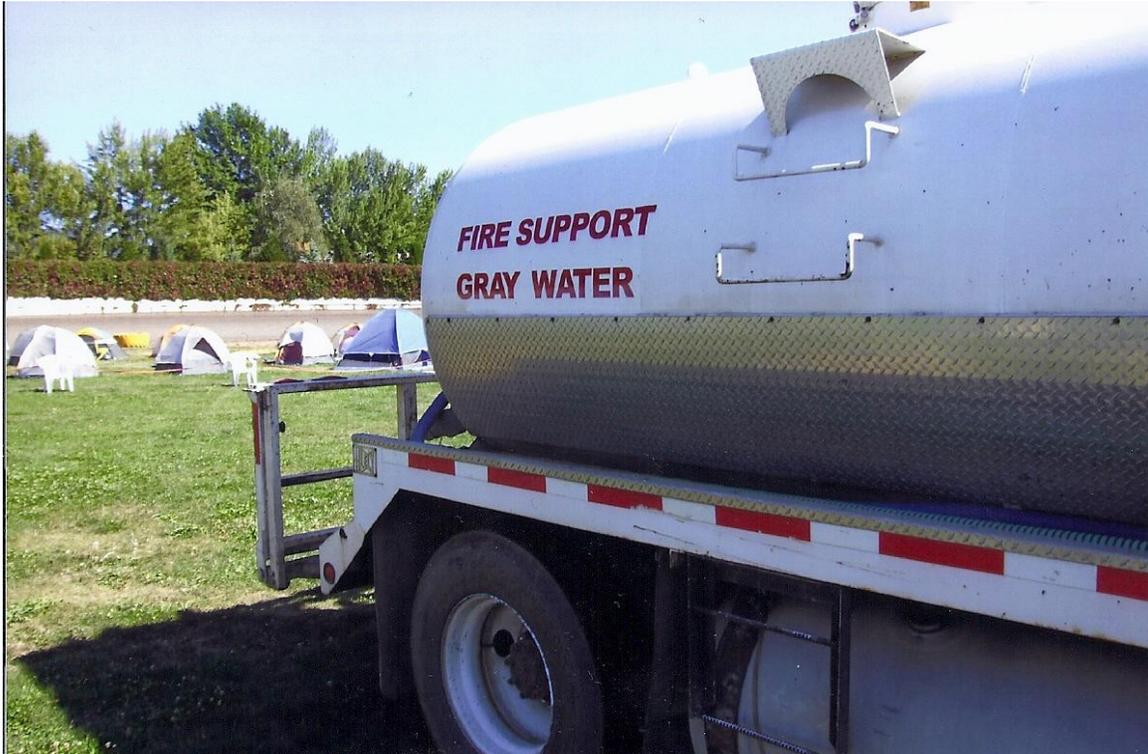
Gray water truck E-27 with CCC tents behind. Scene still secured.

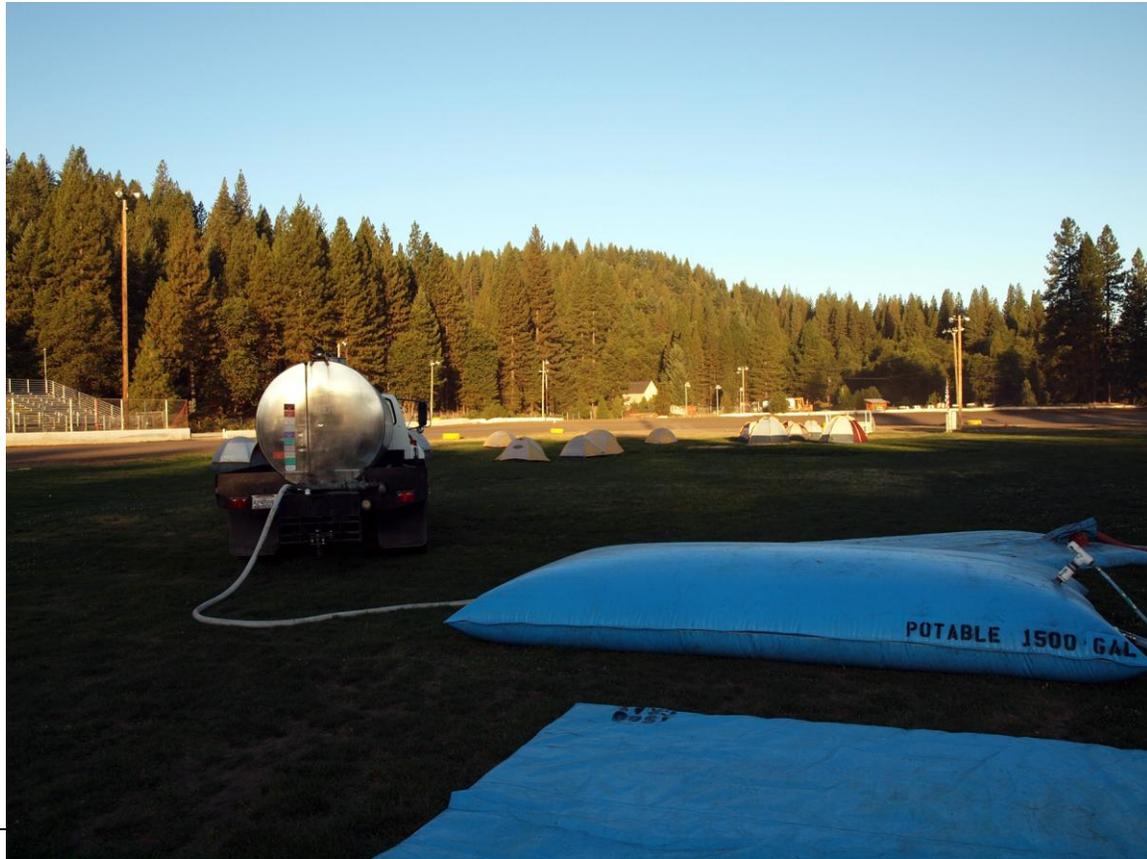
1500 gal water bladders attached to shower unit. Unk truck attached. More sleeping tents to E of shower unit. Picture taken facing W.

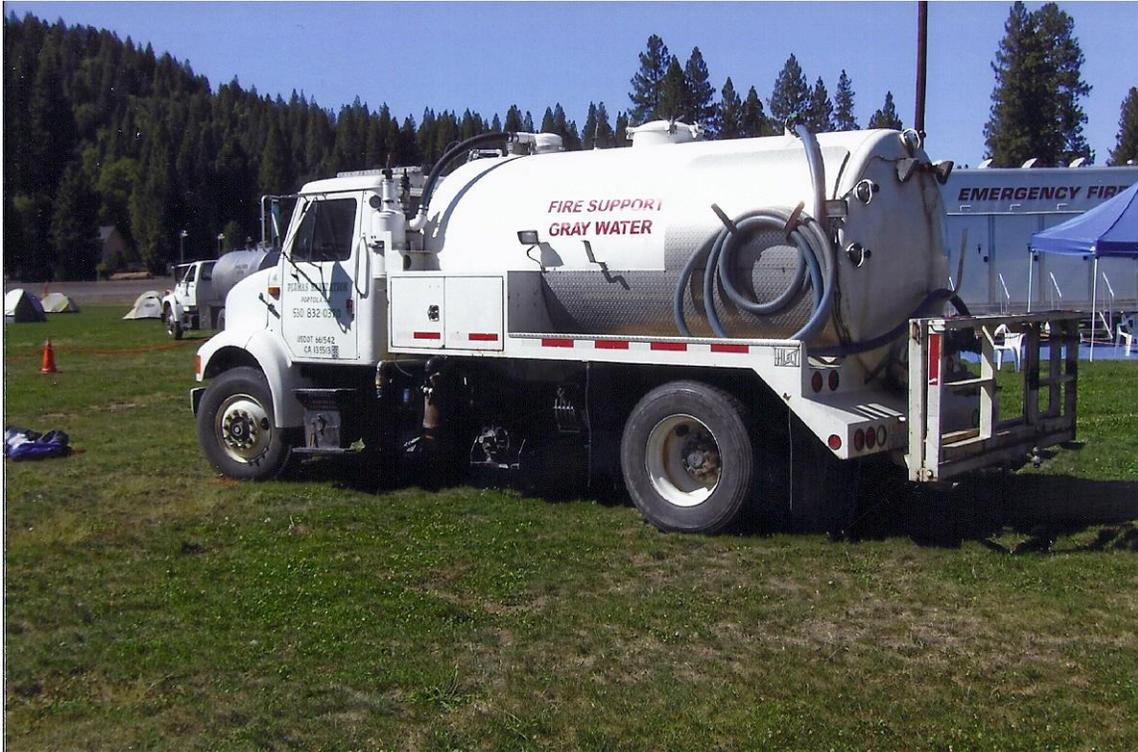
Gray water truck E-27. Sleeping bag in original position. Shower unit on Right. Scene still secured. Picture taken facing W.

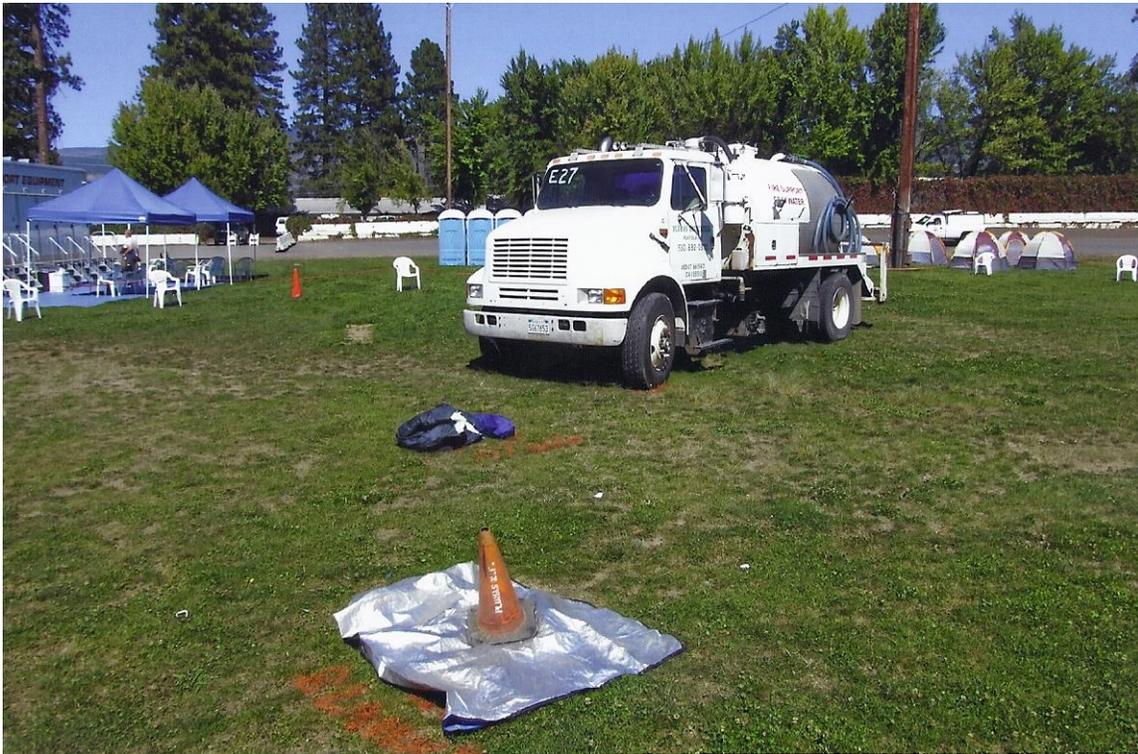
Gray water truck E-27. Sleeping bag and space blanket (cone) in original positions with CCC tents behind. Shower unit on left. Scene still secured. Picture taken facing NE.

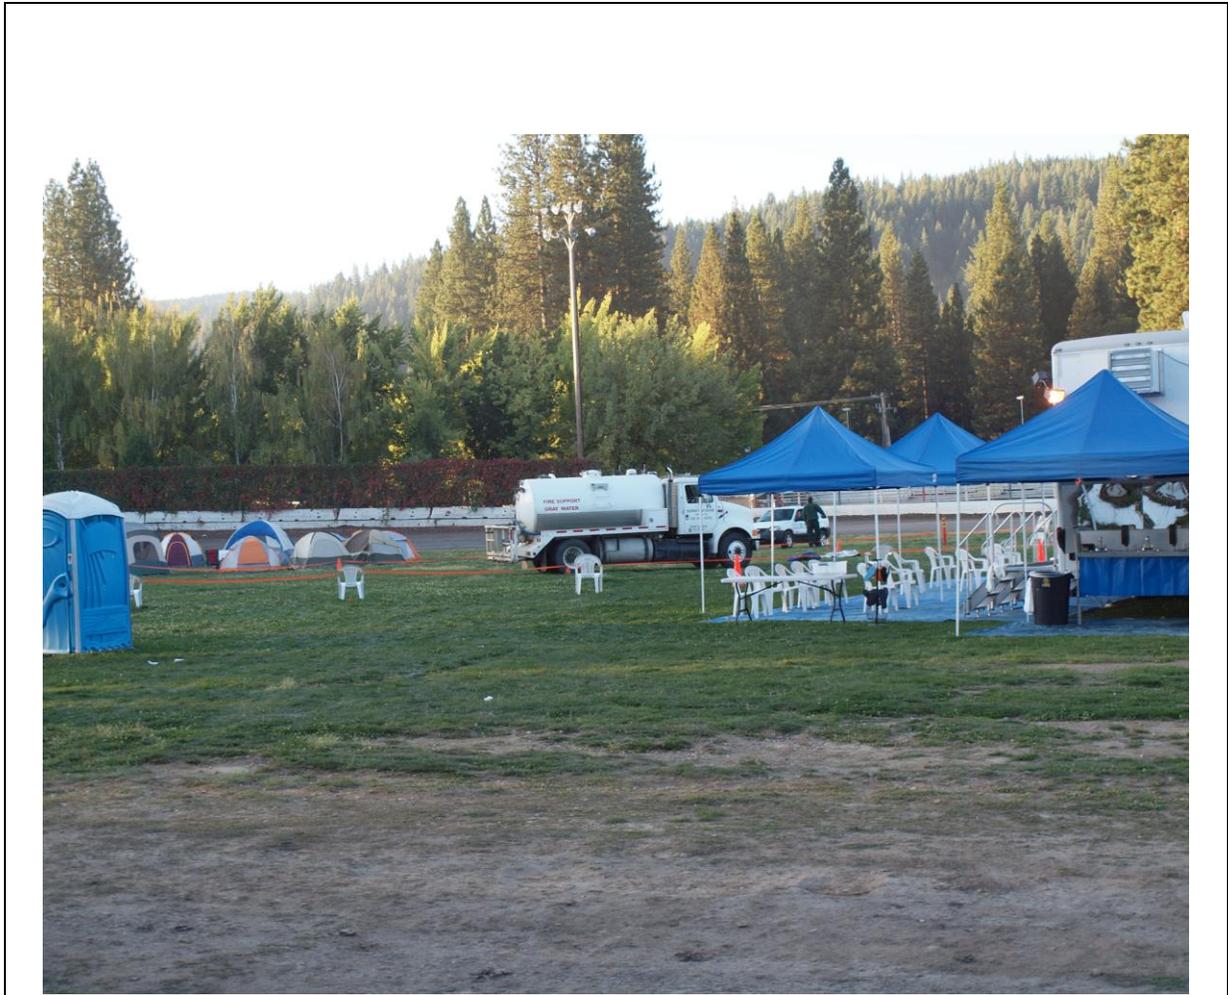
Gray water truck E-27 with CCC tents behind. Shower unit on right. Scene still secured. Picture taken facing S.

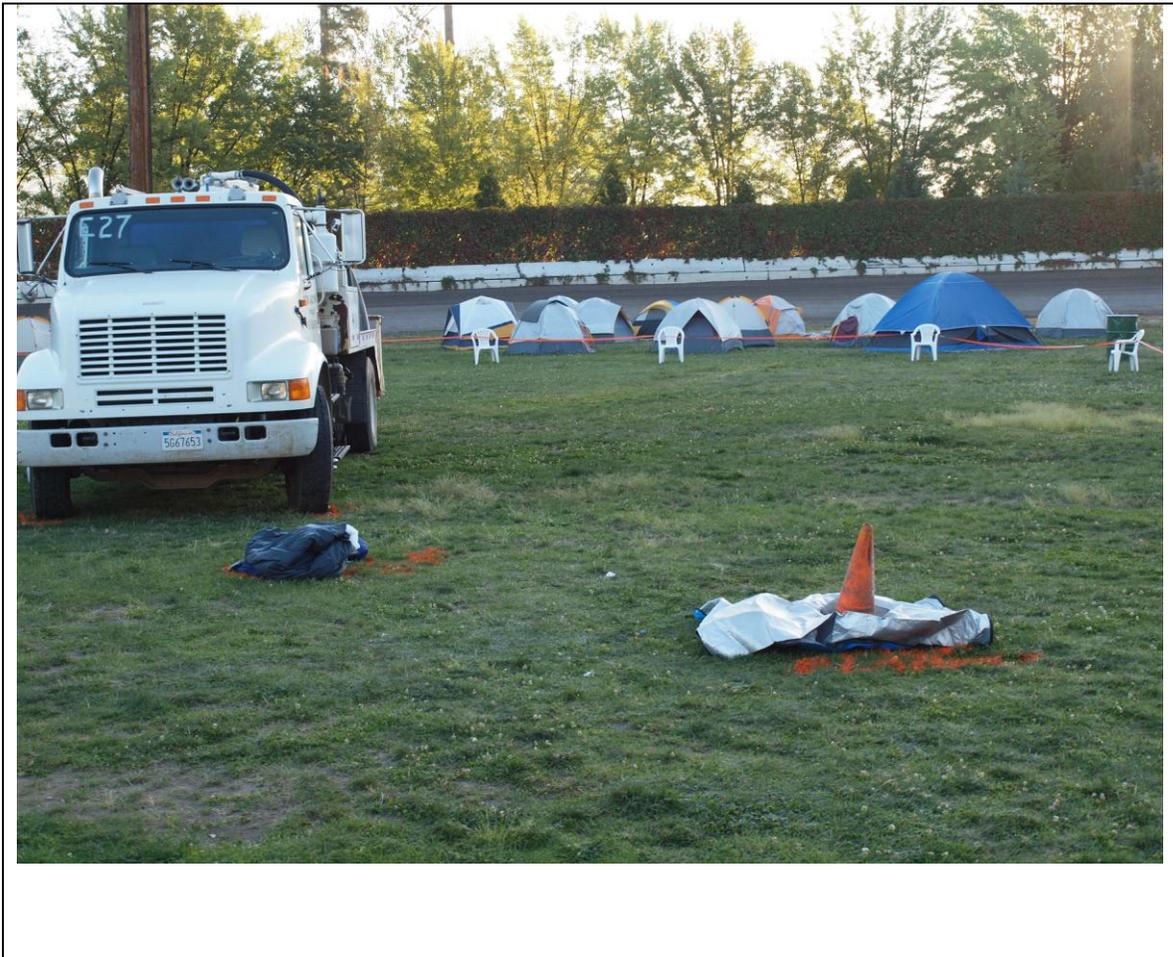
Gray water truck E-27. Sleeping bag and space blanket (cone) in original positions with CCC tents behind. Scene still secured. Picture taken facing E.

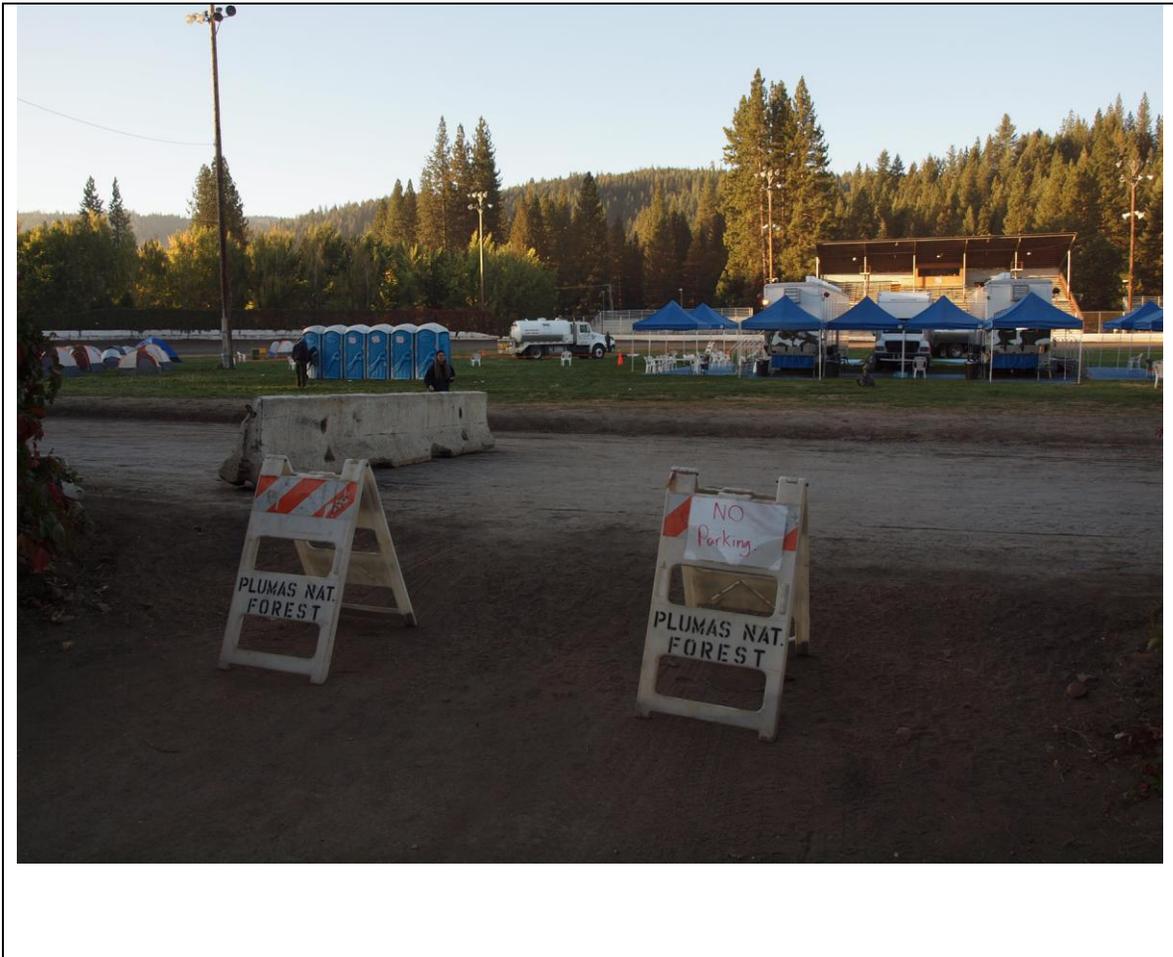
Gray water truck E-27 with CCC tents on Left, Shower unit on Right. Scene still secured. Picture taken facing N. Main entrance to racetrack from stable area. Picture facing S.

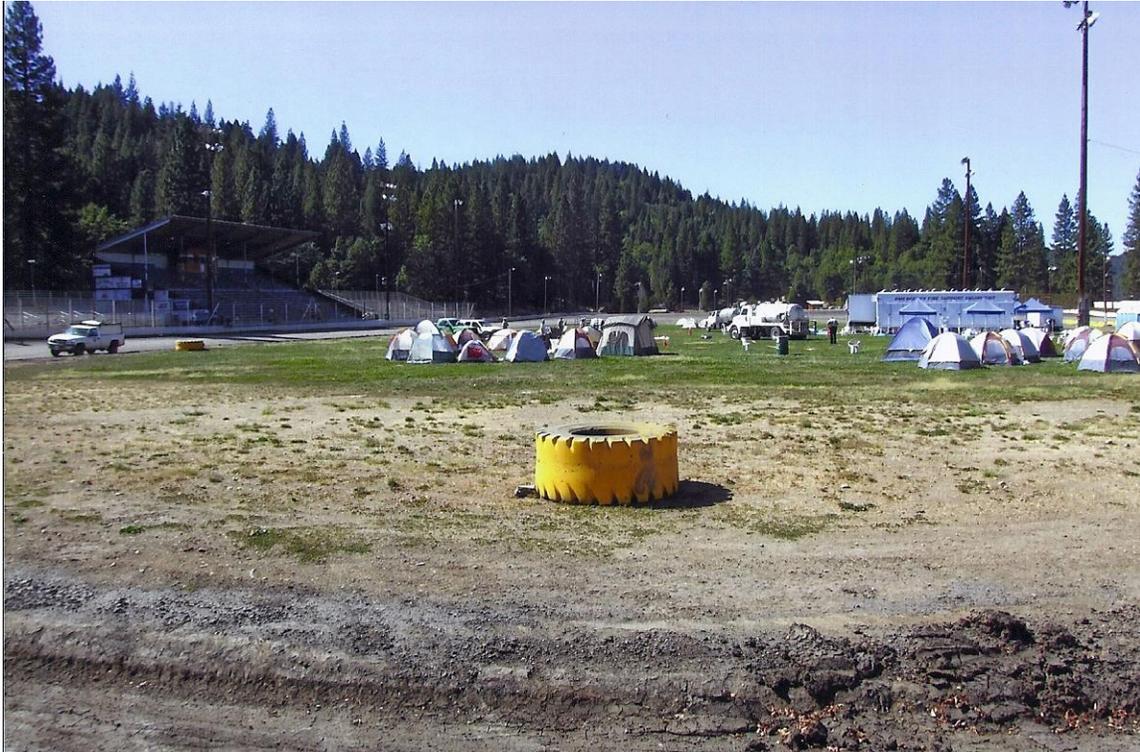
Gray water truck E-27 with CCC tents on Right and Left, Shower unit on Right. Scene still secured. Picture taken facing W.

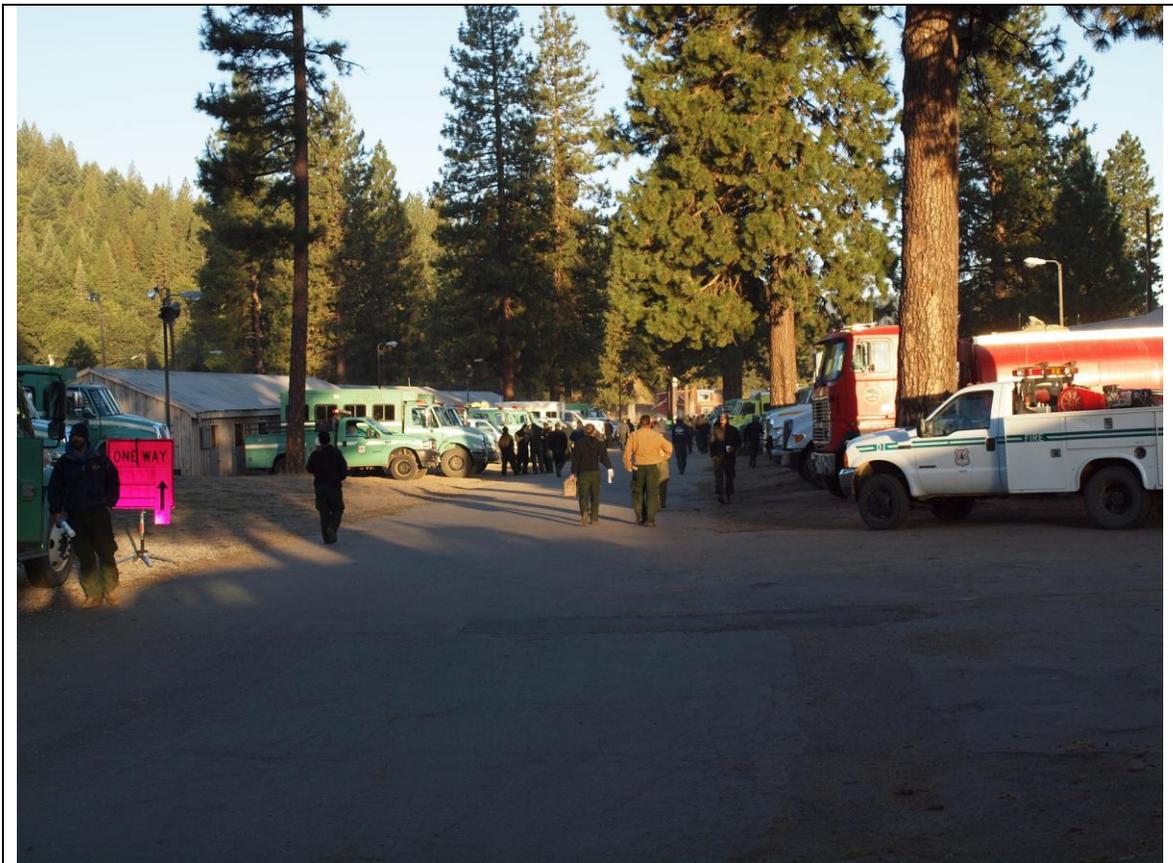
Stable area crowded with crews, engines and buggies. Flow of traffic posted, facing W.

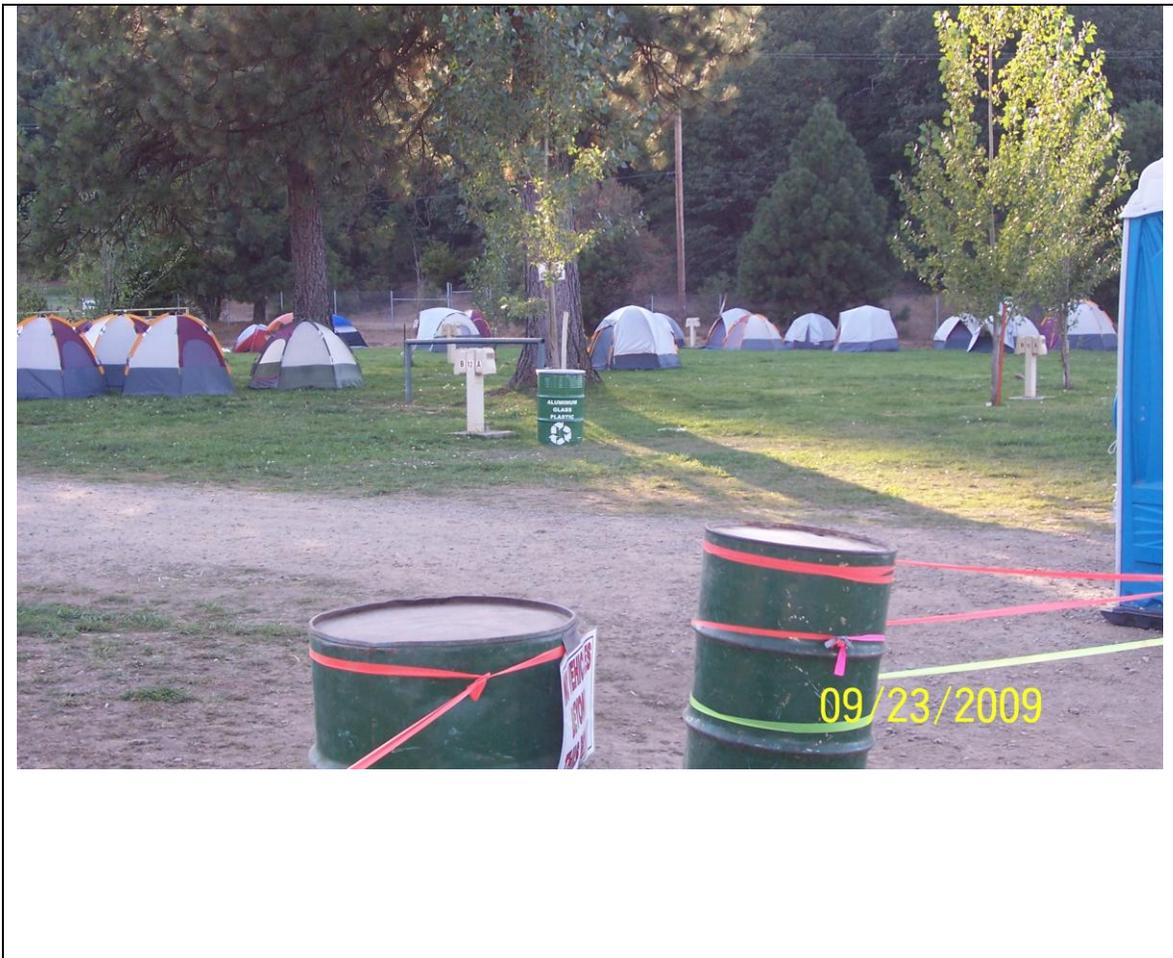
Main crew sleeping/camping area posted and flagged. Picture taken facing NW.

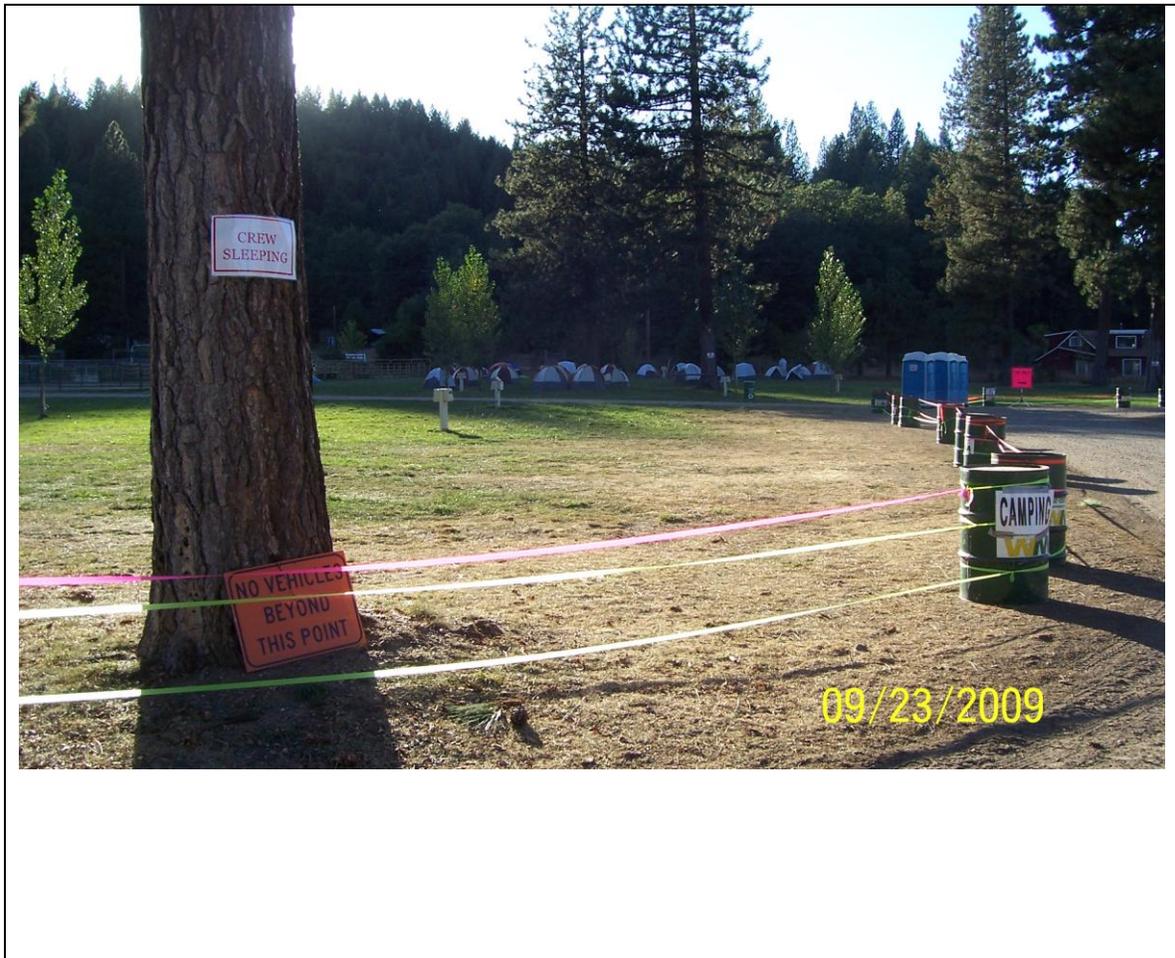
Main crew sleeping/camping area posted and flagged. Picture taken facing W.
