Rapid Lesson Sharing

Event Type: Masticator Rollover

Location: Four Corners Fire
Payette and Boise National Forests
Cascade, Idaho

Road Shoulder Collapses – Causing Masticator Rollover

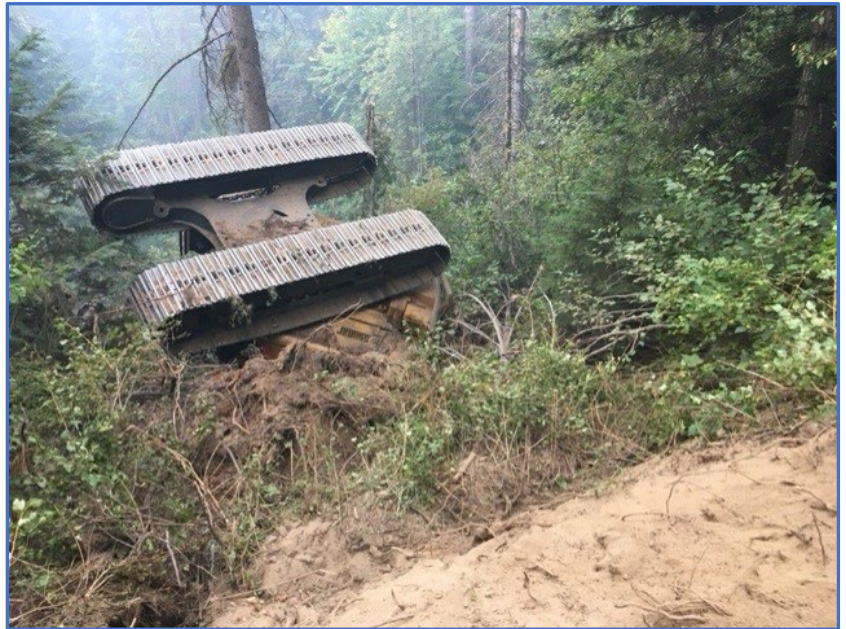
This caused the masticator to tip onto its side and slide downslope approximately 40 feet, where the cab came to rest against a tree—preventing any farther downslope sliding or rolling.

Masticator on its side, where the tree, located 40 feet below the road, prevented the machine from sliding or rolling farther down the hill.

- ❖ Wear your seatbelt.
 - The operator was wearing his seatbelt—a lap belt—which possibly prevented serious injury.
- ❖ When scouting roads, look for more than the obvious.
 - Cracks or small fissures could be clues to unstable roads and the potential for sections of the road to sluff or break away under stress or added weight.
 - Vegetation can conceal road shoulders which could be unstable and/or have softer soil.

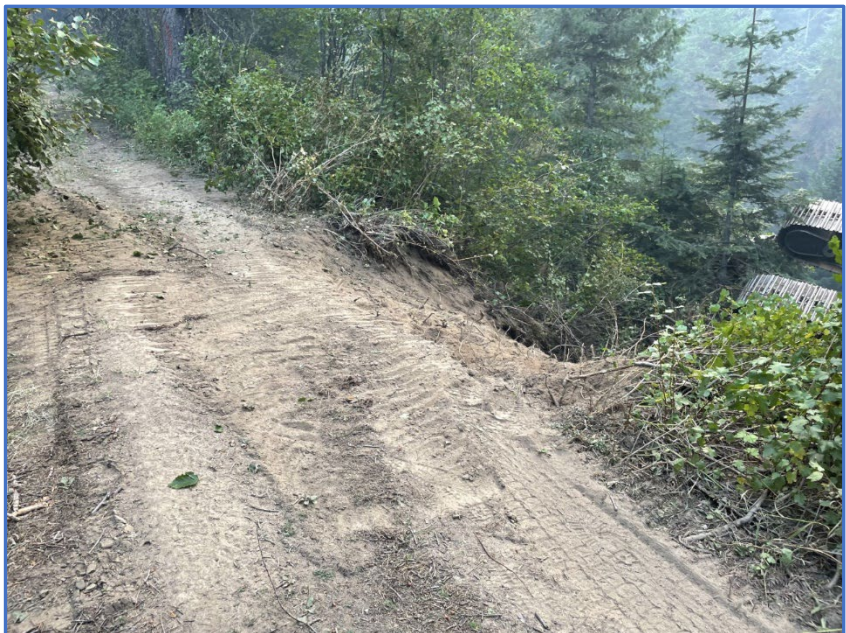
Area of road that gave away. Note the vegetation covering the road's shoulder.

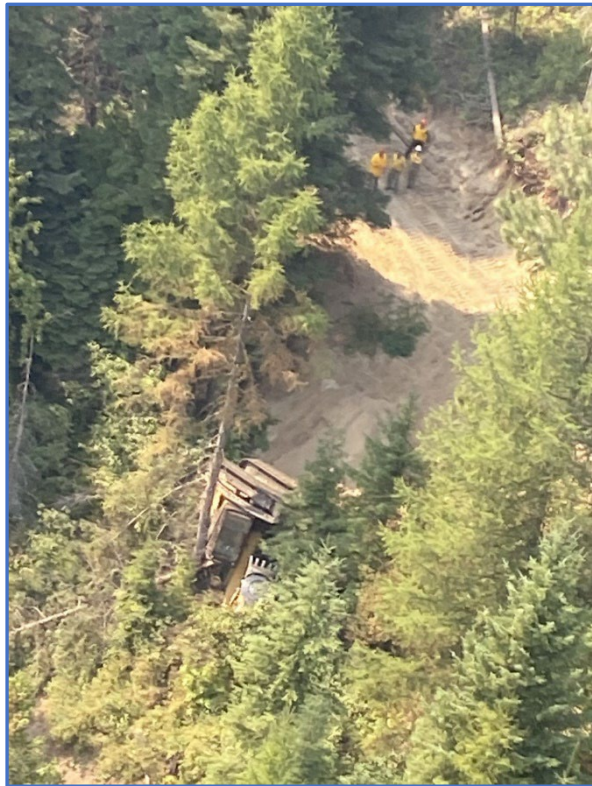
View from the air of the masticator rollover scene.

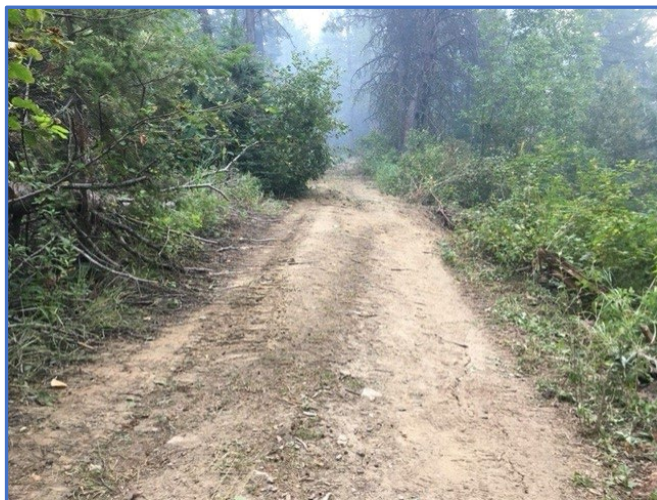
The road where the masticator was working. Notice the crack in the road's right side and the overgrown vegetation along the road's right shoulder.

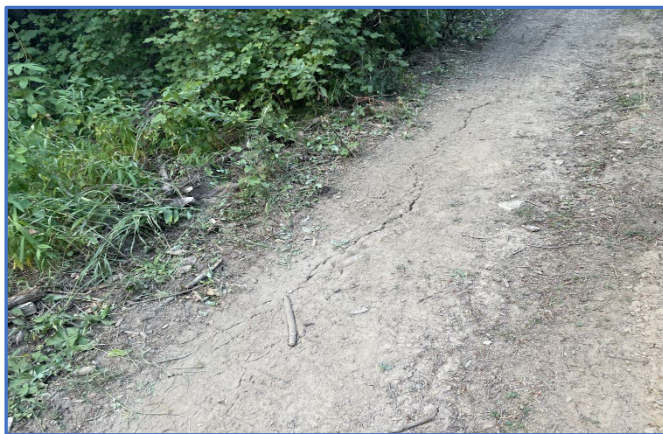
Visible cracks can be seen in the road's downhill side. Vegetation hides the shoulder.
