Rapid Lesson Sharing

Event Type: Dozer Rollover

Date: March 9, 2021

Lessons from a Dozer Rollover on a Prescribed Fire Assignment

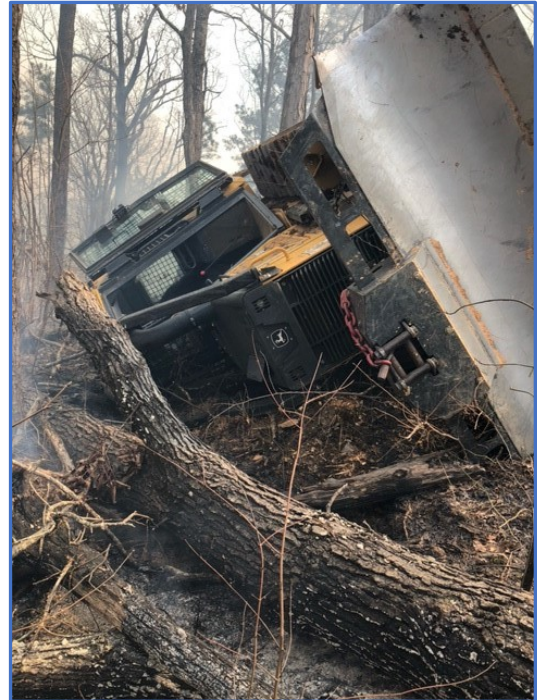
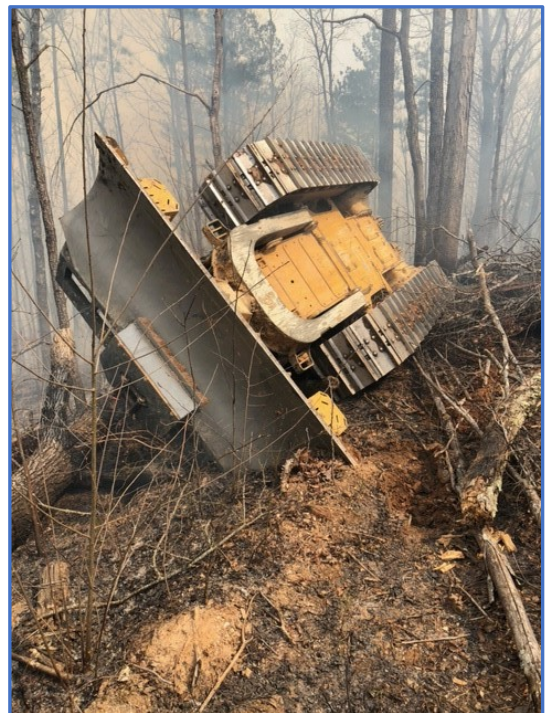
The falling branch tilted the machine to the right—downhill side—and the dozer began to roll slowly over and onto the ground, coming to rest on its right side.

After assessing the situation, the operator shut down the dozer's engine. Because his seat belt was located under his right side, the operator had some difficulty unbuckling the seat belt. After freeing himself, the operator exited the machine out the left door.

Both the dozer and operator seemed unharmed. The dozer operator called the Prescribed Fire Burn Boss (RXB2) and informed him of this incident. The dozer operator also called his supervisor.

They used two chains into D rings to slowly right the dozer. Next, to ensure that all the fluids were able to drain down, they let the machine sit for one hour. After this time period, the dozer was started. It appeared to be undamaged. They therefore walked the dozer to its transport.

- ❖ The operator was aware that his blade was not high in the air. But, as it turned out, the blade was also not low enough to have struck the downed logs instead of climbing up onto them. On this machine, the two storage boxes on the blade obscures the view of the bottom of the blade. This can cause the operator to think the blade is lower than it actually is.
