data points

Recurring Lesson: Equip all UTVs with an accessible and serviceable fire extinguisher.

Over a 10-year span we have recorded eleven separate incidents related to UTVs catching fire.

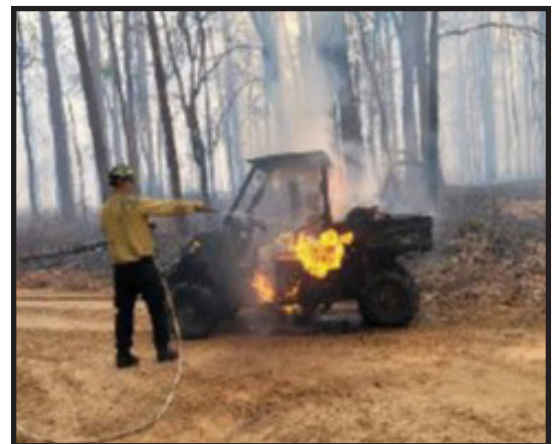
In several instances a fire extinguisher was not available to use. In one case the fire extinguisher was inaccessible (in compartment under seat, seat was on fire). In one case the fire extinguisher did not discharge. In a few of the situations, the fire extinguisher was present and worked as designed. It is worth noting that not all agencies require fire extinguishers on UTVs.

Equip all UTVs with easily accessible fire extinguishers.
Regularly inspect and maintain fire extinguishers.
Inspect all UTVs for flammable debris buildup.

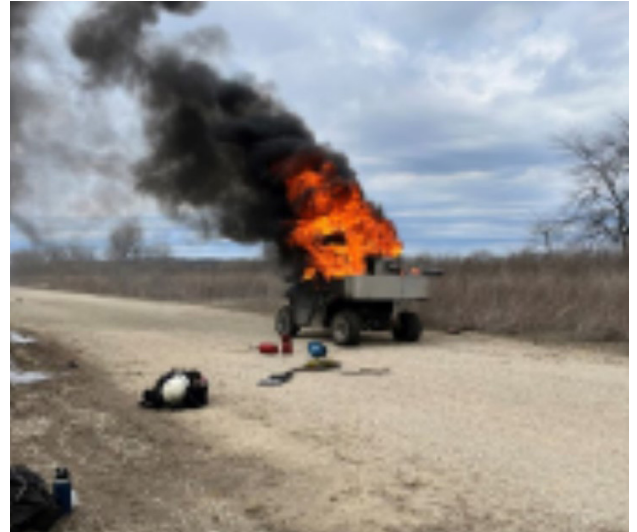
2023 - [Illinois Prescribed Fire UTV Fire](#)

Fire extinguishers were missing on the UTV and the UTV torch mounting bracket, potentially delaying quick knock down of the rapidly spreading fire in the bed of the UTV.

Always check for fire extinguishers on UTVs.

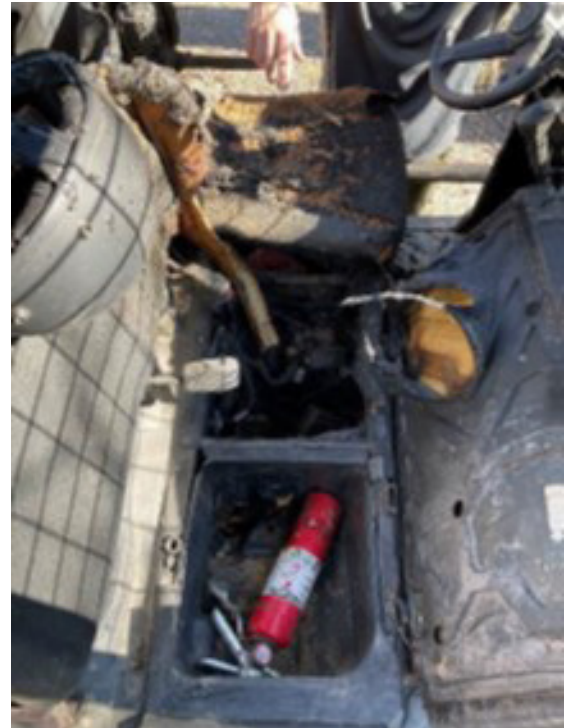
2022 - [Compartment 15 Prescribed Fire UTV Fire](#)

The fire extinguisher assigned to the UTV was not used during this incident. The fire extinguisher was placed in a storage bin under the passenger seat. With fire intensifying and impacting the passenger seat, the UTV Operator was not able to access the extinguisher.

Is the fire extinguisher on the equipment you are operating mounted in a location you can access during a time of need or emergency?

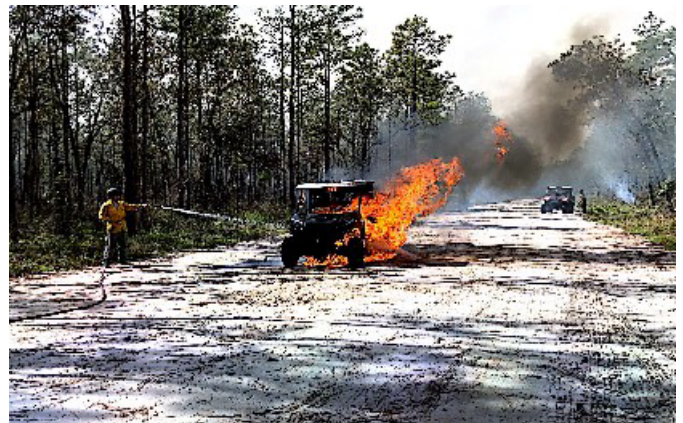
2020 – [Unit 217 Prescribed Fire UTV Fire](#)

While operating a 2018 Polaris 900 UTV on a prescribed fire, the operator looked down and realized that the floorboard under his feet was on fire.

Establish standard operating procedures that include hosing down the under carriage of UTVs after each use. The compartment under the floorboards is not obvious and is not easily cleaned by daily washing.
