Rapid Lesson Sharing

Event Type: UTV Fire

Location: Red Rio Prescribed Fire,
New Mexico

Lessons from Operating UTVs in Tall Grass

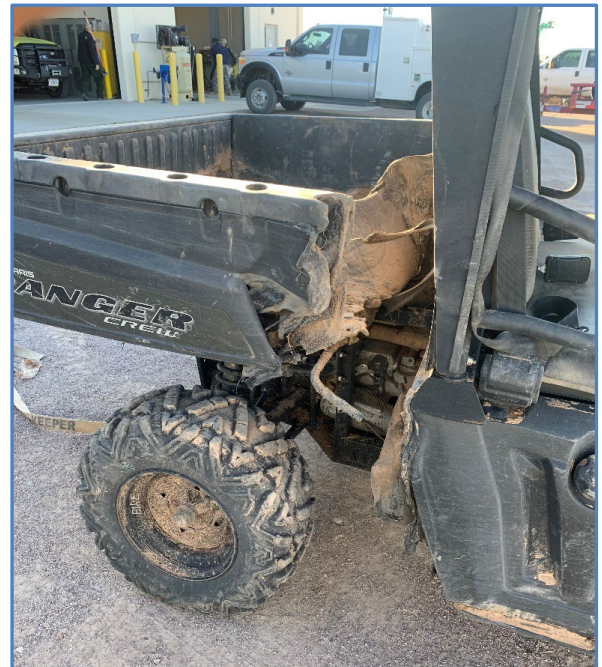
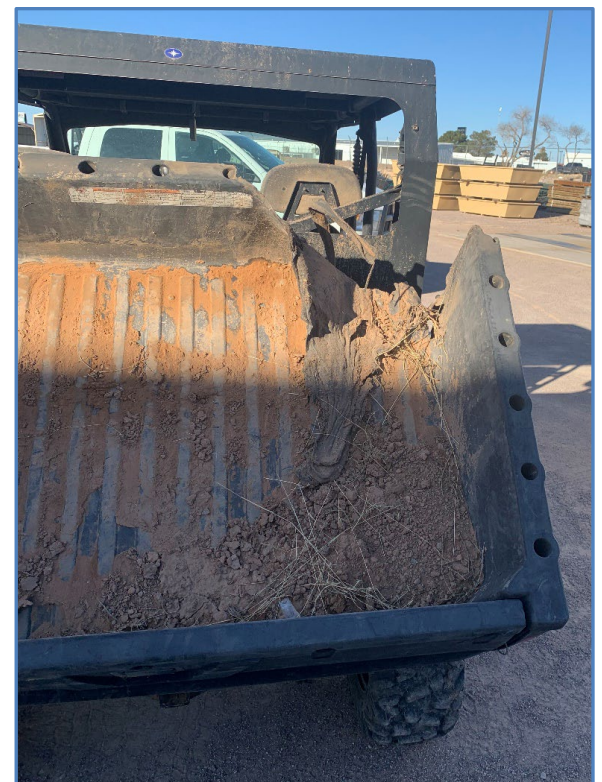
While traveling through the unit in the UTV, I had to drive over tall grass and brush. There were three of us in the UTV on this patrol, and we were not aware that some of the vegetation had become wedged between the UTV's bed and cab.

As I continued driving and patrolling the fire's edge, this wedged vegetation caught fire and melted a corner of the UTV's bed.

Photos show
the melted plastic
burn damage
on the UTV.

- ❖ When driving UTVs in tall fuels, periodically check the vehicle for vegetation.
- ❖ A success regarding this incident is that we were able to safely and quickly extinguish the melting UTV.
- ❖ Moving forward, we will constantly check the UTV for vegetation when driving over tall grass and brush.

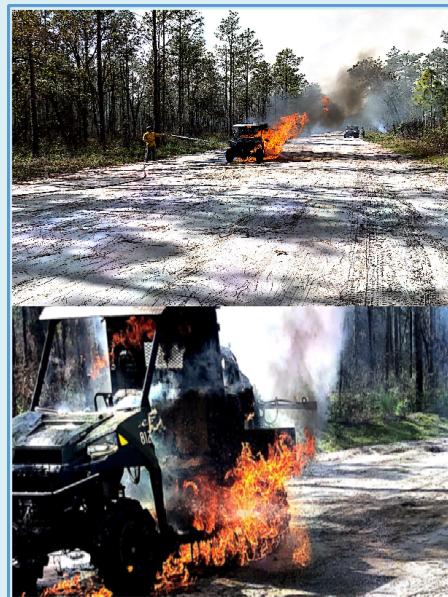
Besides vegetation accumulating between the UTV's bed and cab as occurred in this incident, vegetation can likewise accumulate under the UTV's floorboards—and eventually ignite.

Photos show the UTV fire from the 2020 “Burn Unit UTV Floorboard Fire RLS”—caused by vegetation accumulating and igniting under the UTV's floorboards.

As highlighted in the aftermath of this recent Red Rio Prescribed Fire UTV fire incident, the key lesson is to be checking your UTVs for vegetation accumulation everywhere.
