Rapid Lesson Sharing

Event Type: Removing Combustible Debris Beneath Floor Plates on Polaris Rangers

Location: Wichita Mountain National Wildlife Refuge Fire Shop – Oklahoma

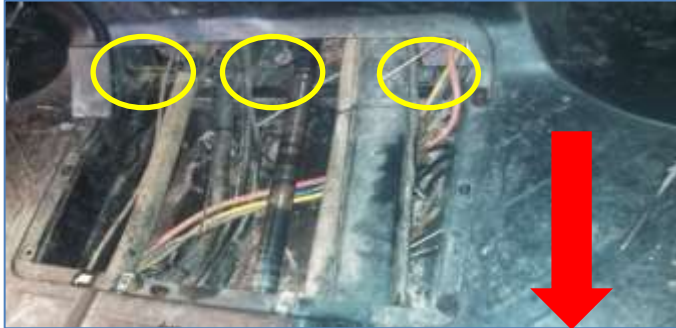
Two weeks ago, our fire staff decided to add a small work light on the rear of our 2011 6x6 Polaris Ranger. When they removed the plastic floor panel to aid in pulling the new wire, they found that the entire compartment underneath the floor panel was completely full of cured grass, sticks, and other dead vegetation. Cleaned out before a picture of this debris was taken, it was described as looking “like a hay bale”.

Photo 1 (above) – Shows the access panel removed. You can see the front drive shaft, several wiring looms, and other plumbing running through the compartment. The areas circled in yellow are the places where the material was able to enter and get packed in under the floor board. On right, paint on the front drive shaft has been worn off from rubbing on the grass and sticks. The red arrow approximates the location of the fuel tank.

Our recommendation is to make removing the floor plate part of your vehicle inspections—and doing so at a minimum of once a month. Realistically, any time the vehicle has been driven in taller grass (1 to 2 feet)—that could be forced through the holes into the under-floor compartment—the access panel should be removed to clean out any material that has accumulated. This will help keep the fire risk to a minimum. We believe that the 4x4 Rangers have a similar compartment in the floor that should also be checked.

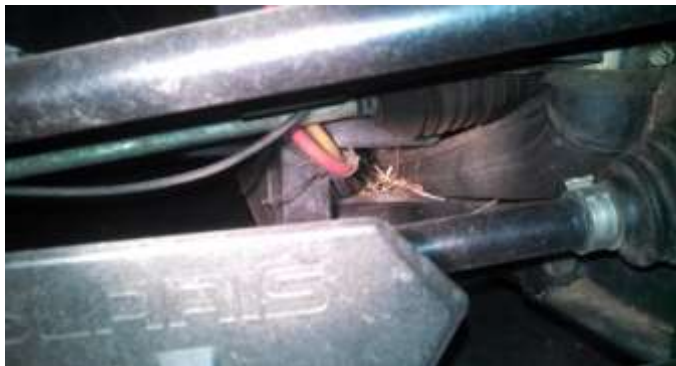
Photo 2 (above) – Taken from the front of the Ranger looking in on the passenger side of the hole (identified in Photo 1 above). The red and yellow cables can also be seen from inside in Photo 1.

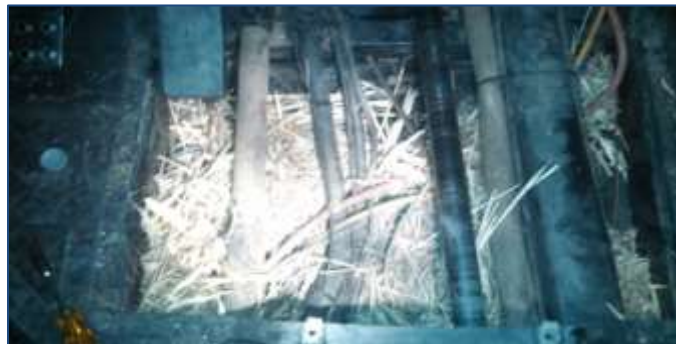
The material, packed in tightly, completely filled the compartment.

Although it doesn't appear that there is a potential ignition source under the floor board, given how these machines are operated, it would be very easy for an external ignition source to light the accumulated material—causing a fire that would be extremely hard to access and put out.

While the floor panel is plastic—and consequently flammable—the underside of the compartment is a metal skid plate that has a few factory holes. The location of this compartment puts it close to the fuel tank, located on the passenger side, also constructed of plastic. Should accumulated vegetation catch fire in there, it places a substantial ignition source close to the gas tank.

Photo 3 (on left) – Shows the accumulation of debris from two operational periods on an RX fire (after the compartment was cleaned out for the original pictures).
