**Event Type:** UTV Accident

**Date:** June 4, 2025

**Location:** Woodworth Station Pasture E,  
Woodworth Station Waterfowl Production Area, a unit  
of the Chase Lake Wetlands Management District  
North Dakota

## **The Story and Lessons from the FWS Chase Lake Wetlands Management District Prescribed Fire UTV Accident**

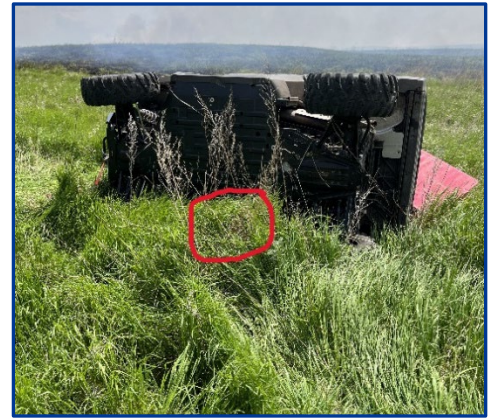
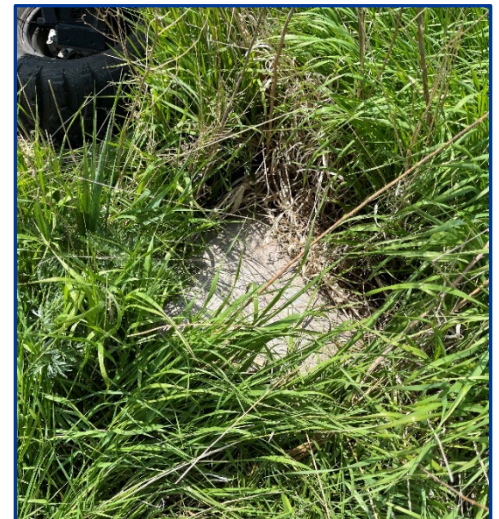
**1334** – While returning to ignite the interior strip fire, UTV A strikes a large rock obscured by tall grass, causing the UTV to roll over on its driver's side. The Firing Boss immediately runs from the north control line to the overturned UTV to assess the situation and administer first aid as needed. The UTV A driver operator is a qualified EMT with a first aid kit included in their line gear. As soon as both occupants are safely out of the UTV, the UTV A driver immediately begins first aid on the UTV A passenger. Once the Firing Boss assesses the situation, the Firing Boss calls over the radio: *"UTV overturned—multiple lacerations and possible broken arm."*

Red circle indicates the location of the rock—hidden by the tall grass—that caused the UTV to tip over onto its side.

- ❖ While participating in interior ignition in uneven, rocky terrain, always wear your seatbelt. U.S. Fish and Wildlife Service policy is to wear a seat belt whenever operating a UTV.

- ❖ While it was not evident that travel speed played a factor in the striking of the rock, it is important to be constantly scanning the direction of travel for unexpected obstacles, regardless of speed of travel.

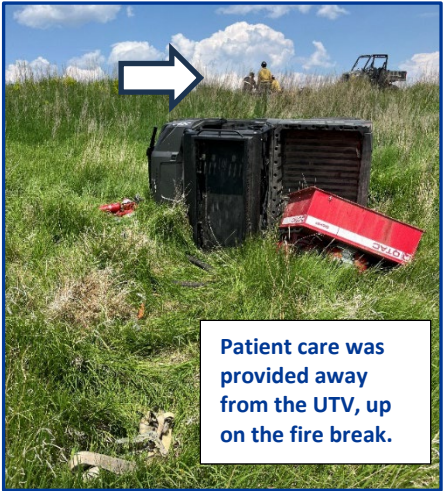
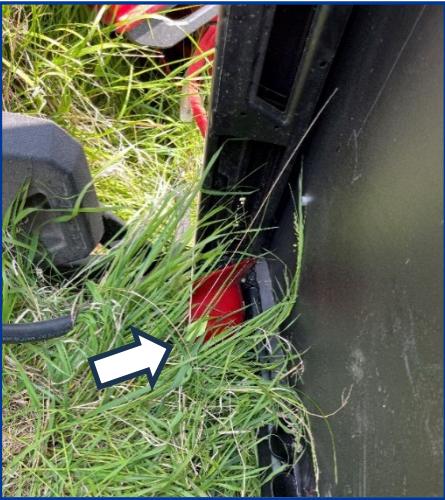
After UTV A struck the rock, the passenger’s head struck the ROPS of the UTV while still wearing his helmet. After the initial impact, the passenger’s helmet was knocked from his head, causing him to hit his head on the roof of the UTV as it fell to its side.

The helmet of the UTV’s passenger.

- ❖ Securing helmet chin straps while operating or riding in a UTV may have limited or prevented the extent of the head injuries to the passenger. It is agency policy that while operating UTVs a helmet must be secured by chin strap.

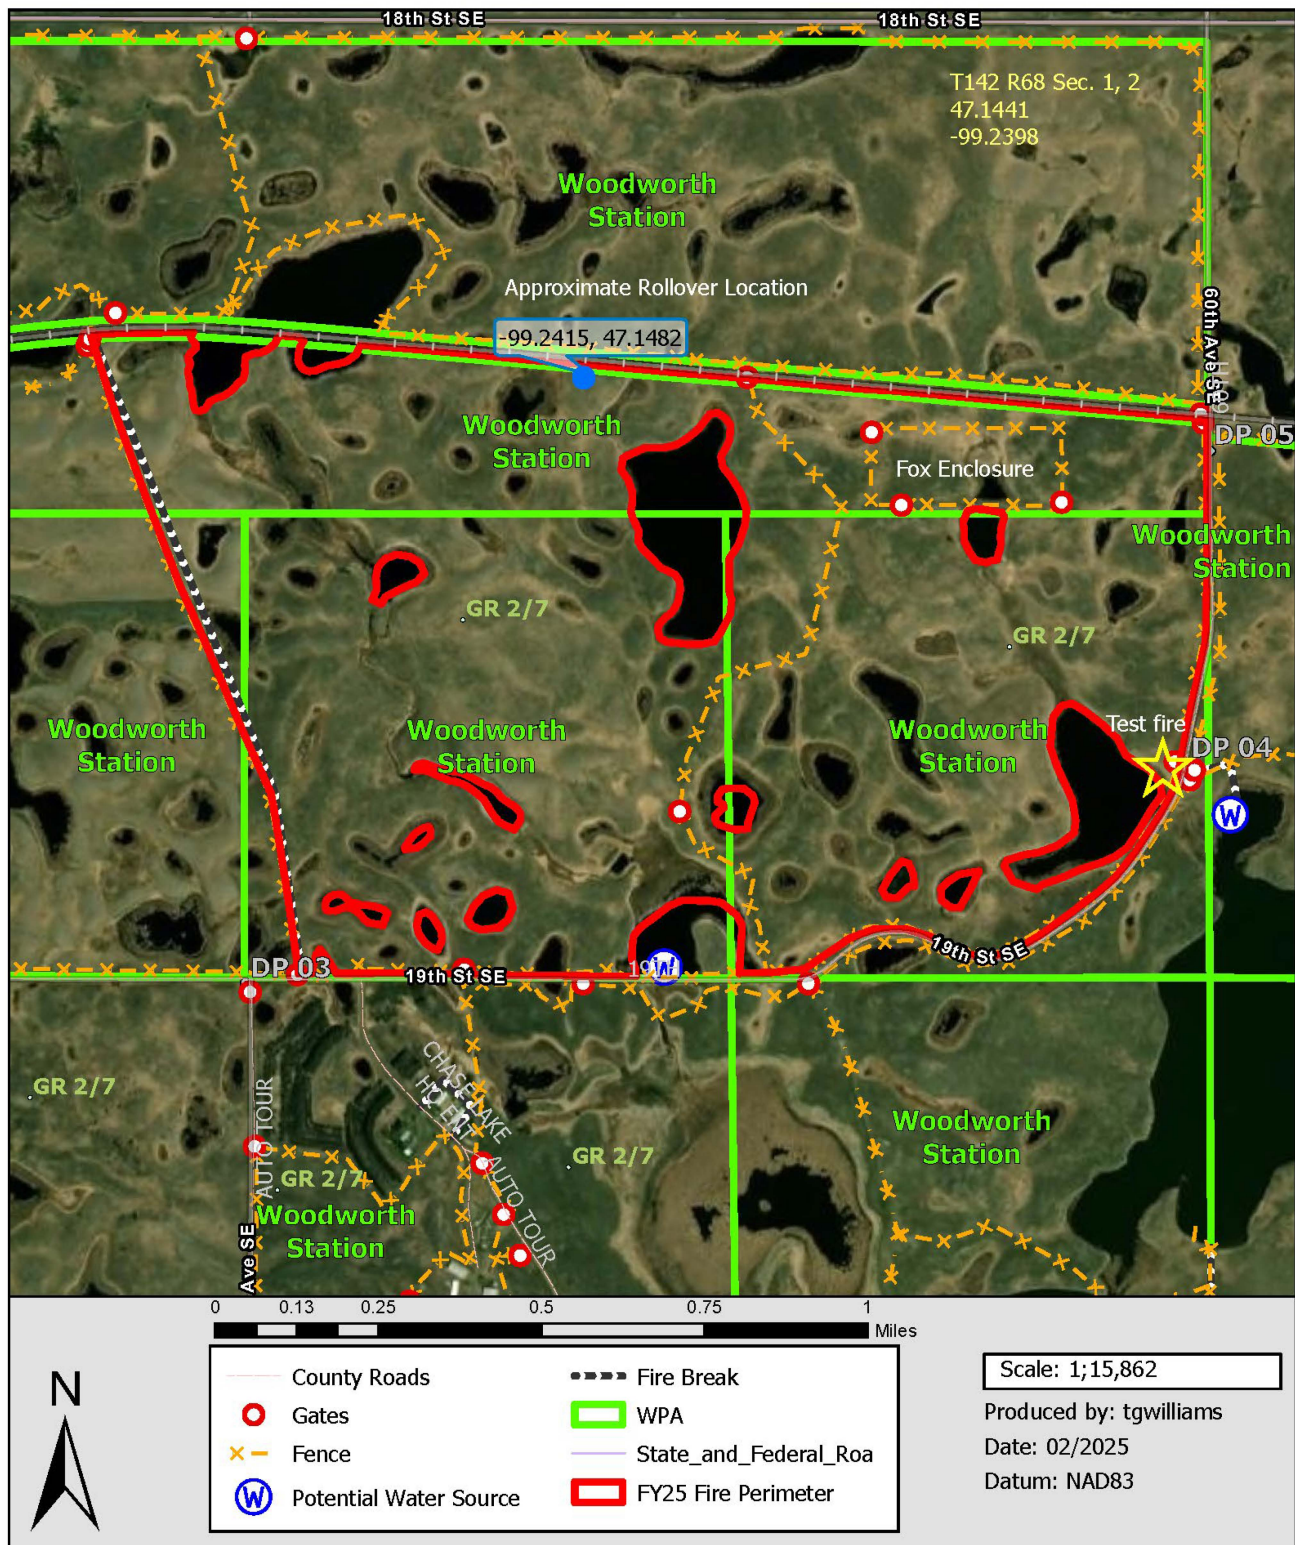
## Project Map

The prescribed fire unit is 359 acres. The unit's control lines are identified as south and east gravel roads. The north control line is an old railroad grade. The west control line is a mowed fire break. Topography within the burn unit is wetlands and rolling hills with large rocks, typical of the Missouri Coteau.
