Rapid Lesson Sharing

Event Type: UTV Rollover

Date: August 8, 2025

The Story and Lessons from a UTV Rollover Incident

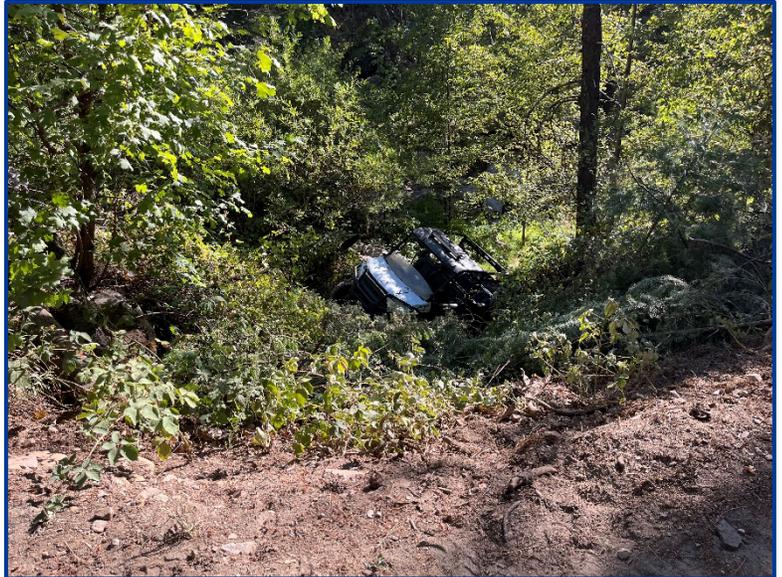
The UTV landed upright on a large pile of boulders in the drainage bottom. The rear portion of the UTV roof was peeled back, but, otherwise, the Rollover Protection System (ROPS) appeared undamaged. None of the crew were wearing their seatbelts. Three of the firefighters were ejected from the UTV, while the other two stayed in their seats. Three of the firefighters were temporarily knocked unconscious, with the Engineer and Engine Captain being the most seriously injured. As they assessed the accident scene, all eyes focused on the Engineer who was bleeding badly from the scalp and forehead.

The UTV somersaulted backward down into the drainage—landing upright on a large pile of boulders.

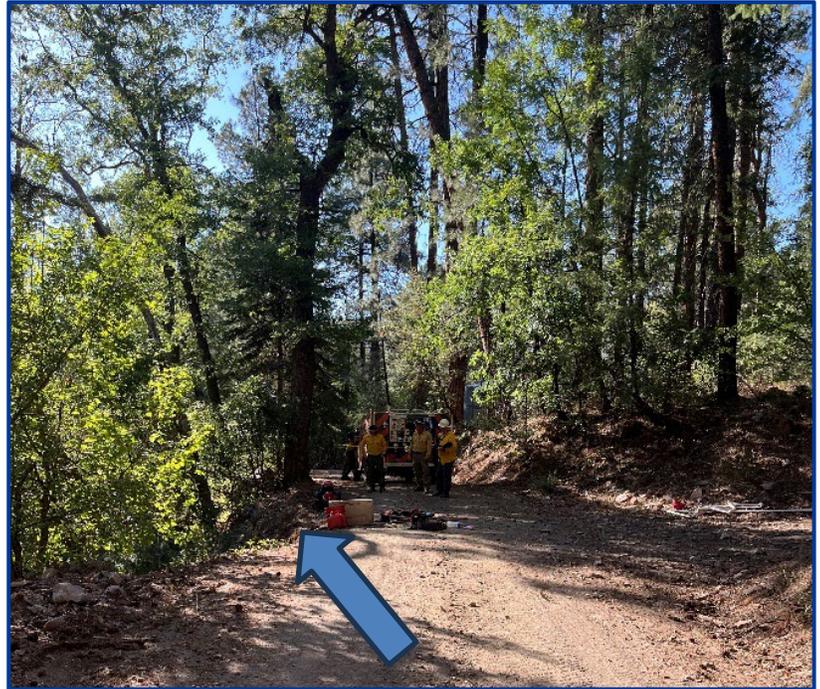
The five-person engine crew loaded up into the UTV with their gear for the day and drove to the hose lay, just a short distance up the road. The road beyond the hose lay was blocked by flagging due to poor road conditions ahead. Positioning themselves for quick egress, the UTV driver (Engine Boss Trainee) backed toward the road embankment. The rear tires sunk off the roadbed’s steep edge. Unable to gain traction, the UTV tilted, slid, and impacted something hard. The UTV and crew somersaulted backward down into the drainage—the crew, all wearing hardhats, hit the UTV ceiling as unrestrained bodies and gear tumbled in different directions.

The turnaround site where the UTV slid off the road. The UTV backed towards the engine, departing the road where the blue arrow is pointed.
