Rapid Lesson Sharing

Event Type: ATV Rollover

West End Prescribed Fire ATV Rollover Incident

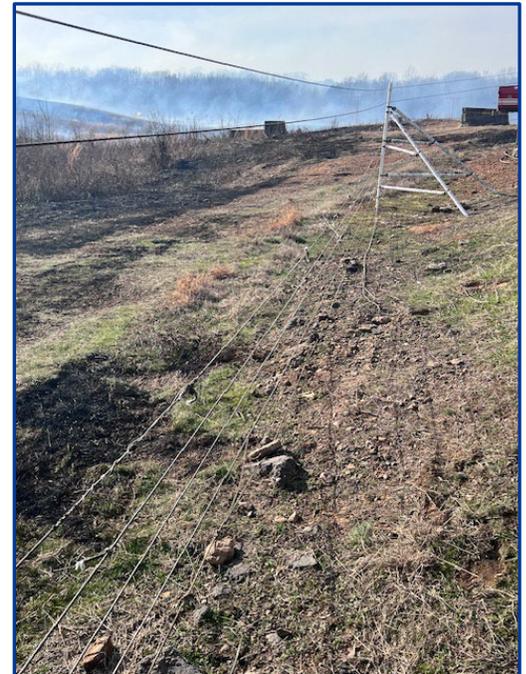
Top – Where the ATV rolled over on the uneven ground into the electric fence.

Around 1430 hours, the Firing Boss Trainee drove an ATV ahead to find possible ignition areas. On the way back, he ran the ATV onto a steep slope between a building and the electric fence. The ATV tipped onto its side into the fence, trapping the Firing Boss Trainee beneath it.

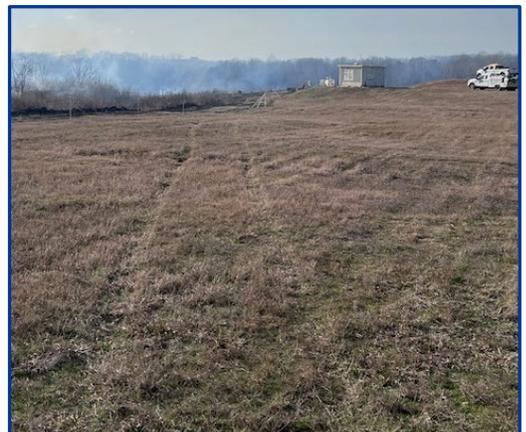
Bottom – The ATV's route to where this rollover incident occurred.
