Rapid Lesson Sharing

Event Type: Vehicle Fire

Date: March 21, 2026

The Story and Lessons from this Burned Vehicles Incident

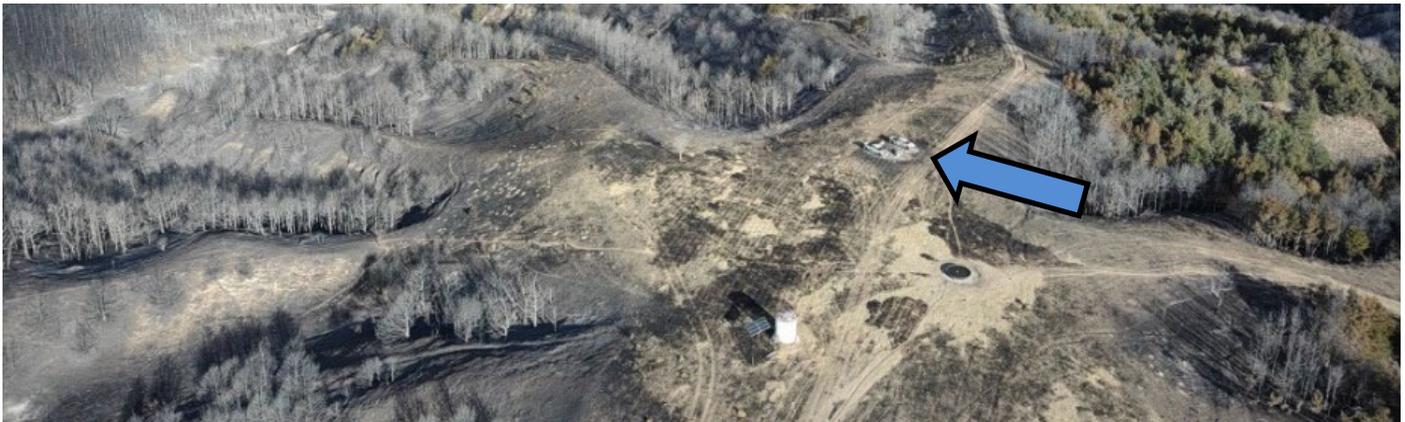
Of their four vehicles, the crew parked three of them—all pickup trucks—on top of a plateau in “good” black with the closest patch of underburned cedars located 700–900 feet away.

The crew, along with several other incident responders, had parked there before and stated that it was a good, safe area for parking vehicles. The aerial photo (below) shows several vehicle tracks of where crews had parked there in previous shifts.

Aerial photo of the parking area was taken after the blowup incident in which the parked vehicles were burned. Arrow indicates where the vehicles were located.

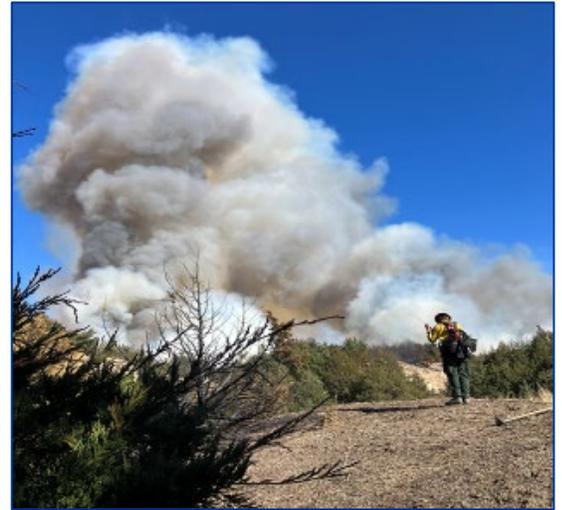
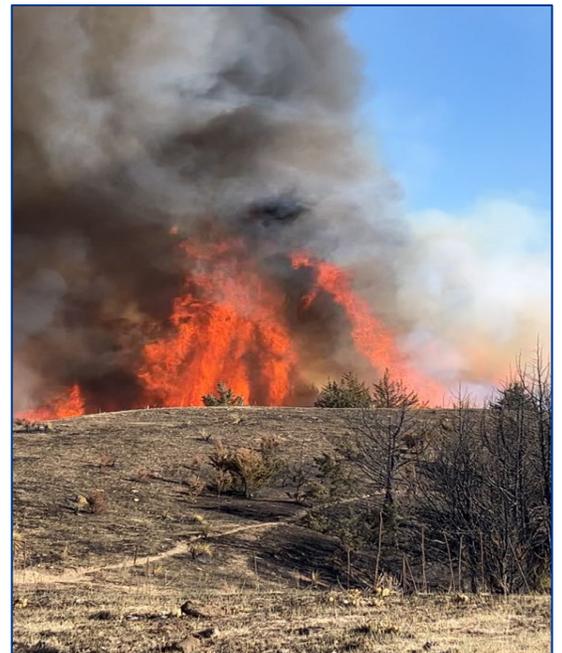
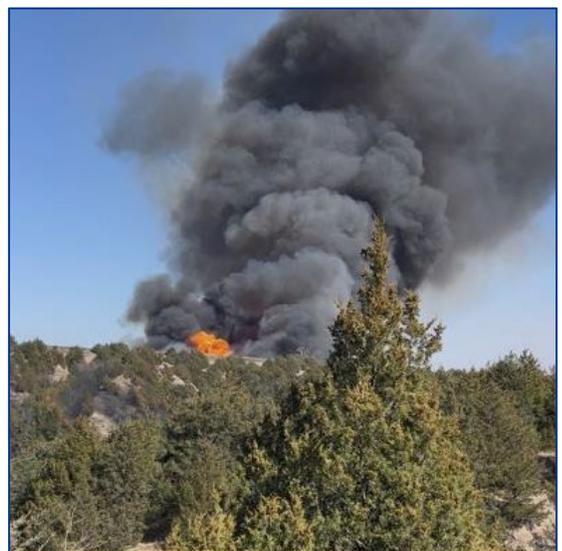
These three photos were taken by members of the three different squads as they returned toward the parking area. They all show how that location was now engulfed in flame.

Around 1600, as one of the squads got to the approximate location of the parking area, they were met by a large black column of smoke and high-intensity flames that were leaning over the parking area's general vicinity. Because of this black smoke and flames, it was unclear where the vehicles were located.

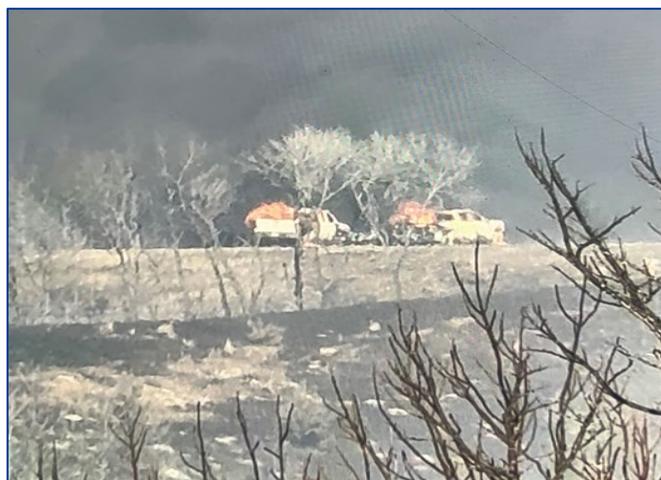
Moments later, the smoke lifted enough to see that the three parked trucks were fully involved by fire. This was communicated over Command: "Three vehicles fully involved in fire; no injuries."

A crew member on the closest squad to the parking area took this photo of their vehicles burning. It was too hazardous to approach any closer.

It is suspected that an ember likely landed in the back of one of the pickup trucks—two had open beds, one had a camper shell—starting a fire which rapidly grew due to the hot and dry conditions. This fire would have been accelerated by the fuel in the saw truck and full fuel tanks in all of the vehicles. The proximity of the vehicles parked next to each other likely increased the fire intensity.

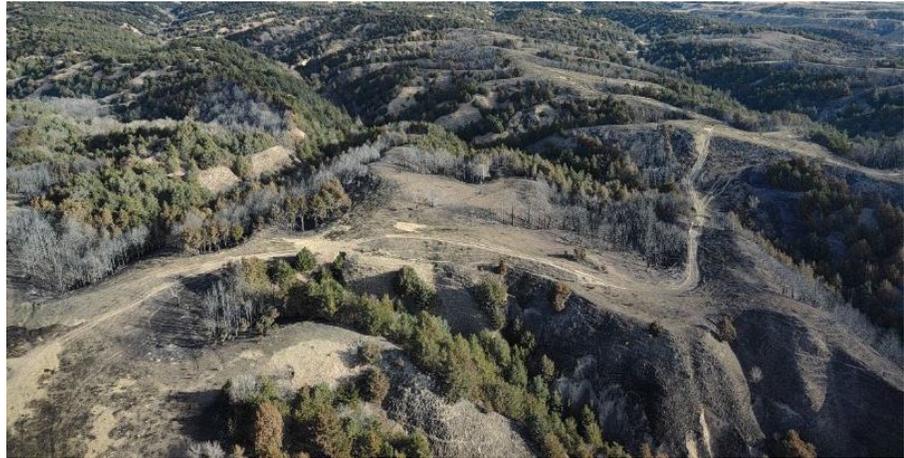
Photo shows the complex terrain with both underburned and unburned red cedar. The location of the parked vehicles that burned is just out of frame to the lower left.
