Rapid Lesson Sharing

Event Type: Equipment Loss (ATV) on Rx

Date: May 4, 2026

Location: Tulelake National Wildlife Refuge, California

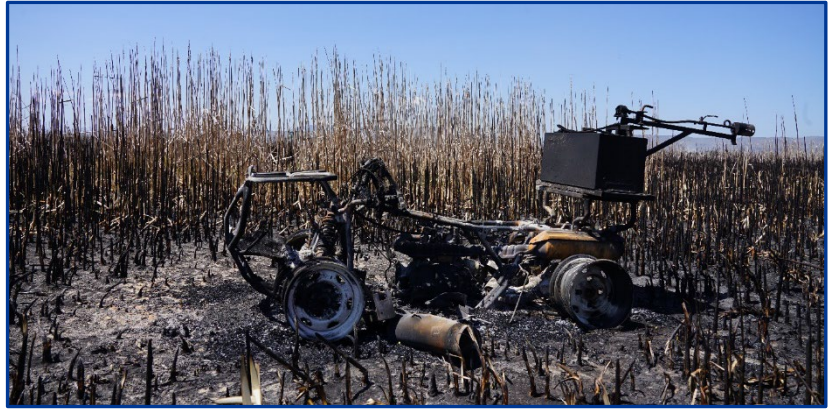
The seven-foot tall tule behind the burned ATV indicates the density and structure of fuels at the location of this prescribed fire equipment loss incident.

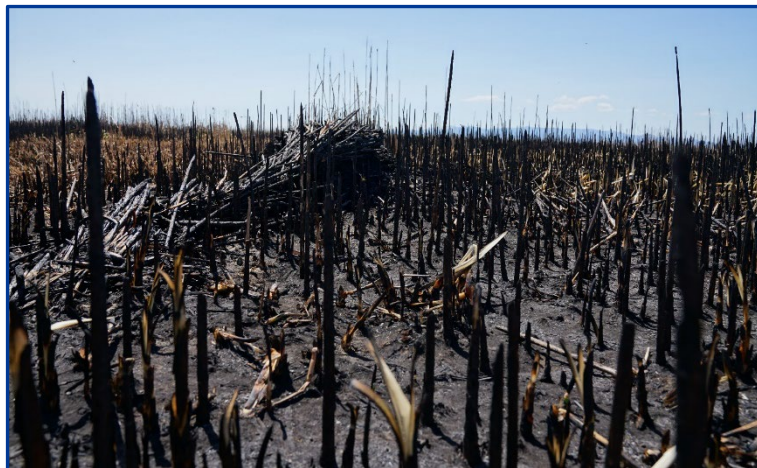
1330: During firing operations, the lead interior lighter encountered an unexpected obstacle while advancing south through dense tules adjacent to the cold black. The ATV was halted by a crescent-shaped berm, approximately four feet high and 60 feet long, composed of compacted tule resulting from wetland water drainage activities. The berm's height, curvature, and surrounding vegetation posed a significant hazard—preventing safe navigation over it.

The remnants of the four-foot-high and 60-foot-long tule berm hazard (on left) composed of compacted tule resulting from wetland water drainage activities. This obstacle required the operator to reposition the ATV.

- ATV operators will maintain at least one set of tires in the black whenever feasible to preserve rapid access to safety zones.
- Ignition personnel should incorporate potential berms or fuel buildup into pre-burn scouting and briefings, particularly in units where recent water management activities have occurred.
- Reinforce the practice of continually reassessing escape routes during mobile ignition and avoiding assumptions about safety based on proximity to the black in light flashy fuels.

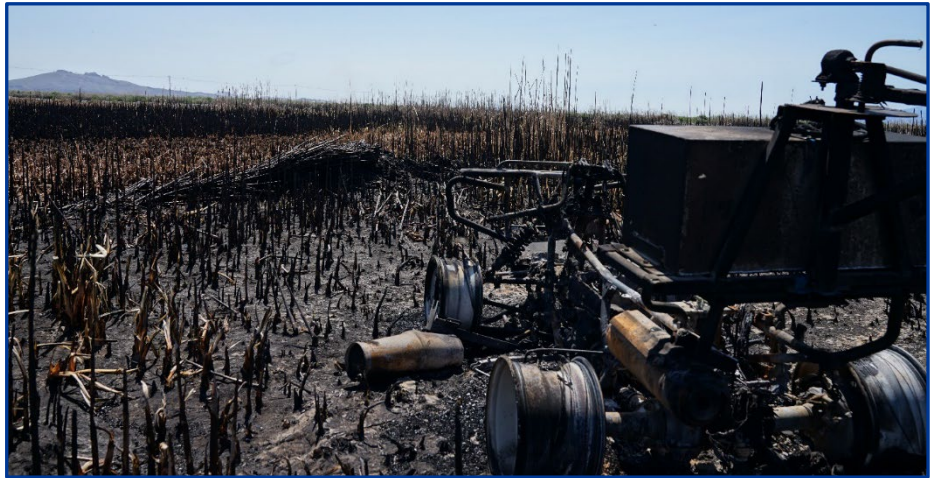
Recognizing imminent danger, the operator promptly exited the ATV and moved to the designated safety zone in the clean black, located roughly 15 feet east of the vehicle. While the operator remained unharmed, the ATV was destroyed. The interval between encountering the berm and reaching safety was estimated at six seconds.

The burned ATV location in relation to the impacted tule berm. The ATV operator’s escape path and safety zone is located 15 feet to the left of the ATV.

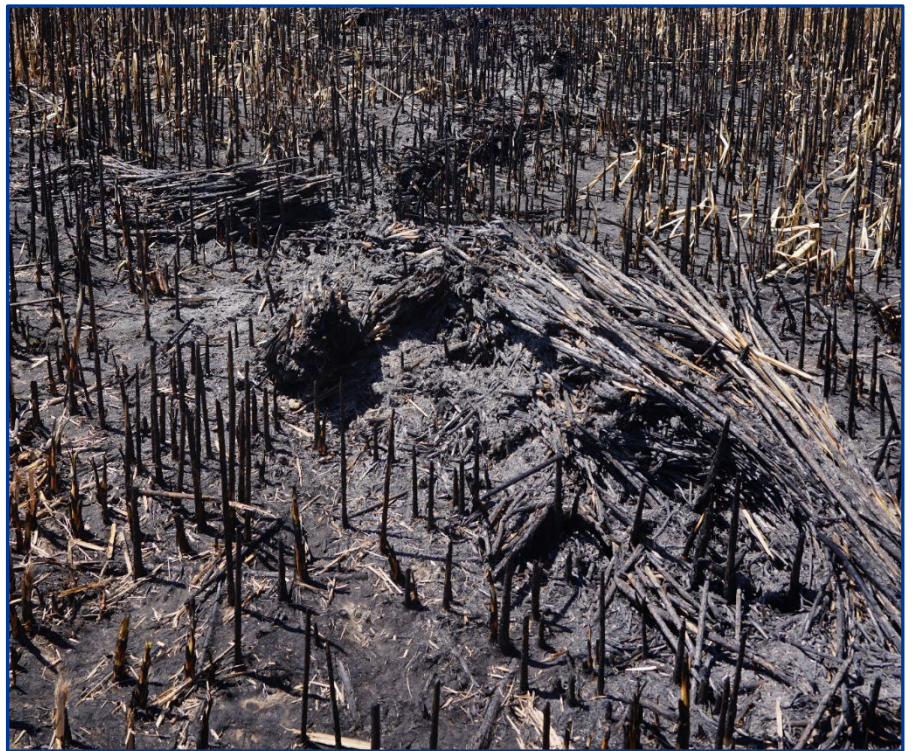
The remnants—post burn—of the tule berm. This photo indicates the berm’s length.
