Bald Angel Prescribed Fire

Engine Rollover Incident- 9/27/2010

Facilitated Learning Analysis

USDA Forest Service

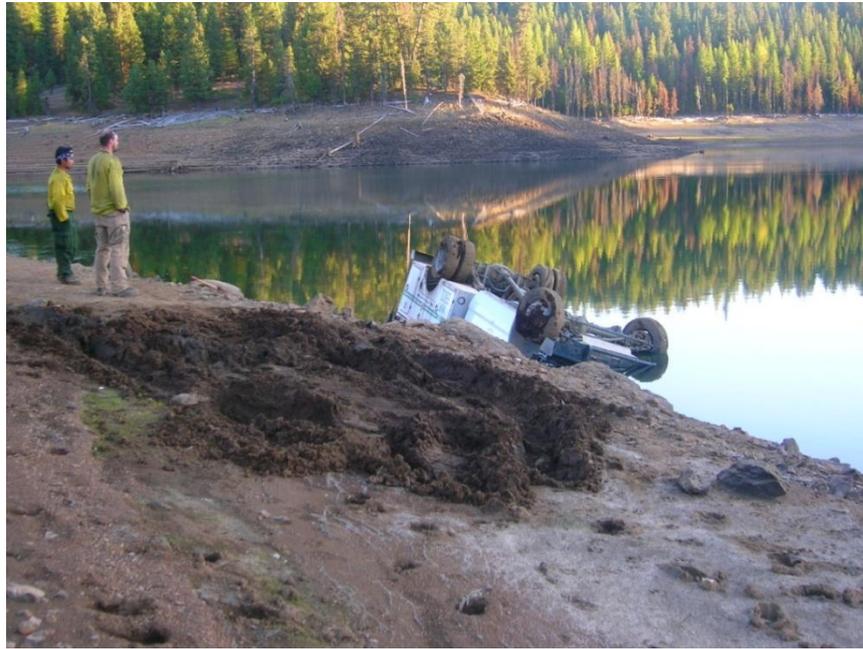
The area where engine was originally stuck.

1430- An engine from the prescribed burn is sent to the reservoir to refill and becomes stuck on the west side of the reservoir near water's edge.

1610- One search group notices an engine stuck on the west side of the reservoir and begins to assist with freeing the vehicle.

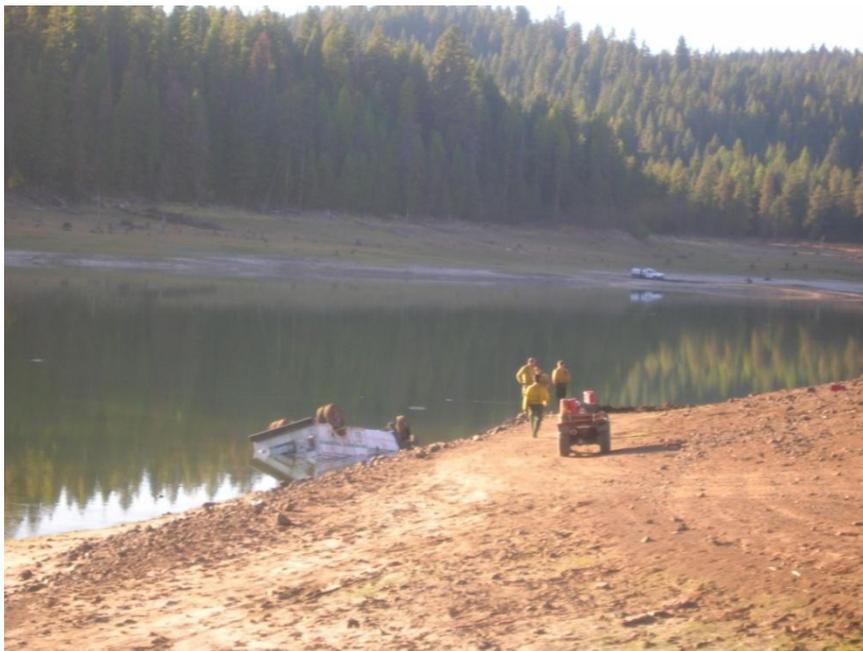
The two track that the engine followed and the other engine that was stuck across the reservoir

1620- While assisting with the engine extraction, an object is observed on the northeast side of the reservoir. Using binoculars, the search group identifies another engine resting upside down in the water. Only the tires and undercarriage are visible. At this time, a noticeable beeping from the rolled engine's back-up alarm was also noted.

Balm Creek Reservoir had been briefed to resources as a potential fill site with the caveat that depending on the water level, access could be difficult and that drafting may not be possible. Volume pumps have been used in the past to eliminate engines from having to park close to the water's edge which would decrease potential for getting stuck. Some areas of the reservoir contain better rock and a harder surface than other areas. Scouting and setting up a volume pump, communicating its locations, and identifying on the project map would eliminate engines getting stuck and shorten turnaround times.
