Rapid Lessons Sharing

MAIN ROTOR STRIKE

An S-61 Helicopter supporting the Cabin Fire on the Sequoia National Forest experienced a main rotor blade strike while positioning to snorkel (siphoning of water) at a dipsite on the Little Kern River.

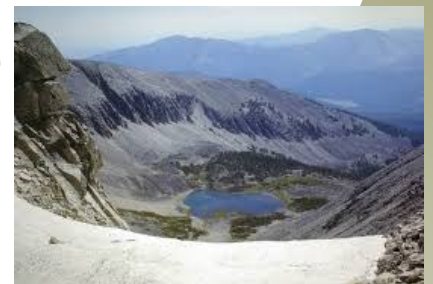
Example of a Cirque Lake

Cirque: A geologic land feature marked by a bowl shape and steep-walled mountains. Cirques are formed by glaciation often containing a small round lake. For aviation resources---cirques pose conditions of erratic, unpredictable winds and are not ideal as dipsites.

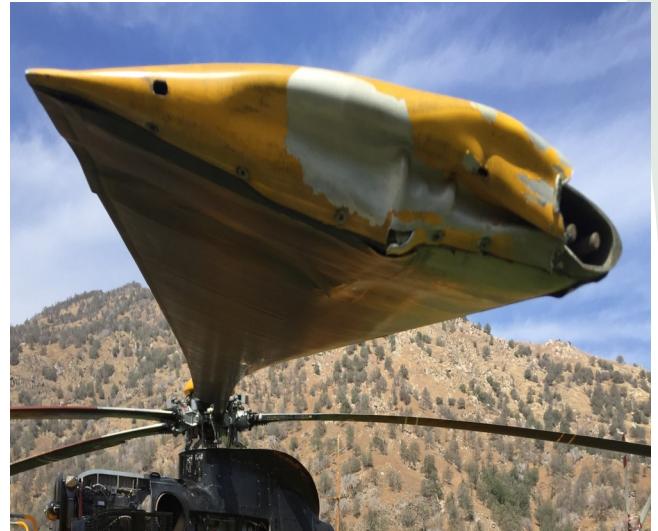
As the pilots descended into the dip site, the SIC communicated instructions to the PIC to “stay left” of the trees. While in the dip, the PIC heard what he suspected was a blade strike, called out the strike, jettisoned the water and immediately initiated a climb out to get clear of the area.

The pilots assessed the condition of the blades and saw no noticeable damage while in flight. On the climb out, the SIC noticed a smaller diameter tree (estimated to be about 8 ft. in height) that had been located at the helicopter’s 4 o’clock position, and missing its top. The Air Attack was notified about the potential blade strike and the pilots provided their intentions to land at the first opportunity. During the short flight to the first suitable landing site, the pilots noted no vibrations or abnormalities

The crew performed a precautionary landing in a field located approximately 10 minutes away from the dip site. The Helicopter Manager was notified of the situation via cell phone. After shut down was complete, the pilots inspected the main rotor blade damage. Maintenance inspectors determined the main rotor blades, rotor-head, transmission and high speed shafts required replacement. The NTSB determined the blade strike as an “Incident”, and it was further classified by the Forest Service as an “Incident with Potential”.

1. Prior to re-positioning an aircraft in a confined area (such as a canyon) , conduct a “fly away” or “go-around”. Disengaging from the spot and flying another lap would allow for additional evaluation and discussion about the site and its potential hazards before committing to it.

2. When scanning and identifying hazards there is always potential to become fixated on the larger more clearly visible hazards like big trees and rocks. This fixation can divert attention from the smaller, less conspicuous hazards. The SIC scans outside for hazards in the 10 o’clock to the 3 o’clock sectors, which limits the area that can be viewed from the cockpit. Obtaining a clear view of hazards at the 4 o’ clock position can be problematic, especially if those hazards don’t appear to be a threat.
