# Rapid Lesson Sharing

**Event Type:** ATV Rollover

**Date:** Aug. 18, 2013

**Location:** Eastern perimeter of Cog Fire – Northwest Colorado

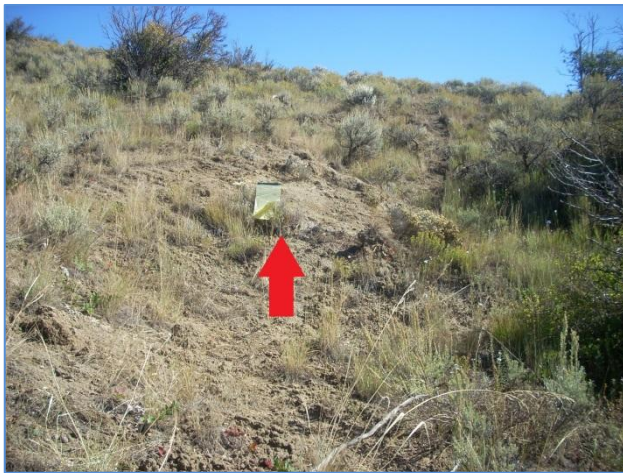
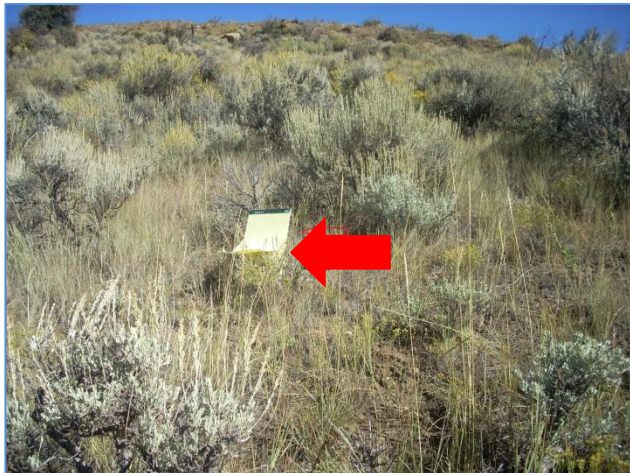
**Top Photo** – Shows the route that the ATV and dozer had previously used to access the top of fire that the Operations Section Chief avoided on this trip. **Bottom Photo** – Red arrow indicates the approximate beginning of rollover location—where the ATV's left front tire hit the sagebrush and initiated tipping.

This slope was dominated by sagebrush with a "knee-high" grass understory and was relatively rock free. At approximately 2000 hours—as the operator came to the upper 1/3rd of the 37 percent slope—he noticed a depression and chose to veer left around this obstacle for about 20 feet—planning to continue back right to align for the path to the road on the ridgeline.

During the right turn and side-slope travel, the operator proceeded slowly with his right knee on the seat and left foot on the left ATV peg for more control. The ATV contacted a sagebrush plant approximately two feet in height which caused the ATV to begin tipping downhill. The operator noticed that the ATV was about to rollover. He pushed the ATV away from himself and landed on the uphill side of the ATV.

The ATV rolled approximately 92 feet downhill and came to a stop on its own. The ATV sustained damage, but the operator, as well as bystanders, did not suffer any injuries.

- Proper riding stance and anticipation of potential roll over is critical to minimize injury.
- Be mindful of routes on slopes with obstacles and increased tipping potential.
- Consider UTVs which are typically more stable when traveling both across and up slopes.
