**Pardee Fire Fatality
Factual Report
July 8, 2013
Kamiah, Idaho**

Executive Summary

Investigation Process

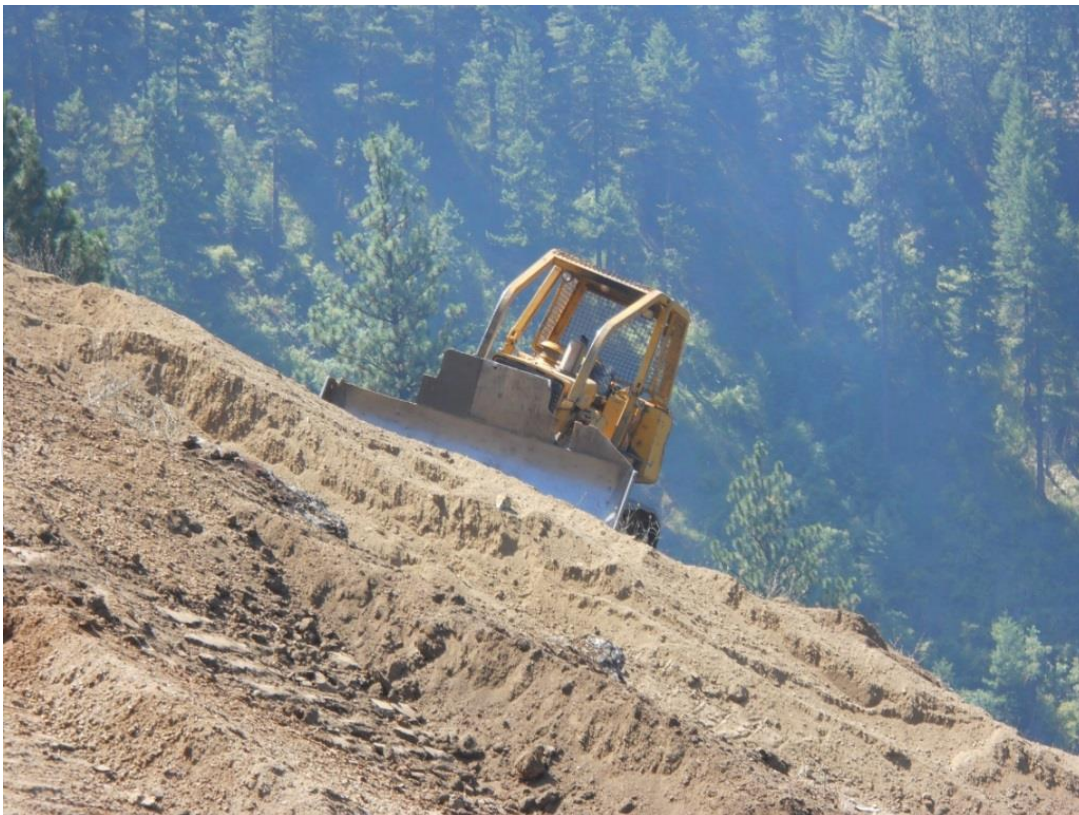
Figure 3. Looking from the side of the hill at the dozer.

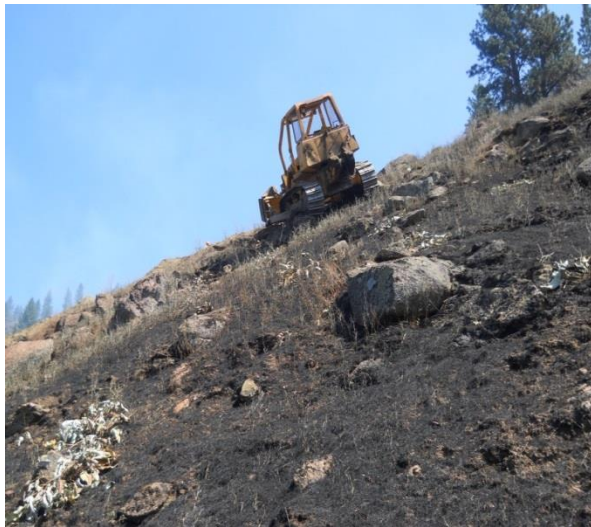
Figure 4. View from downhill.

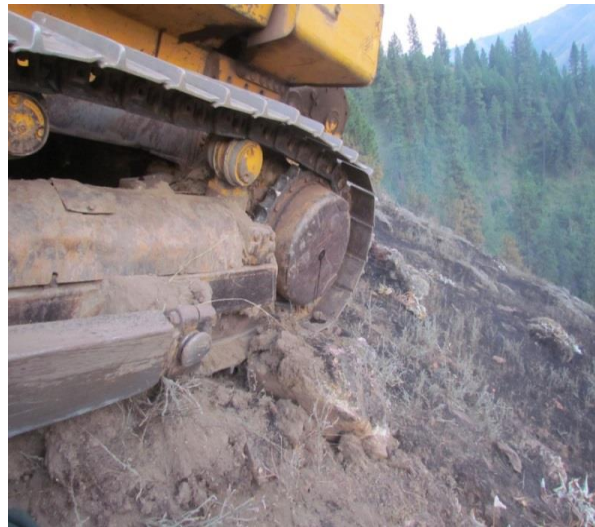
Figure 5. Downhill track rests on rock ledge.

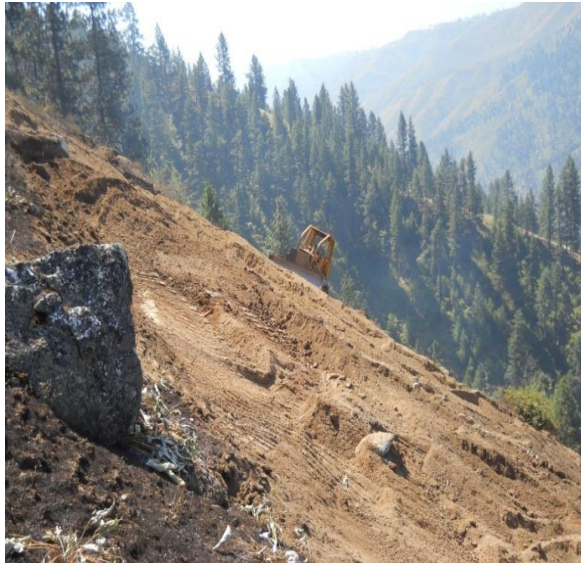
At approximately 1640 hours, the Heavy Equipment Boss is serving as a lookout for the Contract Dozer Operator who is terracing the hill (building pads) to mitigate the steepness of the slope. His dozer continues to experience difficulty getting up the hill and overheats. The Contract Dozer Operator idles down his dozer an additional three times allowing it to cool.

Figure 1. Ground disturbance showing terracing efforts.

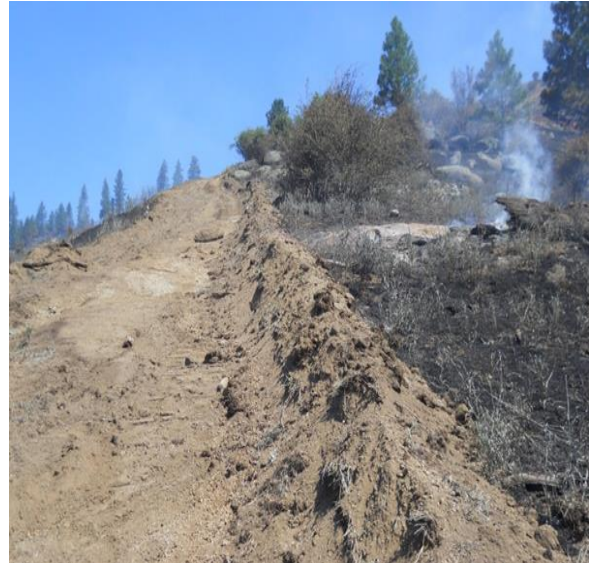
Figure 2. Dozer line looking up from the windfall stopping point.

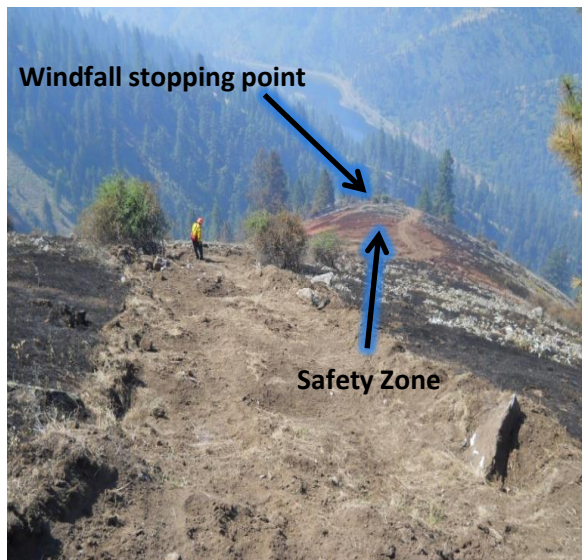
Figure 3. Dozer line looking downhill just below DP2.

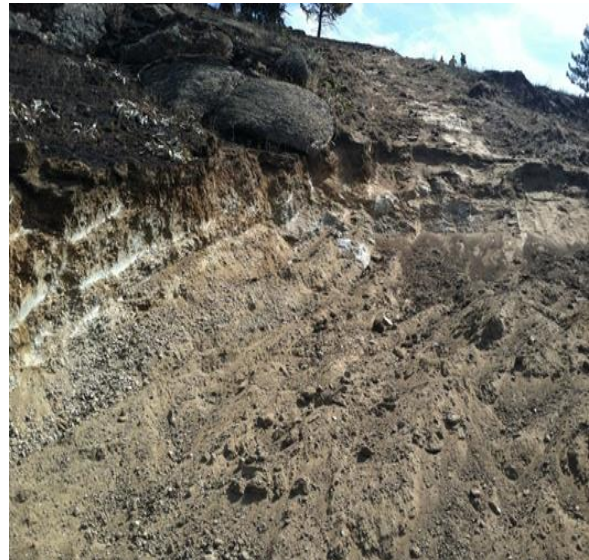
Figure 4. Ground disturbance showing terracing efforts.

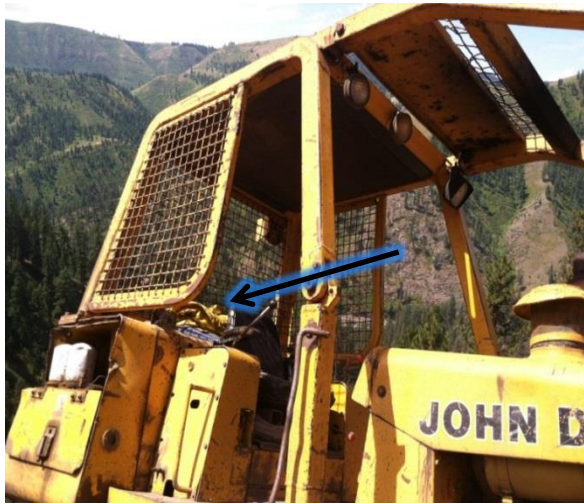
Finding 2: The Contract Dozer Operator was operating on the fireline without wearing his PPE. **This factor is determined to be non-finding to the accident.**

Figure 5. Yellow flame-resistant shirt and fire shelter.

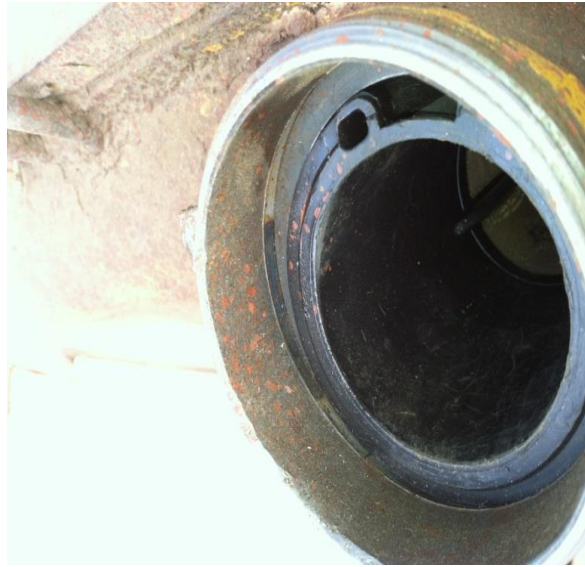
Finding 1: The dozer and transport were not inspected prior to use for the Pardee fire. Visible hazards would have found the dozer unserviceable (***See Appendix C: Photographs***). An agreement for the contracted dozer and transport was not in place prior to use on the fireline (***See Appendix B: No Contract Agreement in Place***). **This factor is determined to be non-finding to the accident.**

Figure 6. Missing fuel cap: note retardant inside and on threads.

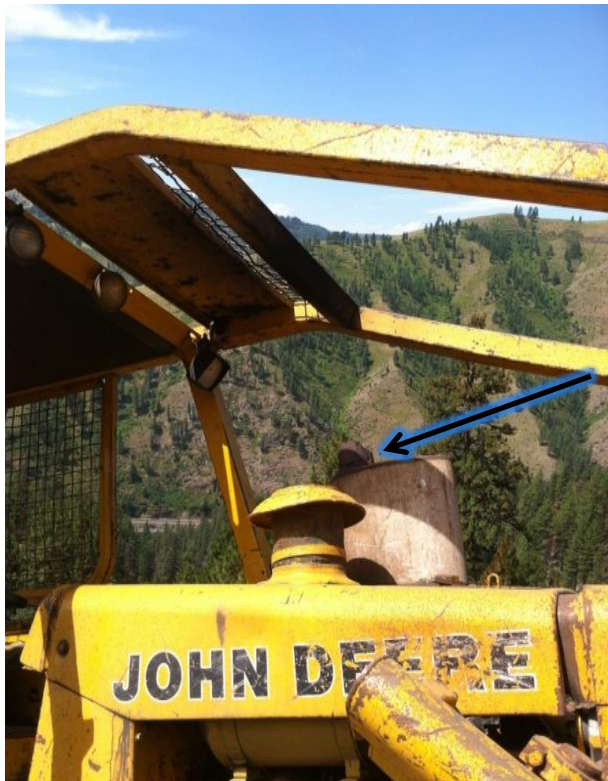
Figure 7. Broken exhaust.

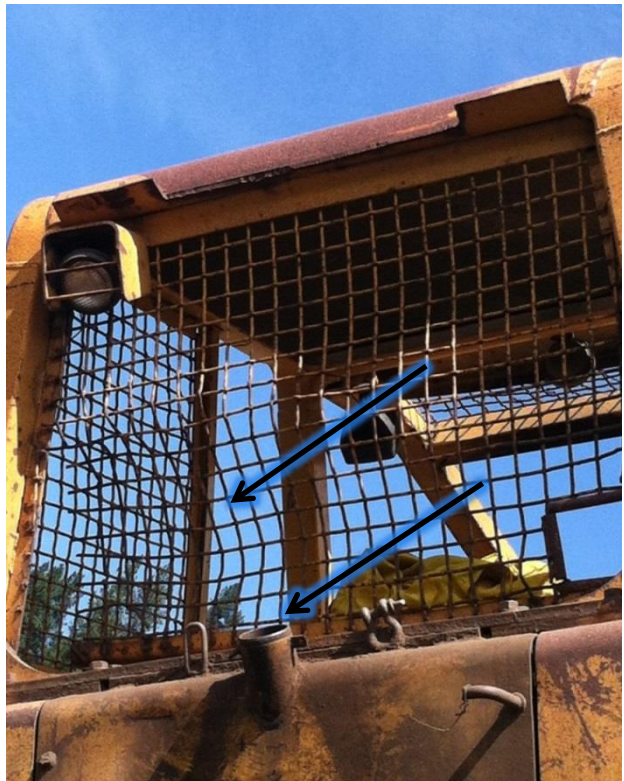
Figure 8. Broken mesh on cage and missing fuel cap.

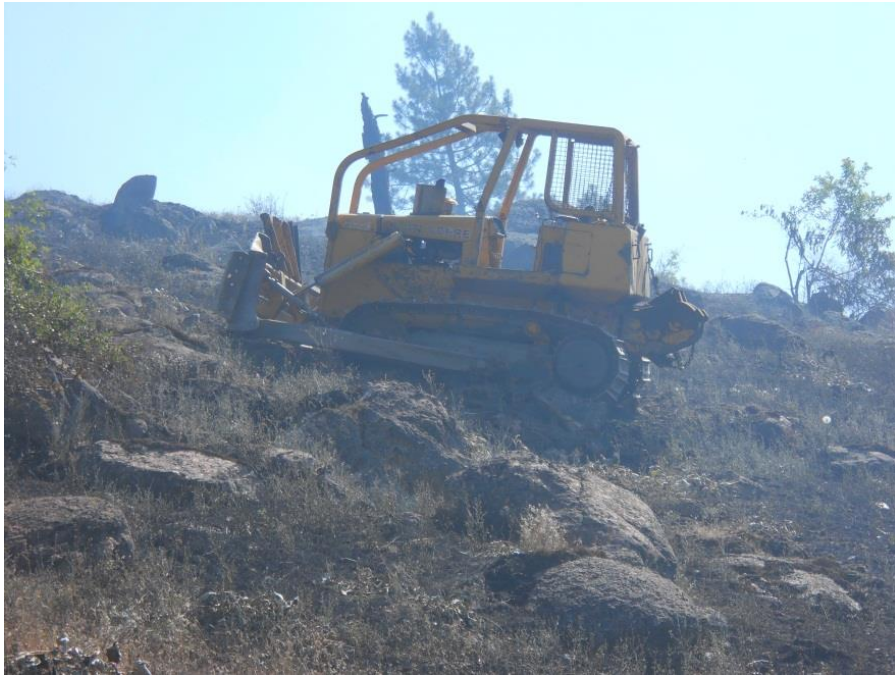
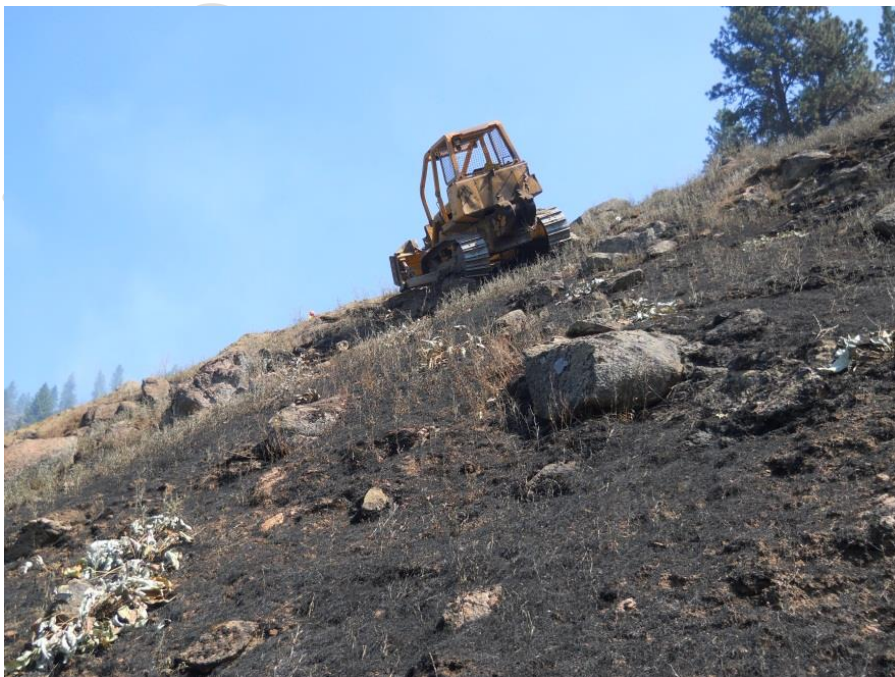
As the Heavy Equipment Boss approaches the dozer, he sees the Contract Dozer Operator positioned leaning back over the seat of the cab. His head and left arm are facing downhill and his right arm is draped above his head. The dozer was located precariously on the steep slope with the blade up, brake not set and still idling. The Heavy Equipment Boss turns the machine off and lowers the blade to secure the dozer.

Figures 8 and 9. Location where the dozer was found.
