Wildland Fire Investigation Report

FLINT CANYON FIRE
September 6, 2012
Fire Investigation Report

Location:
Bureau of Land Management – Idaho Falls District
Idaho Falls, Idaho

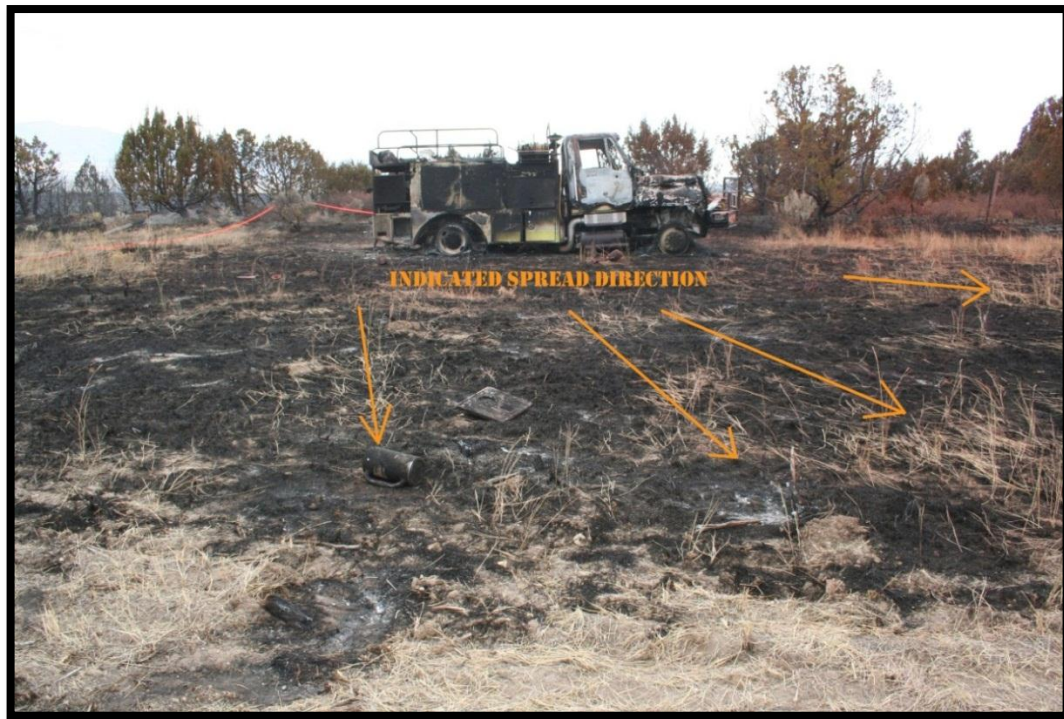
Figure 2: Burn pattern indicators suggests fire backs away from E3462 into the wind after engine is engulfed in flames
