ATV Accident Lessons Learned

Kelley Fire
ID-STF-000423

September 3, 2013

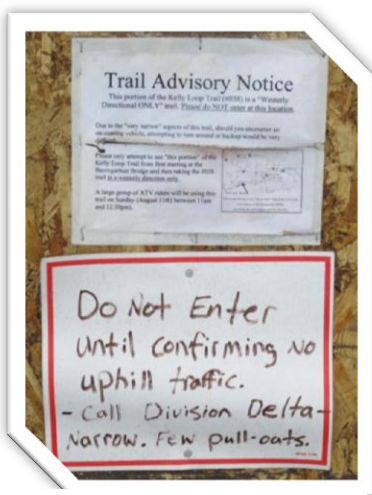
Sign placed at DP 11. This is the location where the ATV operator entered the trail.

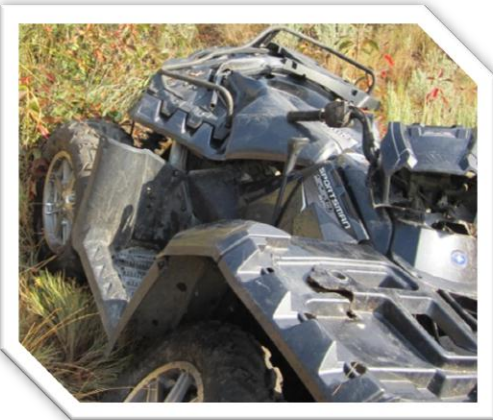
Right side of ATV

over. As he was backing up he noticed an area on the outside of the trail that looked wide enough to allow the UTV to pass. As he pulled onto the shoulder, the loose soil gave way and caused the rear right tire to drop off. The operator of the ATV had only two choices at that point: 1) he could try and throw his weight forward shifting the balance to the front tires and attempt to drive out, risking being impacted by the vehicle if it rolled or 2) he could bail out and get clear of the vehicle to lessen the chance of personal injury. In a split second decision the operator bailed off the ATV, landed on the downhill side of the vehicle in heavy brush and took a few tumbles down the hill but was not impacted by the ATV as it tumbled past him. The ATV did several flips and took serious damage as it careened down the steep slope until it reached a point where the terrain started to flatten and the brush was able to slow it to a point where it came to rest upright on its tires.

-The operators of both of the vehicles should have called out on the radio stating their intended direction and location of travel. This communication could have alerted the other operator and a good passing location could have been identified to avoid a traffic jam.

-Upon recognizing the traffic jam had occurred, all parties should have shut the vehicles off and devised a plan to remedy the situation. This communication could have identified safe alternatives to solo backing by the operator of the ATV such as: using a spotter(s); testing the pullout for stability; using all four individuals to manually lift and slide the ATV around; or calling for help from other crewmembers or heavy equipment to construct an adequate turnaround spot.

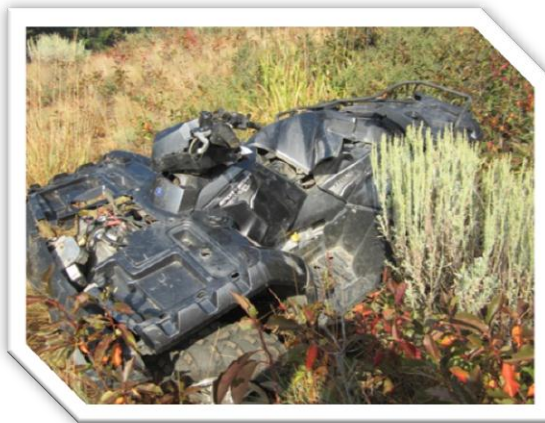
Left side of ATV

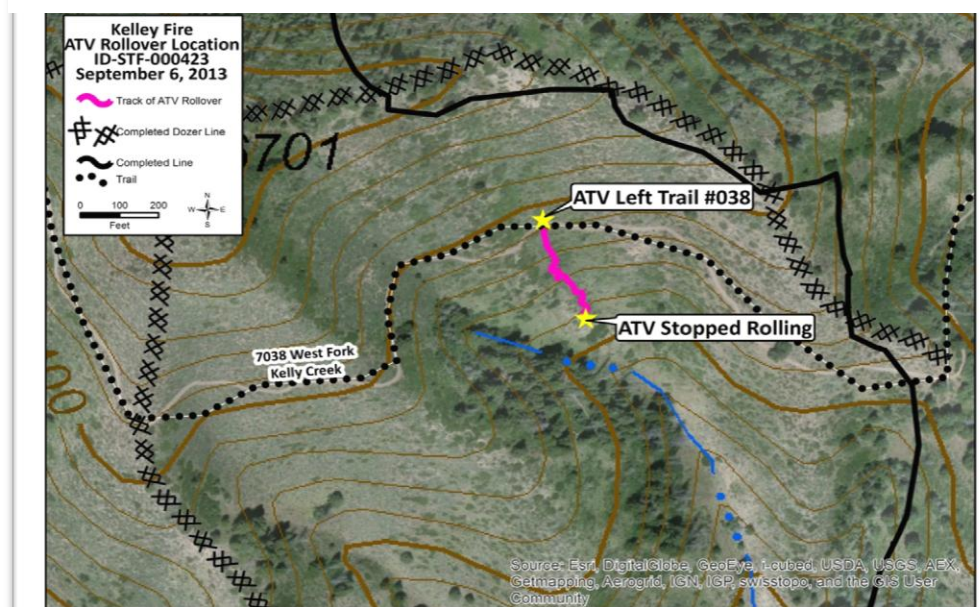
Map of ATV accident site
