North Divide ATV Incident

Facilitated Learning Analysis

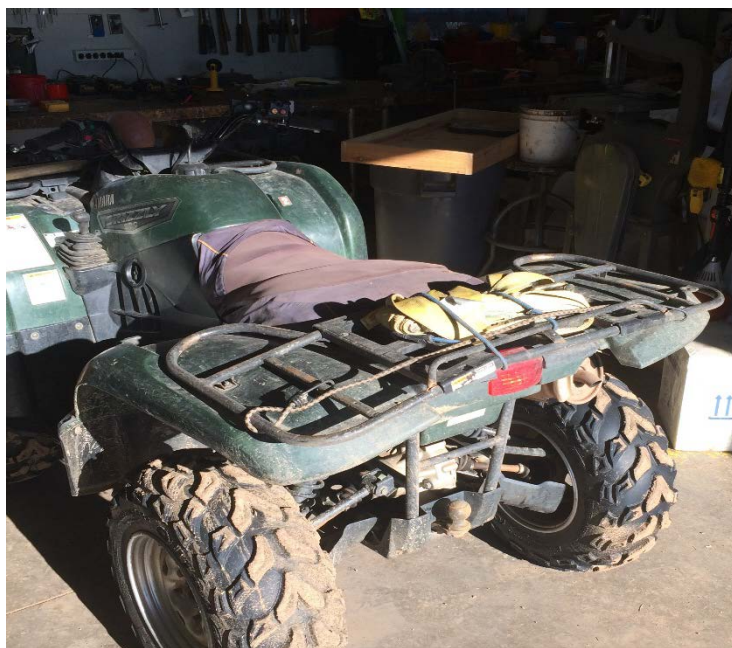
Minimal damage to the rear tool rack caused by the ATV incident.

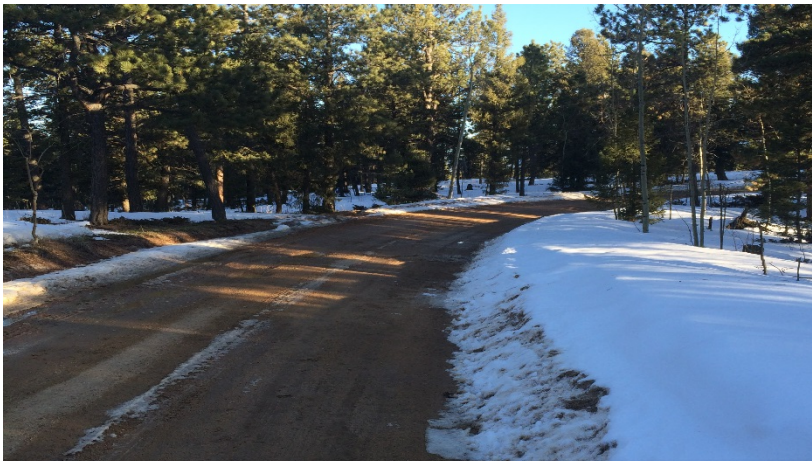
Picture of snow berm at incident site after significant road melting had occurred, which is not representative during the incident.

Sam was now following George the last half mile back to the trailhead. During the last half mile of the trip, along a shady spot, Sam encountered a change in road conditions causing the ATV to make contact with the two-foot tall snow berm.

During this contact with the snow berm the right front end of the ATV reacted violently throwing Sam into the snow embankment. As a result the ATV was facing the opposite direction on the road laying on its side.

- ❖ In addition to the minimum ASI required training, develop an ATV training plan that incorporates additional training modules that prepare operators for riding in realistic seasonal conditions.
- ❖ Organize an ATV instructor working group to discuss ATV accidents, near misses, and training to identify best practices and promote a learning organization.
- ❖ "Don't underestimate non dangerous conditions. It doesn't take much to get injured on an ATV", Sam.
- ❖ Conduct your pre-ride check and always carry your safety gear (survival kit, first aid, communications, food, water) regardless of the distance you plan to ride from your vehicle.
- ❖ Clear communication between team members is critical.
