# Rapid Lesson Sharing

**Event Type:** UTV Rollover

**Date:** Aug. 20, 2015

**Location:** Rattlesnake Fire;  
Arizona

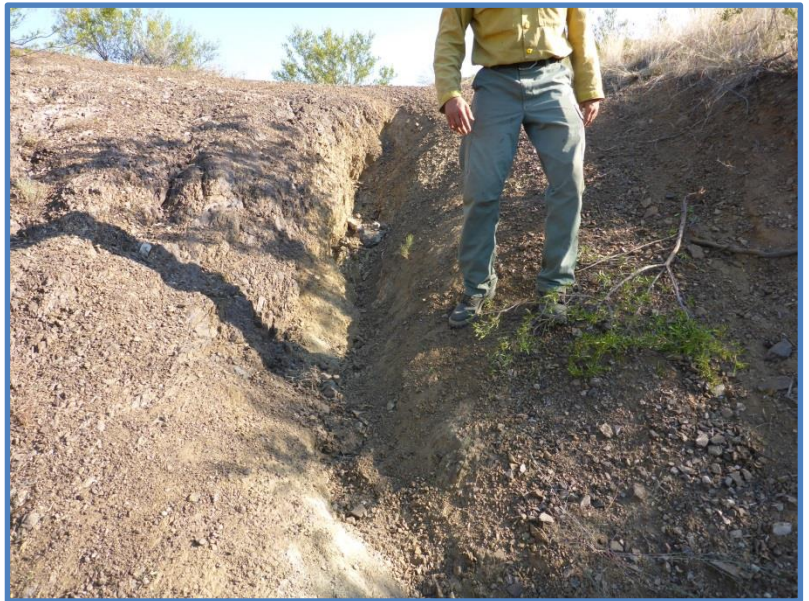
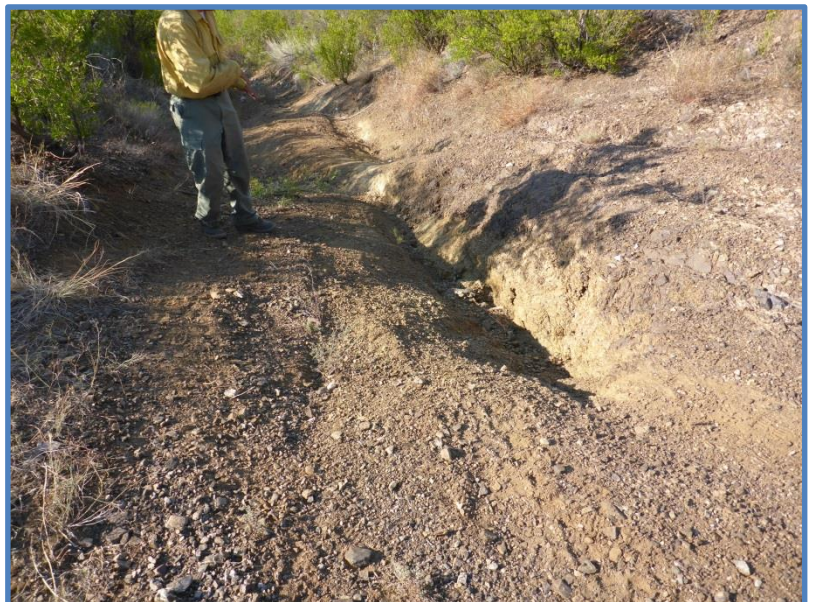
As the second UTV starts its descent, the passenger-side wheels slide into the wash-out ditch area. The UTV comes to a stop. It is leaning severely over onto the machine’s passenger side. It is “hung-up” on its frame’s undercarriage.

***Photos show where the descending UTV slid into this wash-out ditch area. The UTV came to a stop, severely leaning over onto the passenger’s side. When the operator and two passengers exit the UTV, the reduction of the vehicle’s weight allows the UTV’s suspension to rise—freeing the UTV’s undercarriage. Even with the engine off and the transmission engaged, the UTV moves down the hill and eventually rolls over.***

But as the passengers and operator exit the UTV, the subsequent reduction of the vehicle's weight allows for the UTV's suspension to rise—freeing the UTV's undercarriage.

Even with the engine off and the transmission engaged, the UTV begins to roll down the trail. Forward momentum carries the UTV some distance before it hits another washed out area, causing the UTV to roll over. The vehicle comes to rest midway down the trail.

- ✓ Even if you are an experienced UTV operator, always plan for the worst case scenario. In this incident, setting the emergency brake may have prevented the UTV from rolling.
- ✓ When in a questionable situation, stop. Assess the situation and develop a plan to mitigate the situation. In this case, they made the right decision—unfortunately, gravity and terrain won.
- ✓ Selecting the right tool for the job is very important. The use of UTVs in this situation was the appropriate tool for the job. The access in this area is extremely rough with narrow roads/trails and un-accessible to normal (low clearance) vehicle travel.
