# Rapid Lesson Sharing

**Event Type:** Trailer in Tow Disconnect

**Date:** July 29, 2016

**Location:** State Highway 90,  
Arizona

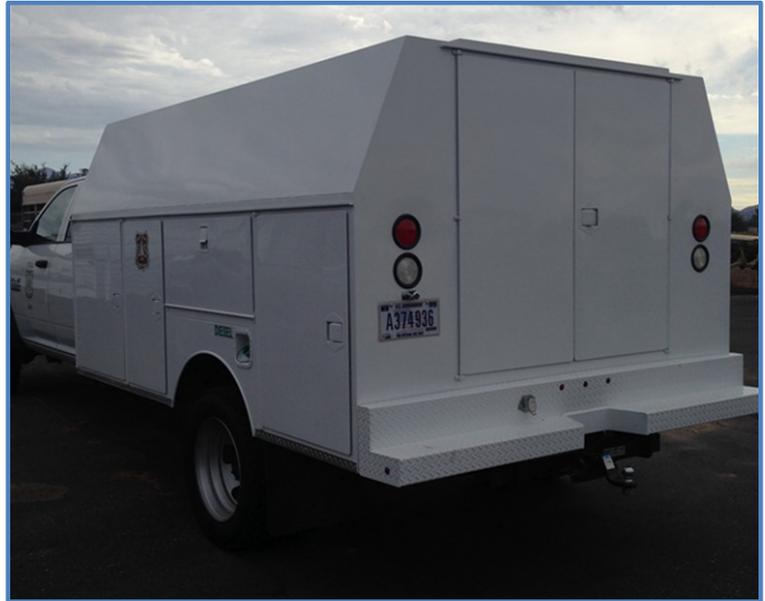
*After slowing down and stopping in the parking lane, we discovered that the trailer hitch had disconnected from the ball on the receiver hitch. One of the two safety chains had ground through and was hanging on the trailer tongue.*

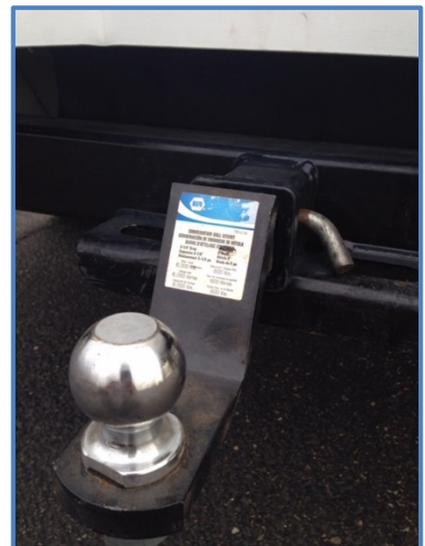
His response was: "You're dragging something." After slowing down and stopping in the parking lane, we discovered that the trailer hitch had disconnected from the ball on the receiver hitch. One of the two safety chains had ground through and was hanging on the trailer tongue.

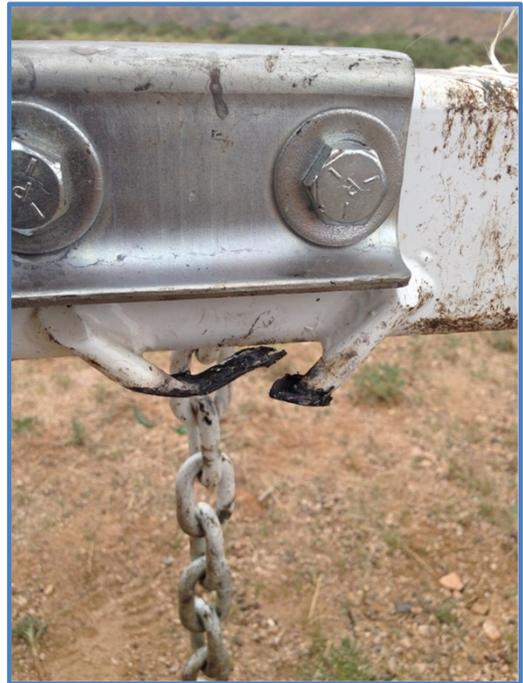
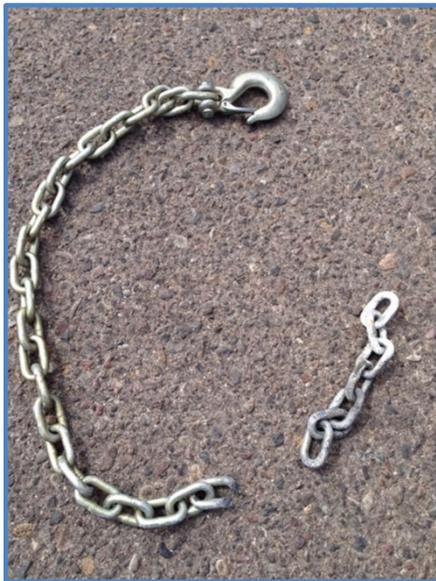
No injuries occurred and no damage to the towing vehicle occurred. Damage on the sign trailer was limited to the two areas where the safety chains are attached. Both safety chains were in contact with the pavement for a distance. This resulted in one of the chains being ground through and converted into two separate chains. The electric connection was also severed.

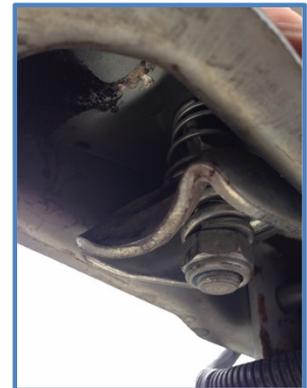
After closer inspection, we noticed that the small piece of metal that is normally pulled up under the ball when the trailer is connected onto the ball was too low and not in the necessary position to hold the trailer onto the ball. It was tight enough to hold the trailer tongue on the ball when we lifted up on the trailer tongue—resulting in what appeared to be a correctly attached trailer.

This tongue-to-ball hitch connection was corrected using a box wrench to tighten the nut on the underside of the hitch. After this correction was made, no further problems developed on either trailer being towed.
