Lahaina Fire Incident Analysis Report

September 13, 2024
Columbia, MD

Fire Safety Research Institute

This document is the second in a series of three (3) reports commissioned by the Hawai‘i Department of the Attorney General (DOAG) to provide an independent review of the tragic fire that destroyed much of Lahaina, Hawai‘i, on August 8-9, 2023.

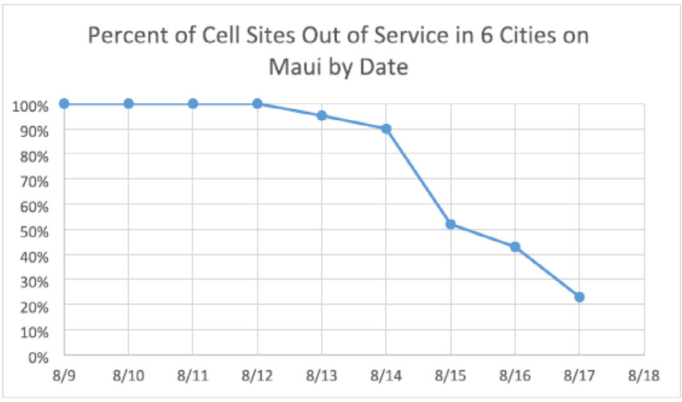
Figure 3.5.1 FCC-registered cell sites out of service in the County of Maui, HI. Source: Federal Communications Commission, Communications Status Report for Areas Impacted by Hawai'i Wildfires August 9-17, 2023.

For August 9-12, 2023, the Federal Communications Commission report indicates that 100% of the cell sites were out of service (Figure 3.5.1).

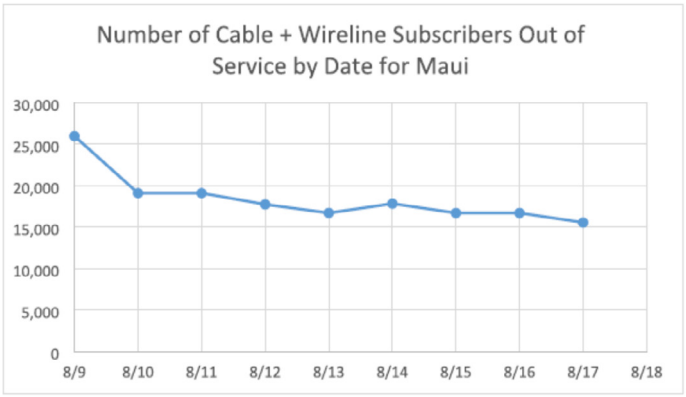
Figure 3.5.1.1 Number of cable and wireline subscribers out of service by date for Maui.[149]

Wireline and cable telecommunications services were also rendered inoperable for many subscribers from the impacts of the August 8-9, 2023, fires, including electrical failures, fire impingement, etc. (Figure 3.5.1.1)

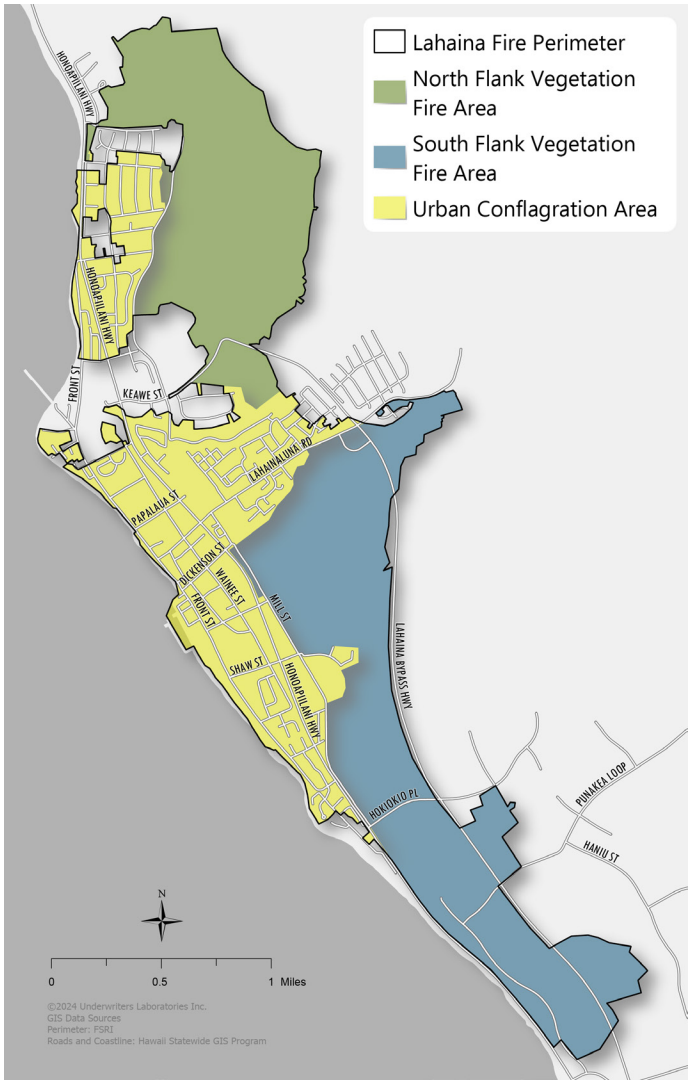
The Lahaina PM fire consisted of a wildfire-initiated urban conflagration flanked by fast-moving vegetation fires on the north and south (Figure 3.7.7.5.1).

Figure 3.7.7.5.1 Map of Lahaina PM fire perimeter showing area of urban conflagration and vegetation fires on north and south flanks.

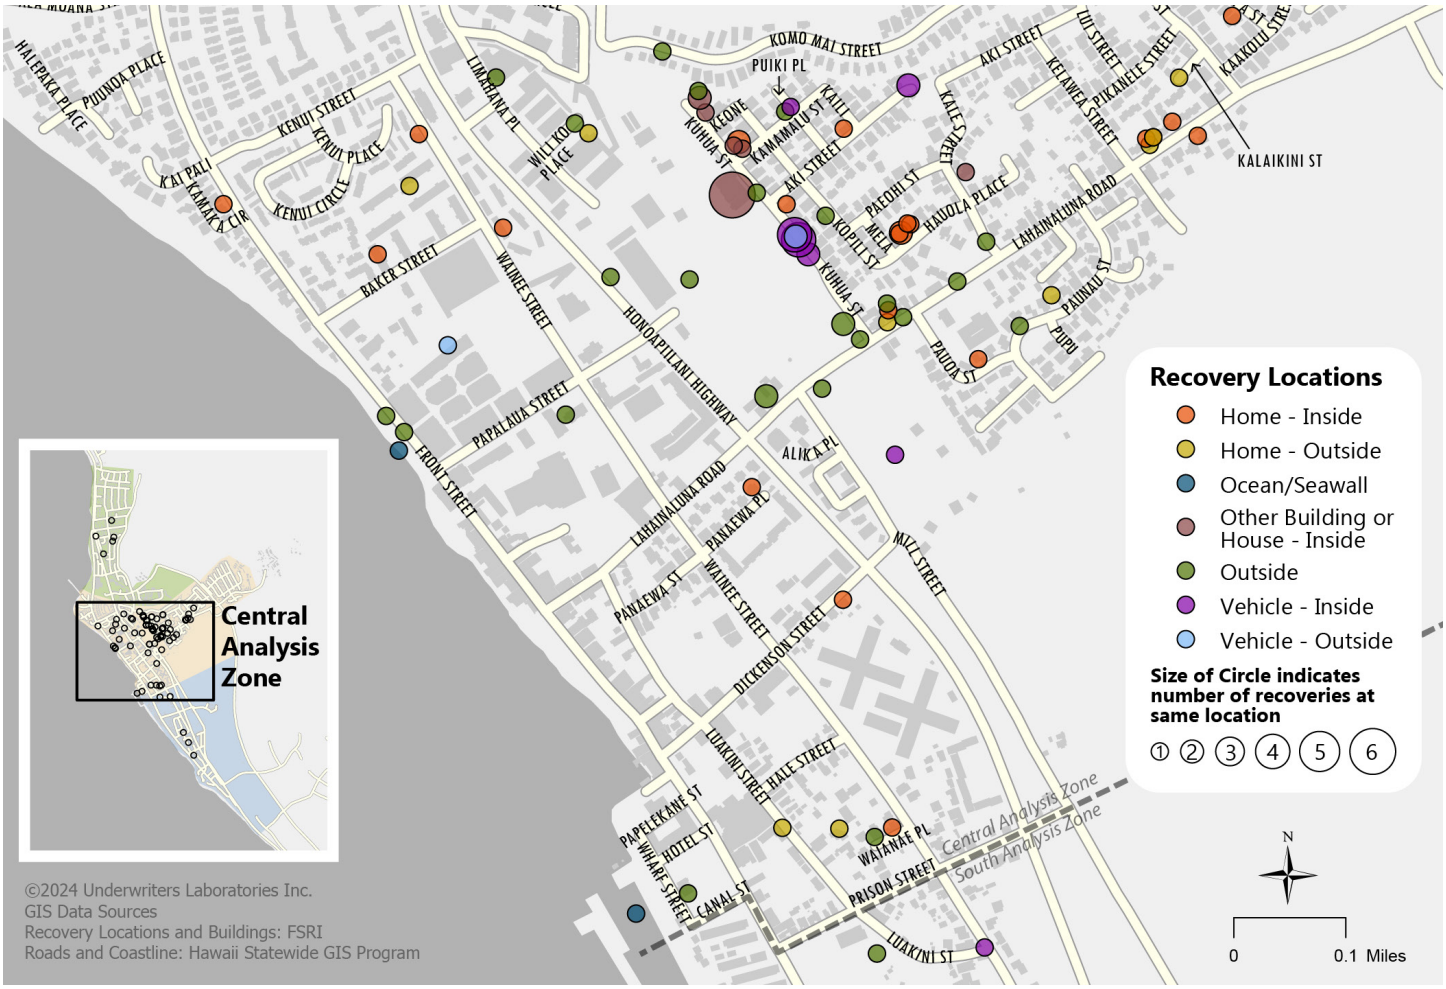
Figure 3.8.10.1 Recovery locations and descriptions of fire fatalities for the central analysis zone.

The largest number of fatalities, 82 (80%), took place in the central part of Lahaina, the area bounded by Kahoma Stream to the north and Dickenson Street to the south (Figure 3.8.10.1). This area experienced rapid initial fire spread and the least available evacuation time. See the Phase One report (pages 45-83) for additional details on where and when the fire progressed.

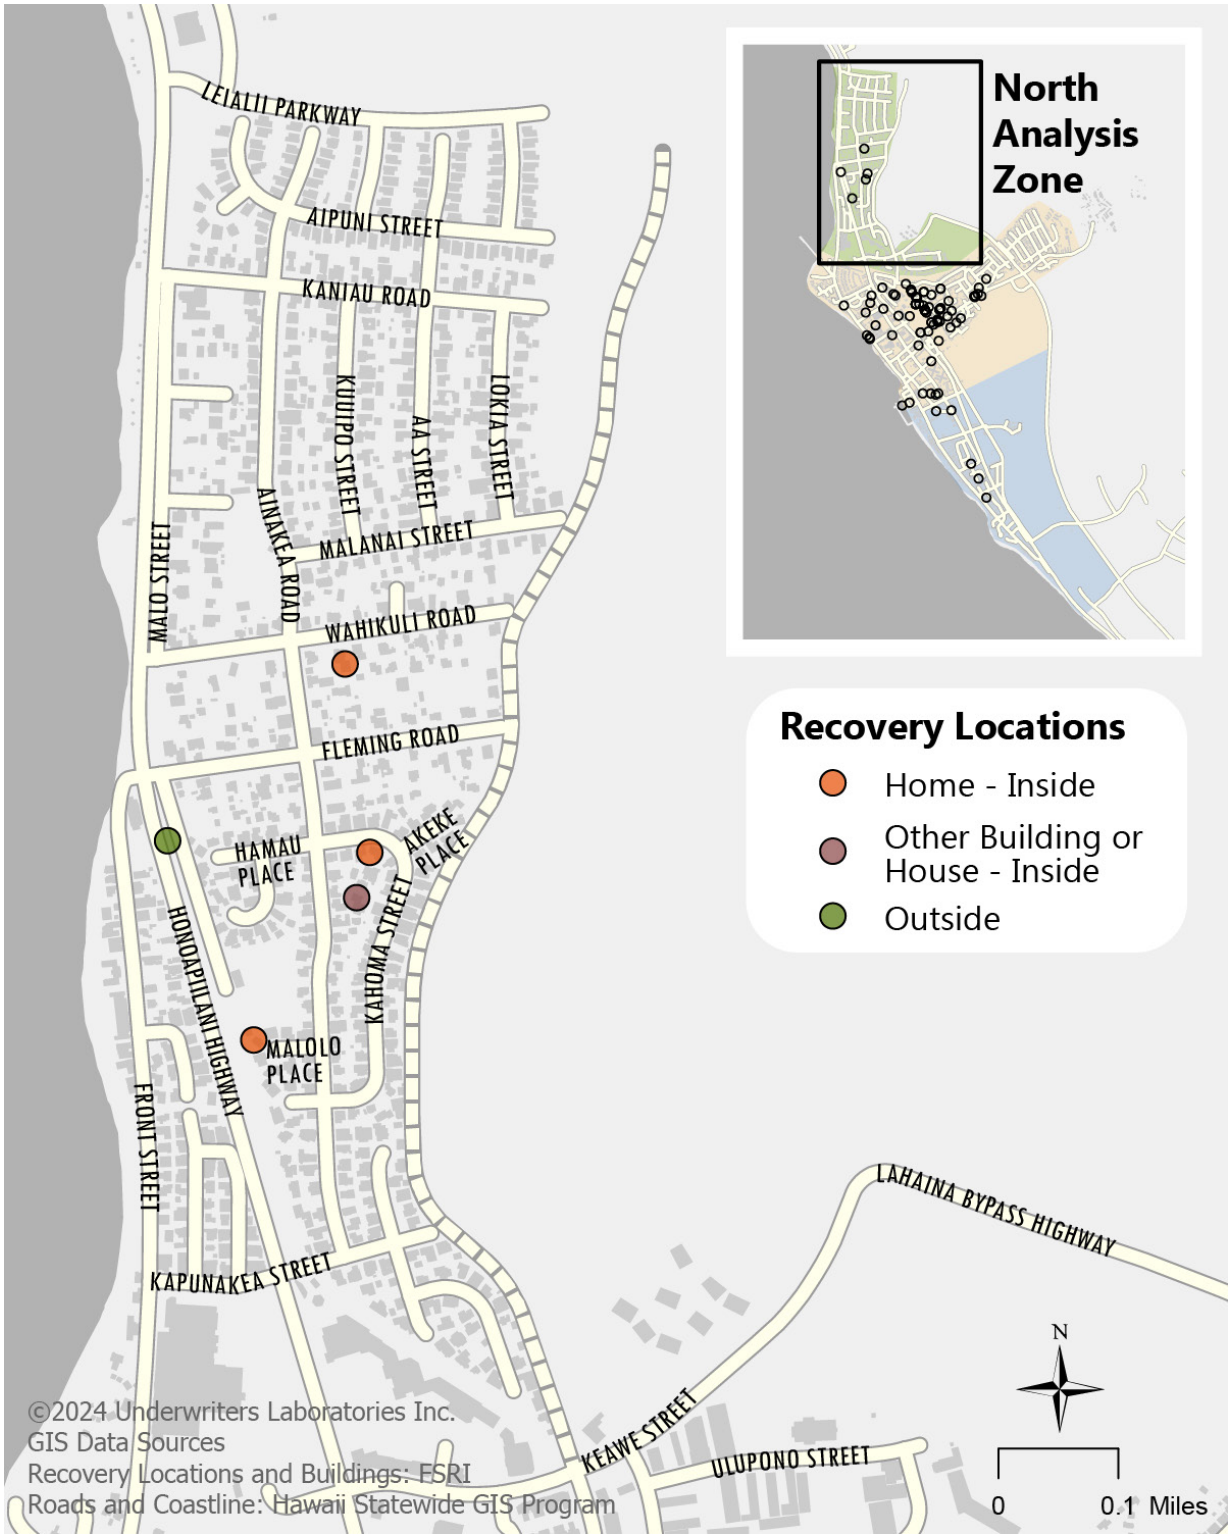
Eleven (11%) fatalities occurred south of Dickenson Street and five (5%) fatalities occurred north of Kahoma Stream (Figures 3.8.10.2 and 3.8.10.3). Four (4%) victims died later due to injuries sustained during the fire.

Figure 3.8.10.2 Recovery locations and descriptions of fire fatalities in the north.

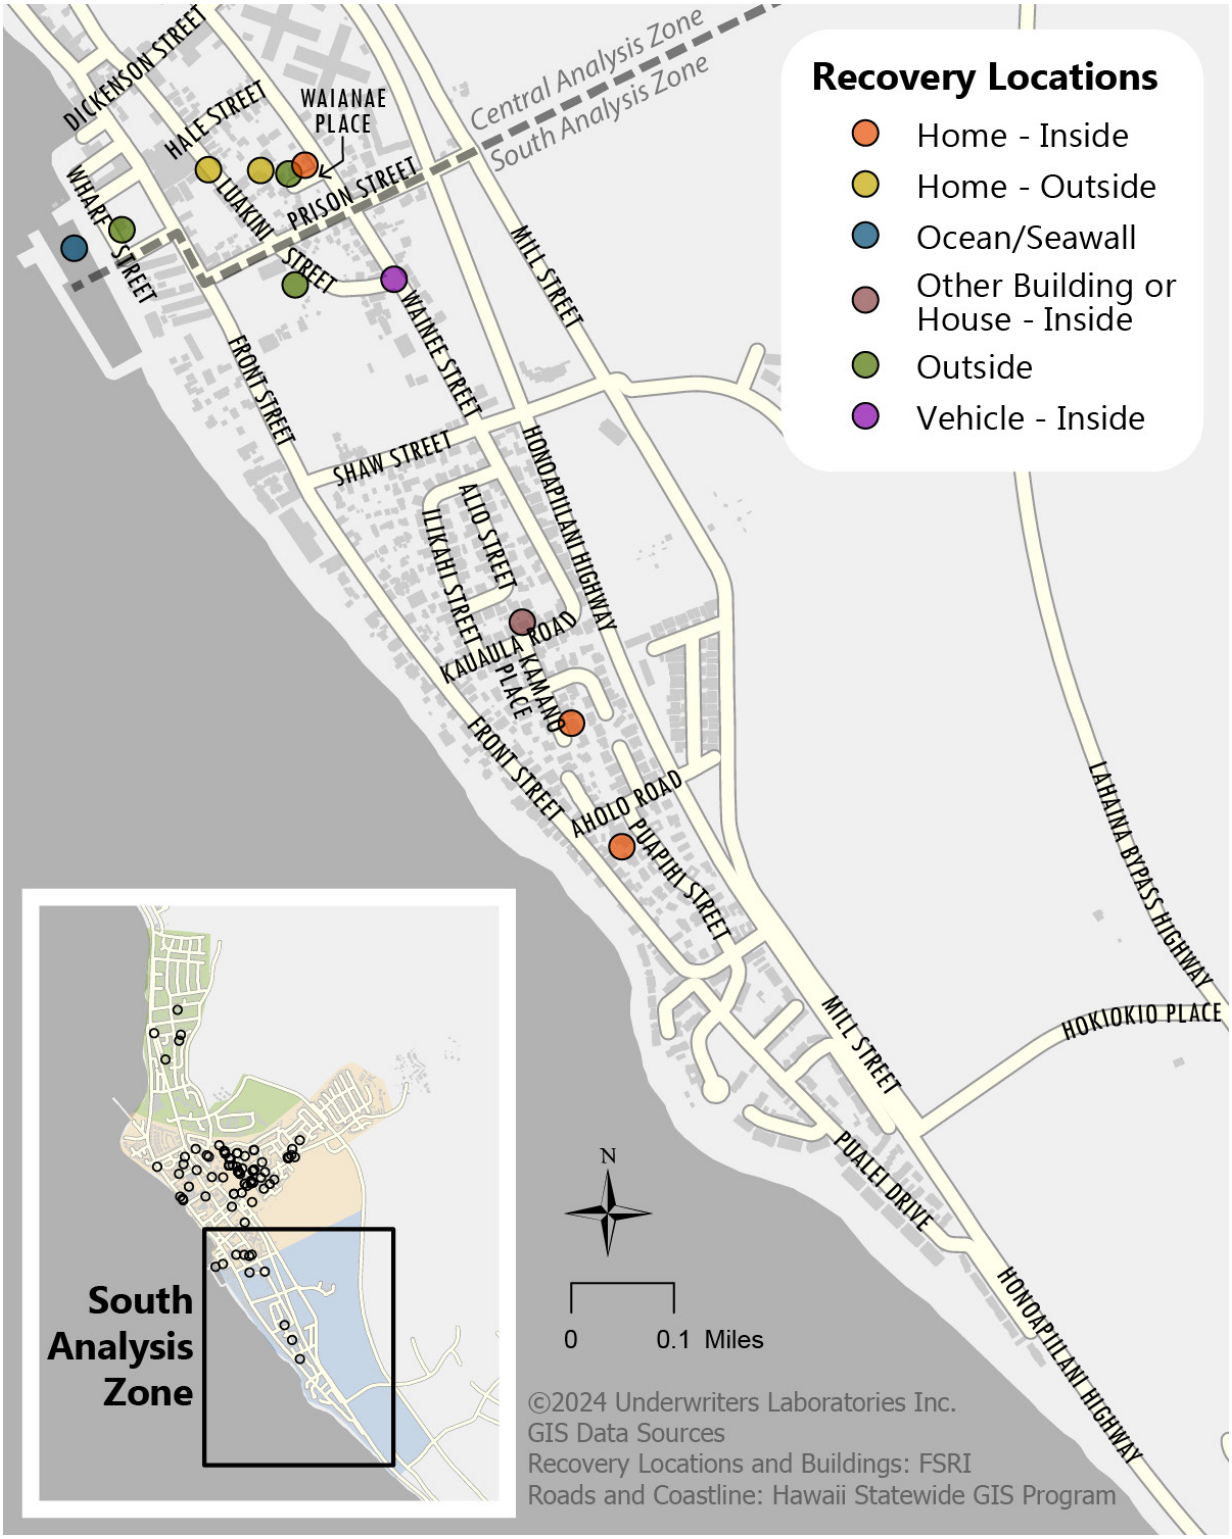
Figure 3.8.10.3 Recovery locations and descriptions of fire fatalities in the south.

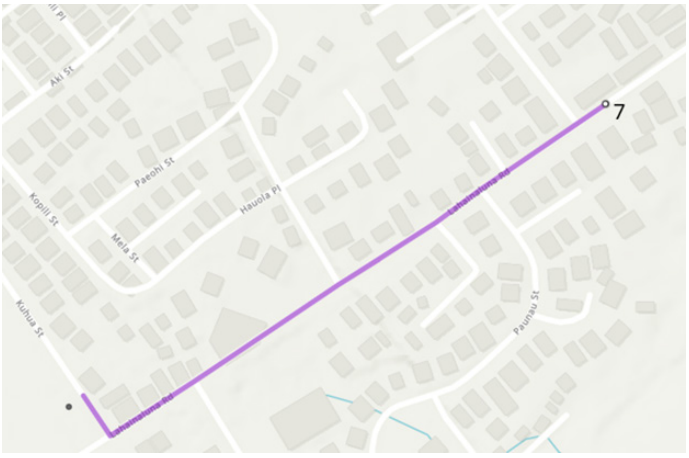
There were three (3) clusters of fatalities located in the Lahainaluna neighborhood. The first was at the Hale Mahaolu Eono independent-living apartment complex at 8[redacted] Kelawea Street. Seven (7) residents were among the fatalities. Six (6) were recovered on the facility property and one (1) evacuated to the area of Lahainaluna Road and Kuhua Street and was recovered there (Figure 3.8.10.4).

Figure 3.8.10.4 Evacuation path of the resident of the Hale Mahaolu Eono independent-living apartment complex at 8[redacted] Kelawea Street who was recovered on Kuhua Street.

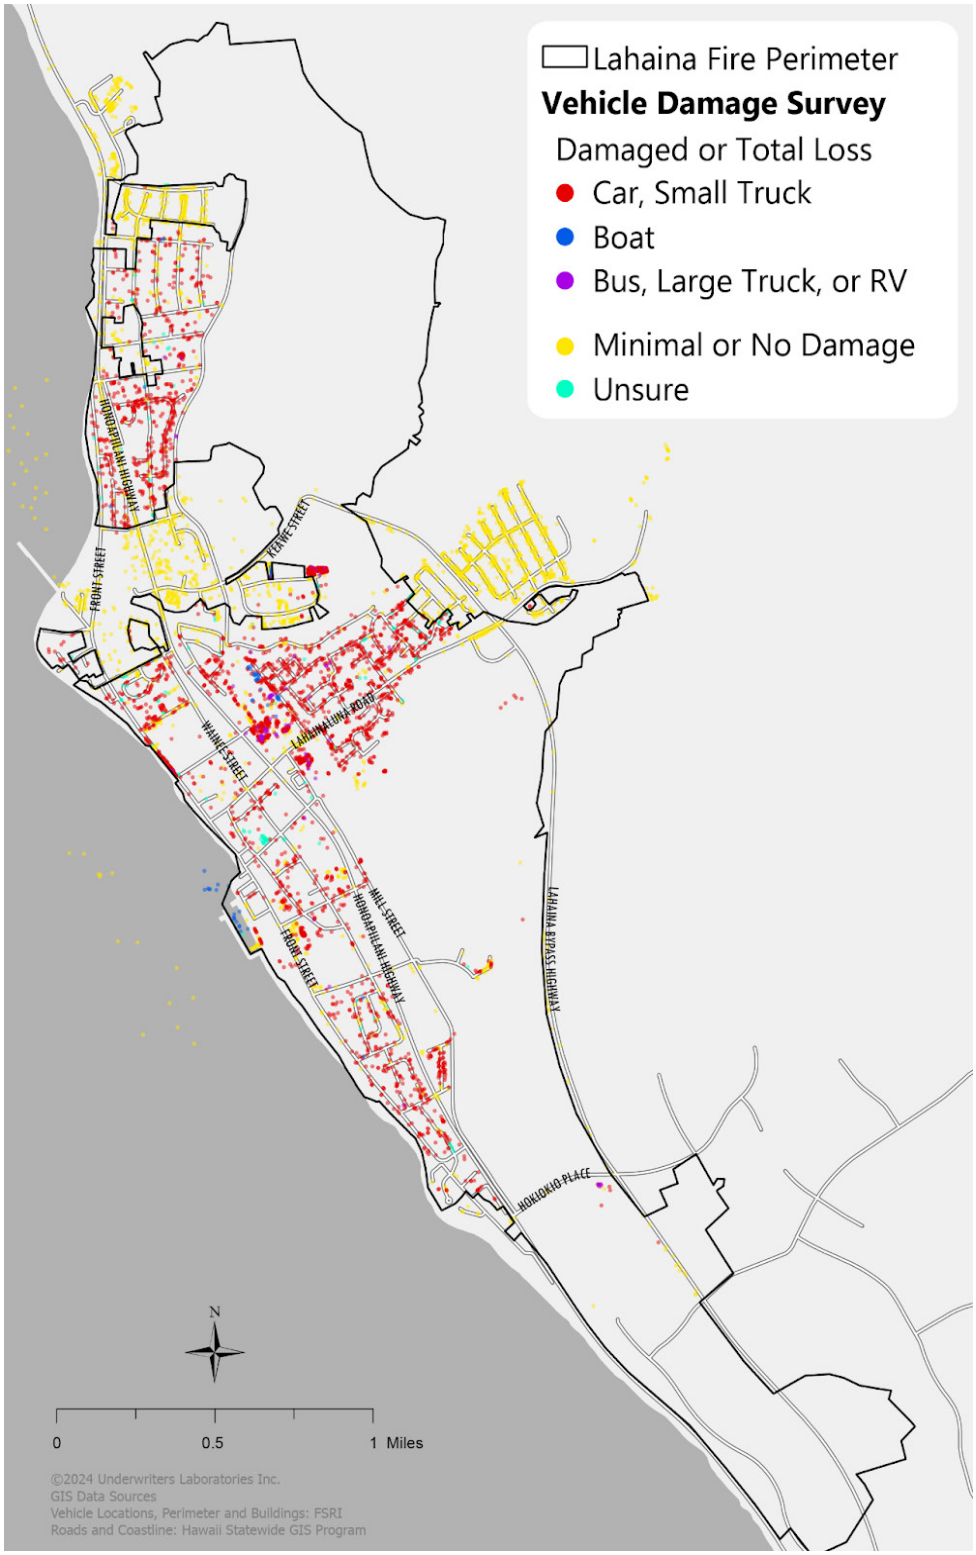
FSRI conducted a visual survey using post-fire aerial imagery captured August 11-13, 2023, to create a dataset of vehicle locations and damage classification (Figure 4.2.2.1). It is evident from the imagery (and as reported) that vehicles, both destroyed and undestroyed, were moved at some point during or after the incident.

Figure 4.2.2.1 Overview of incident area with location of vehicles identified in aerial imagery captured August 11-13, 2023.

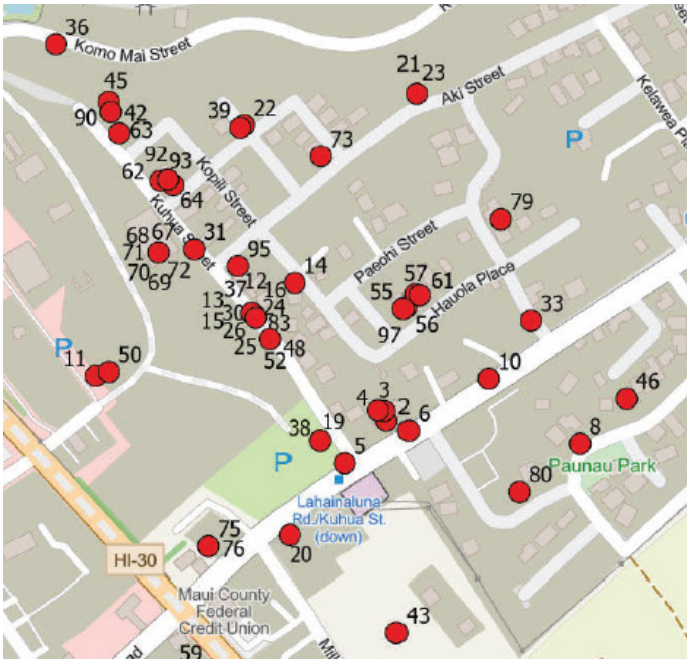
Figure 4.3.3.1.8 Fatality locations in this area as provided by the MPD.

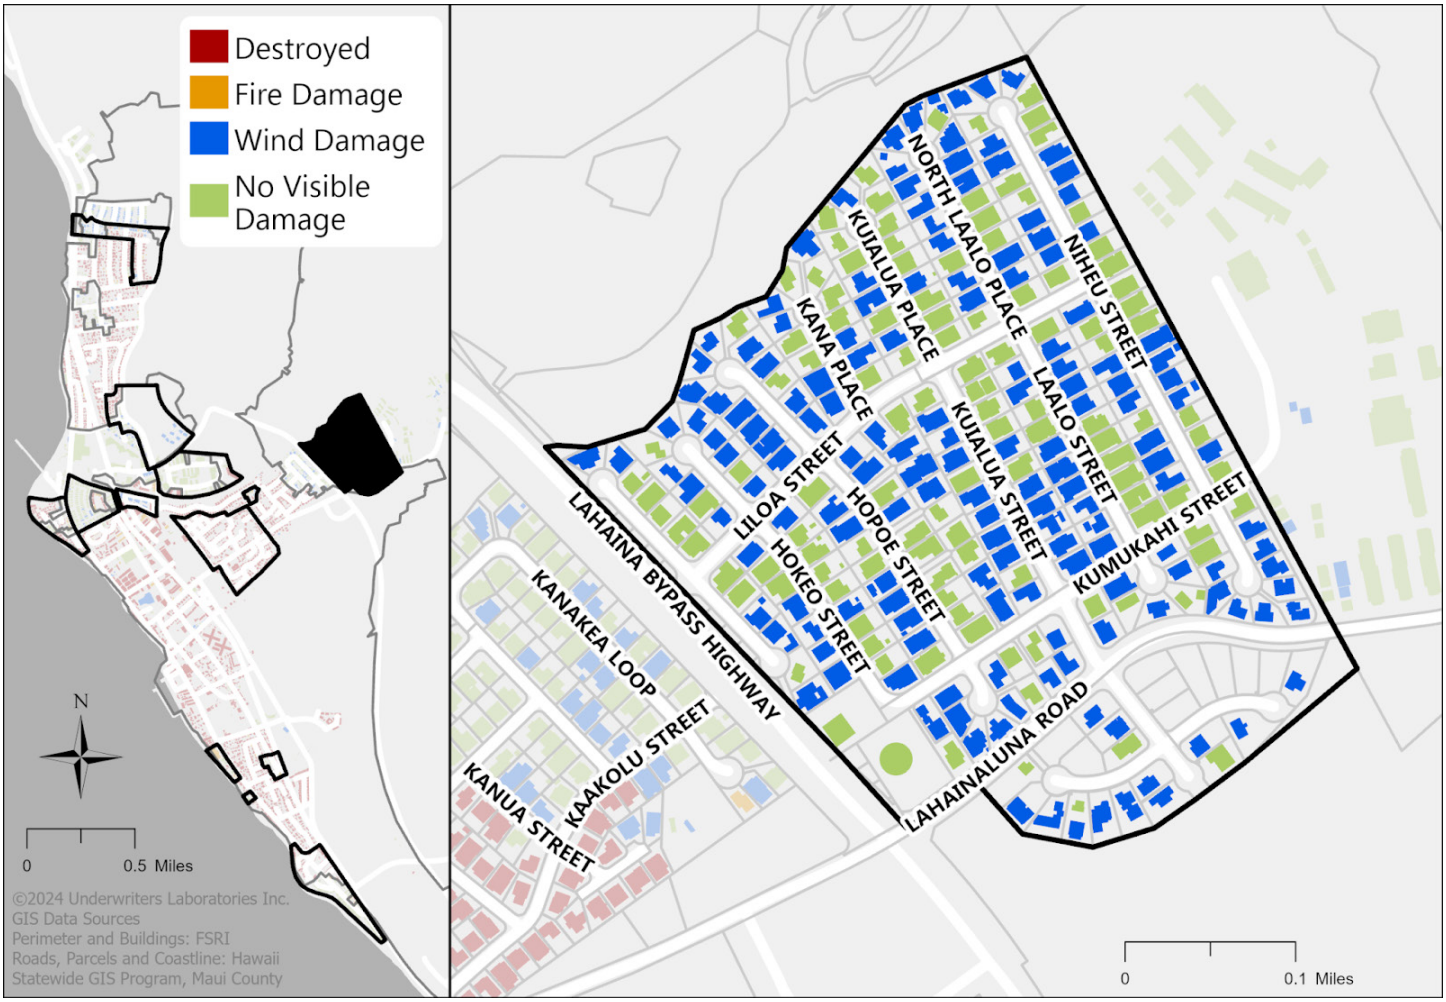
Figure 4.3.3.2.2 Damage classification assessment map of Kelawea Mauka III subdivision analysis area.

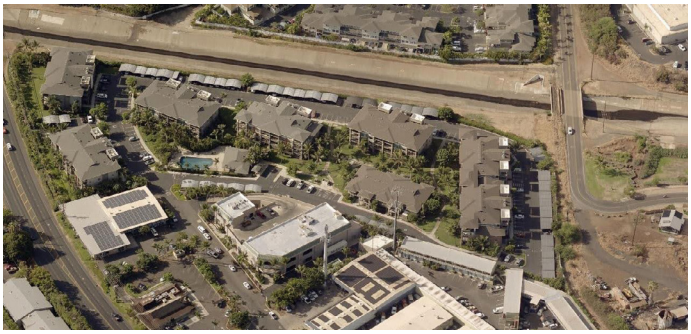
The Opukea apartment complex comprises seven (7) apartment buildings and one (1) office/amenity building along and south of Kahoma Stream (Figure 4.3.3.4.1). The complex was built in 2008 and construction features include stucco exterior walls and composition shingle roofs.

Figure 4.3.3.4.1 Pre-fire aerial imagery (captured August 10, 2021) of Opukea Apartments.

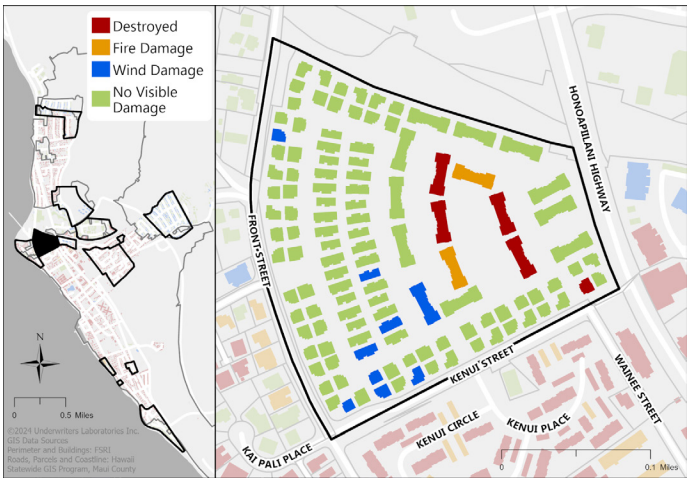
Figure 4.3.3.5.2 Damage classification assessment map of Kahoma Village analysis area.

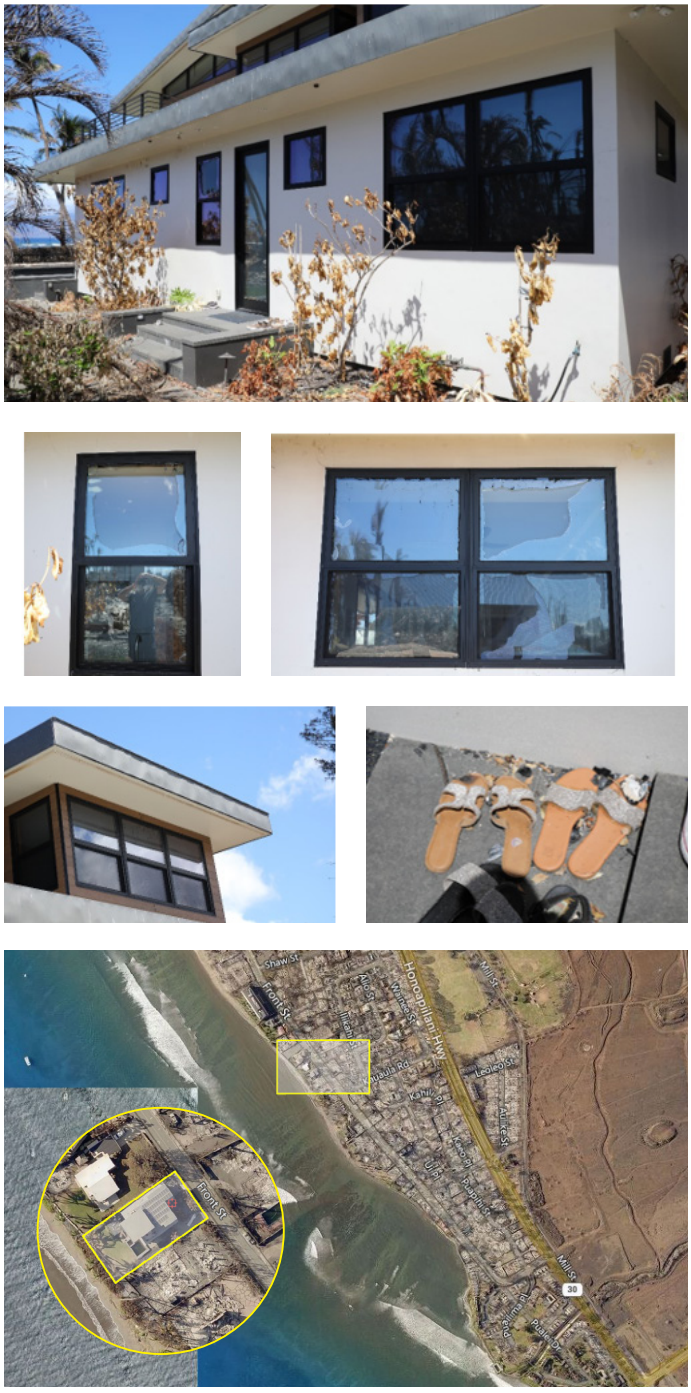
Figure 4.3.4.1.13 Window damage on the south side of 4[redacted] Front Street. Ember damage to shoes on doorstep indicates energetic embers were present in the area, which could have increased risk for ignition of interior combustibles had windows completely failed. Inset: Viewpoint showing the area depicted in the photographs above.

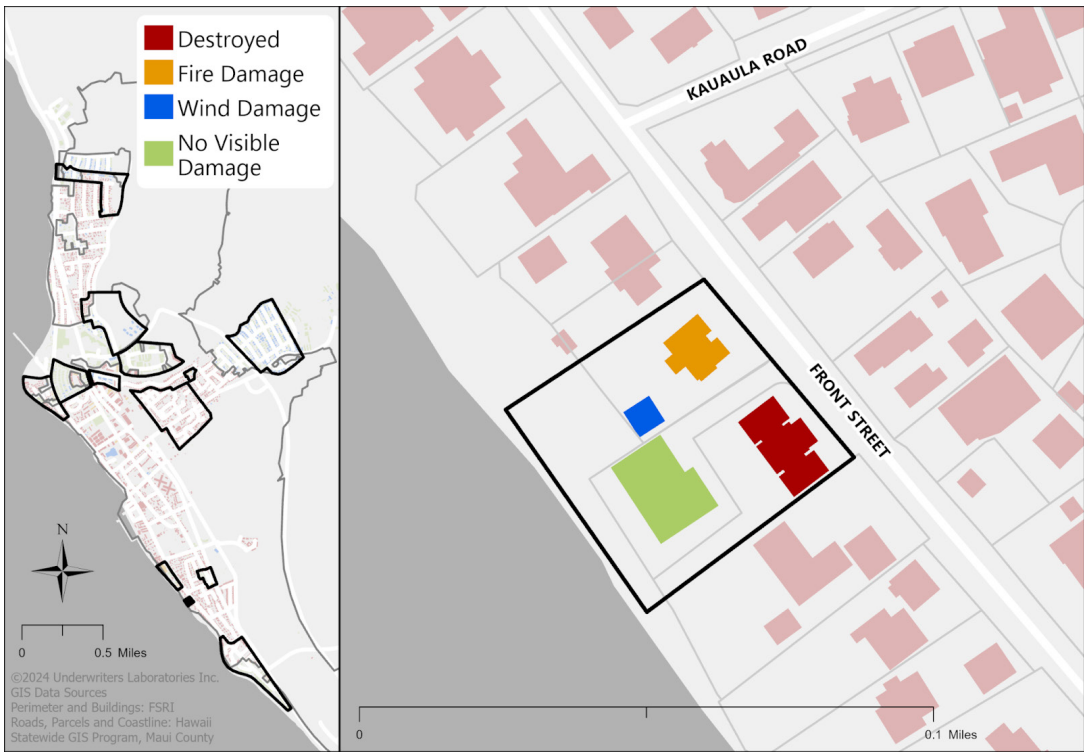
Figure 4.3.4.3.2 Damage classification assessment map of analysis area.

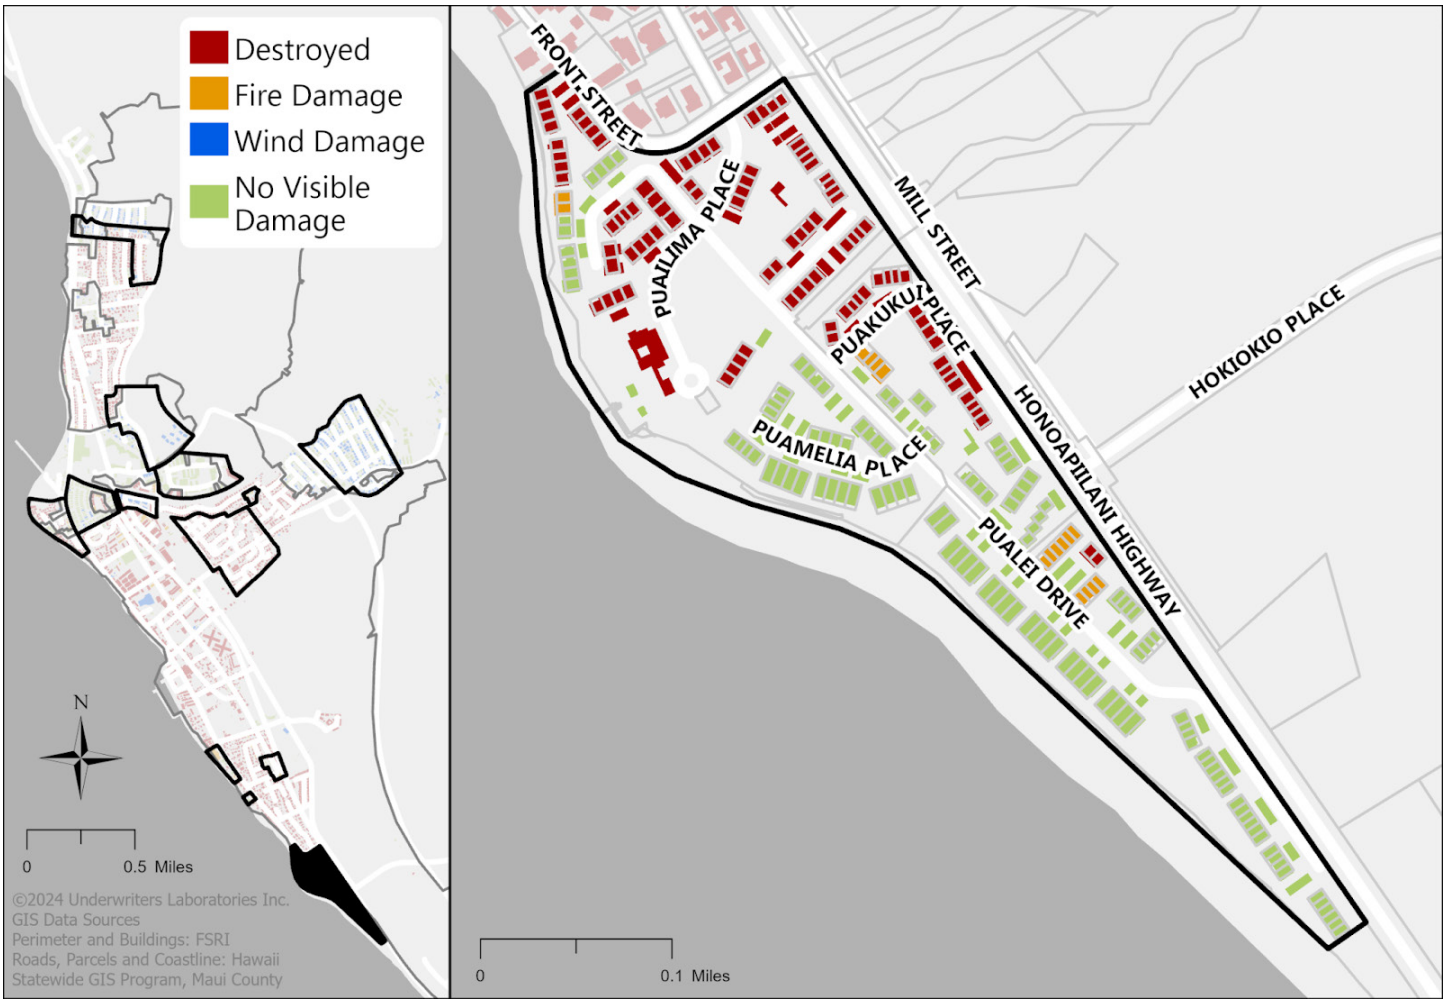
Figure 4.3.4.4.2 Damage classification assessment map of the Puamana Community analysis area.

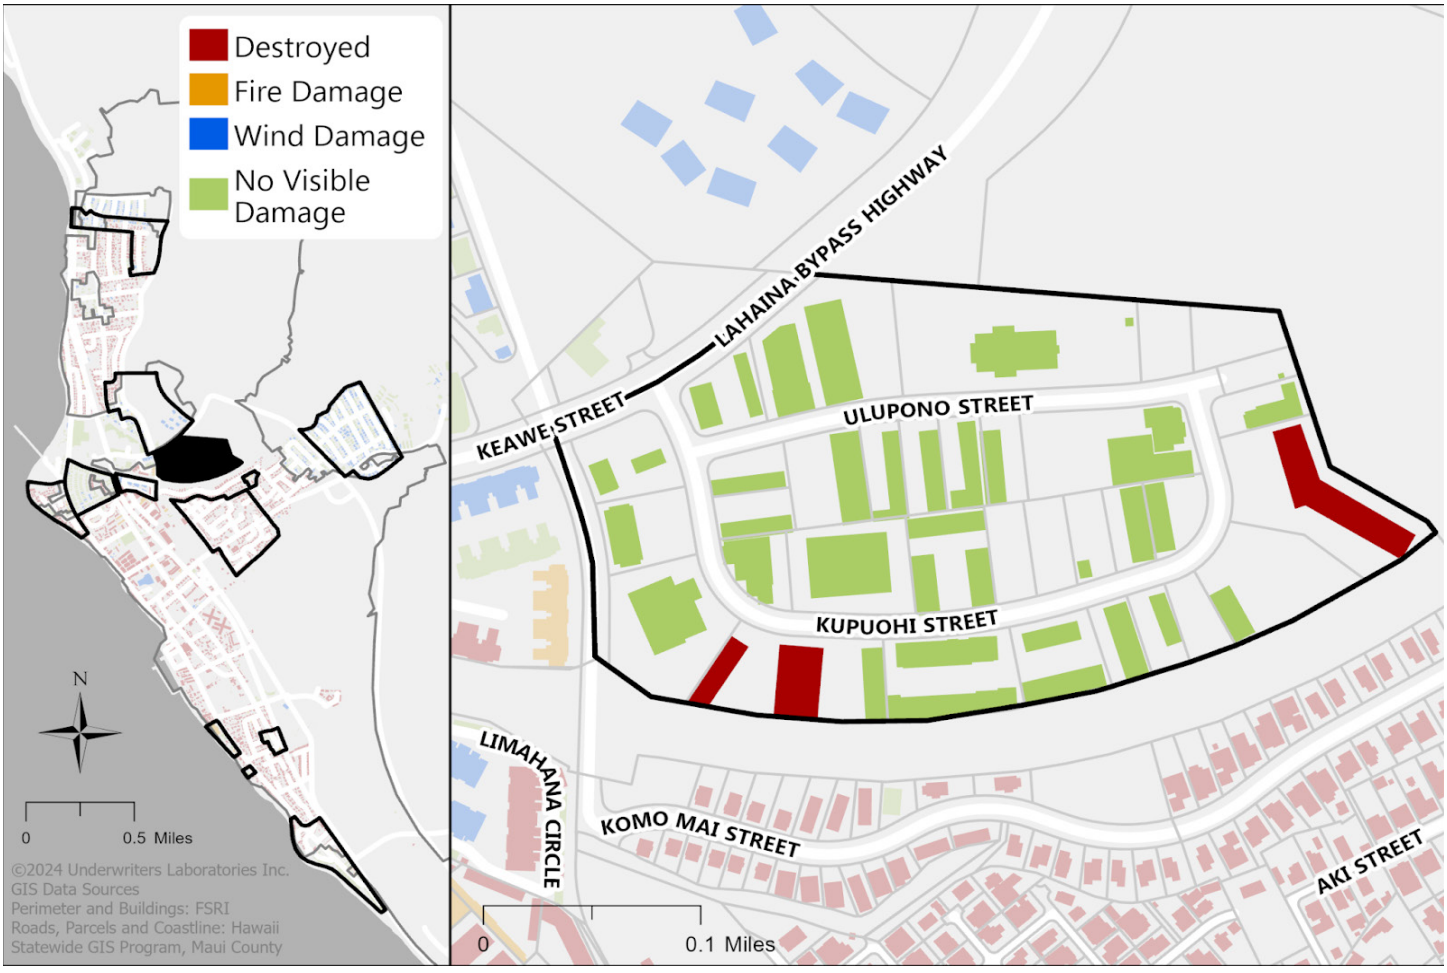
Figure 4.3.5.1.2 Damage classification assessment map of the Lahaina Business Park analysis area.

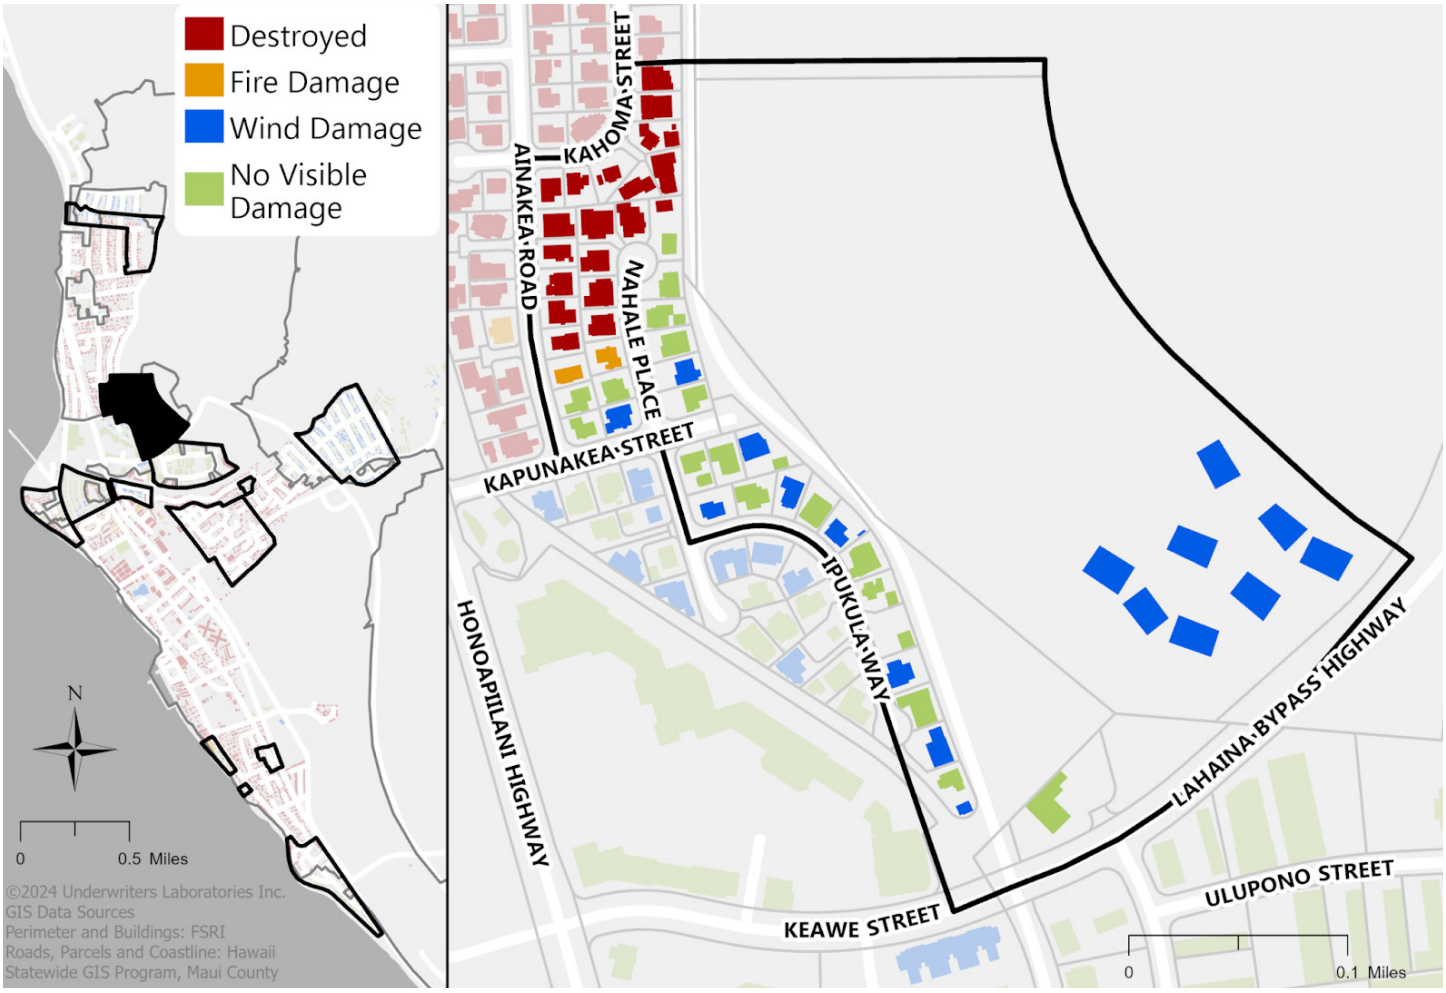
Figure 4.3.5.2.2 Damage classification assessment map of the Keawe Street Apartments at the Villages of Leialiʻi analysis area.

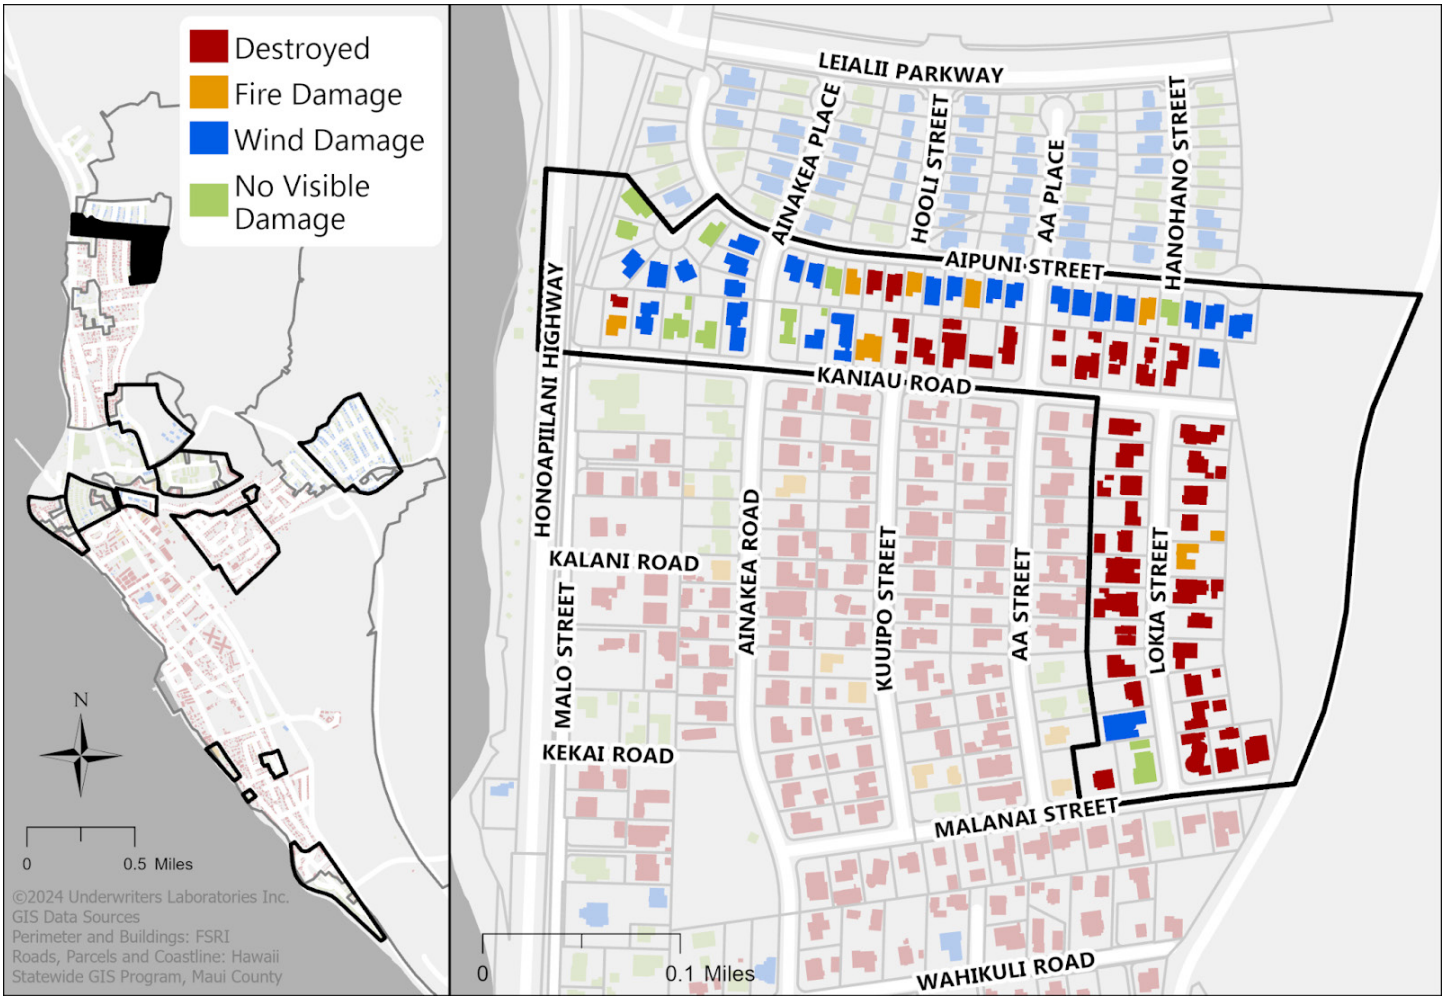
In the North zone, structures between Kaniau Road and ‘Aipuni Street were the northernmost structures to be destroyed by the fire (Figure 4.3.5.3.1). Only 13 of the 31 structures on the north side of Kaniau Road survived the fire, with most of the surviving structures grouped toward the west (makai) end of this road (Figure 4.3.5.3.2).

Figure 4.3.5.3.2 Damage classification assessment map of analysis area.

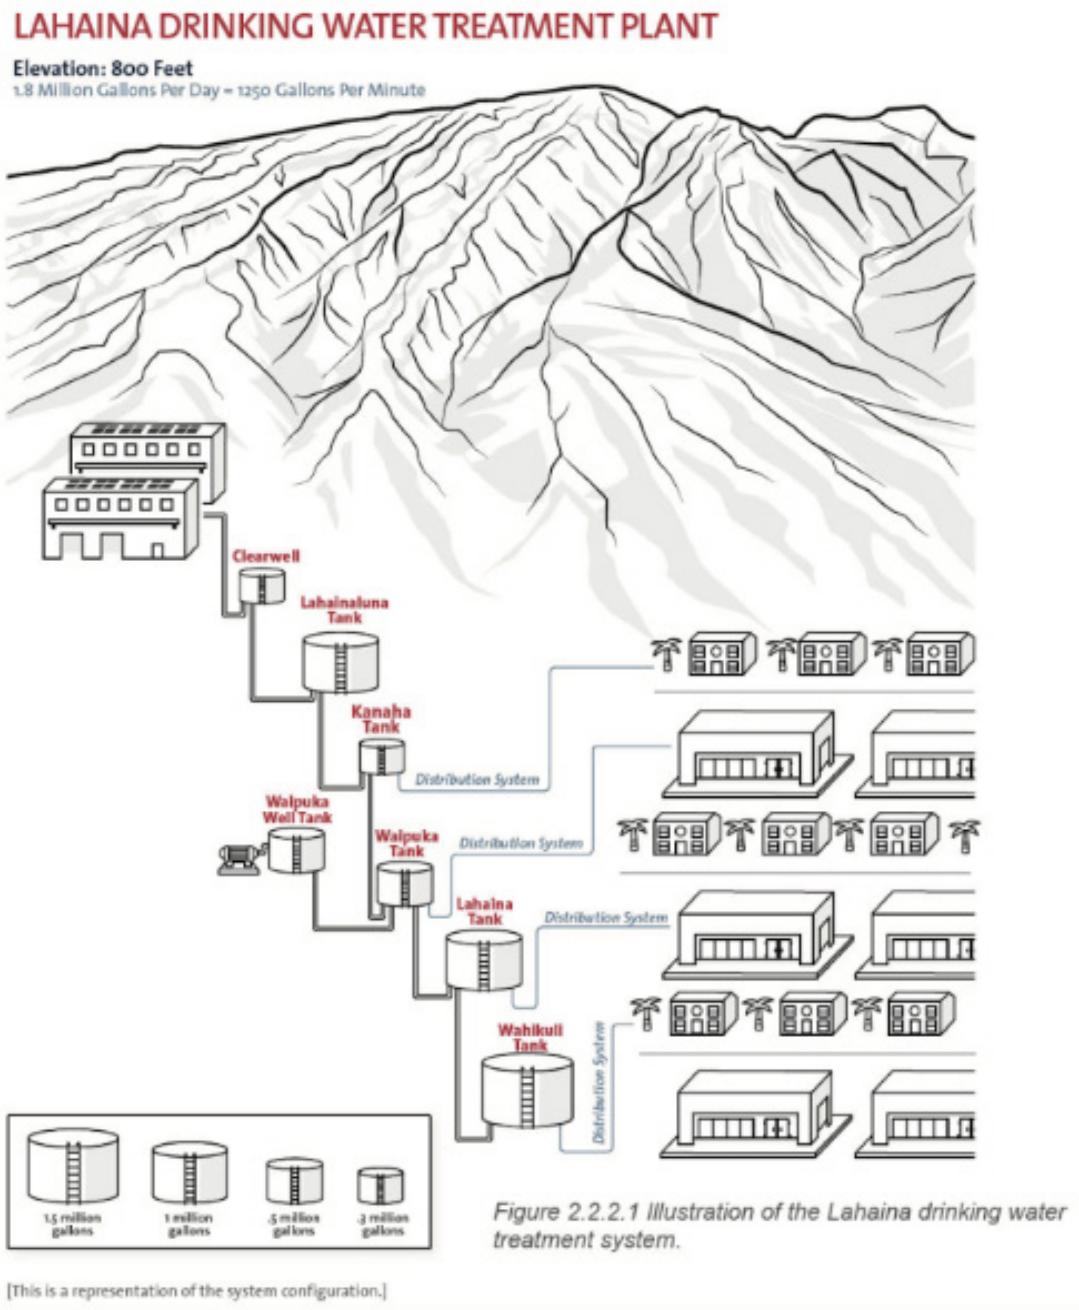
The last tank in the south system to be filled is the 1.5 MG Wahikuli Tank (TK102) which is located to the north of the other tanks in the storage and distribution system. Again, all storage tanks within the distribution system are filled by gravity and distribution system pressures are the result of elevation change within the system and water level in the storage tanks.

Figure 6.8.1 Lahaina drinking water treatment system.

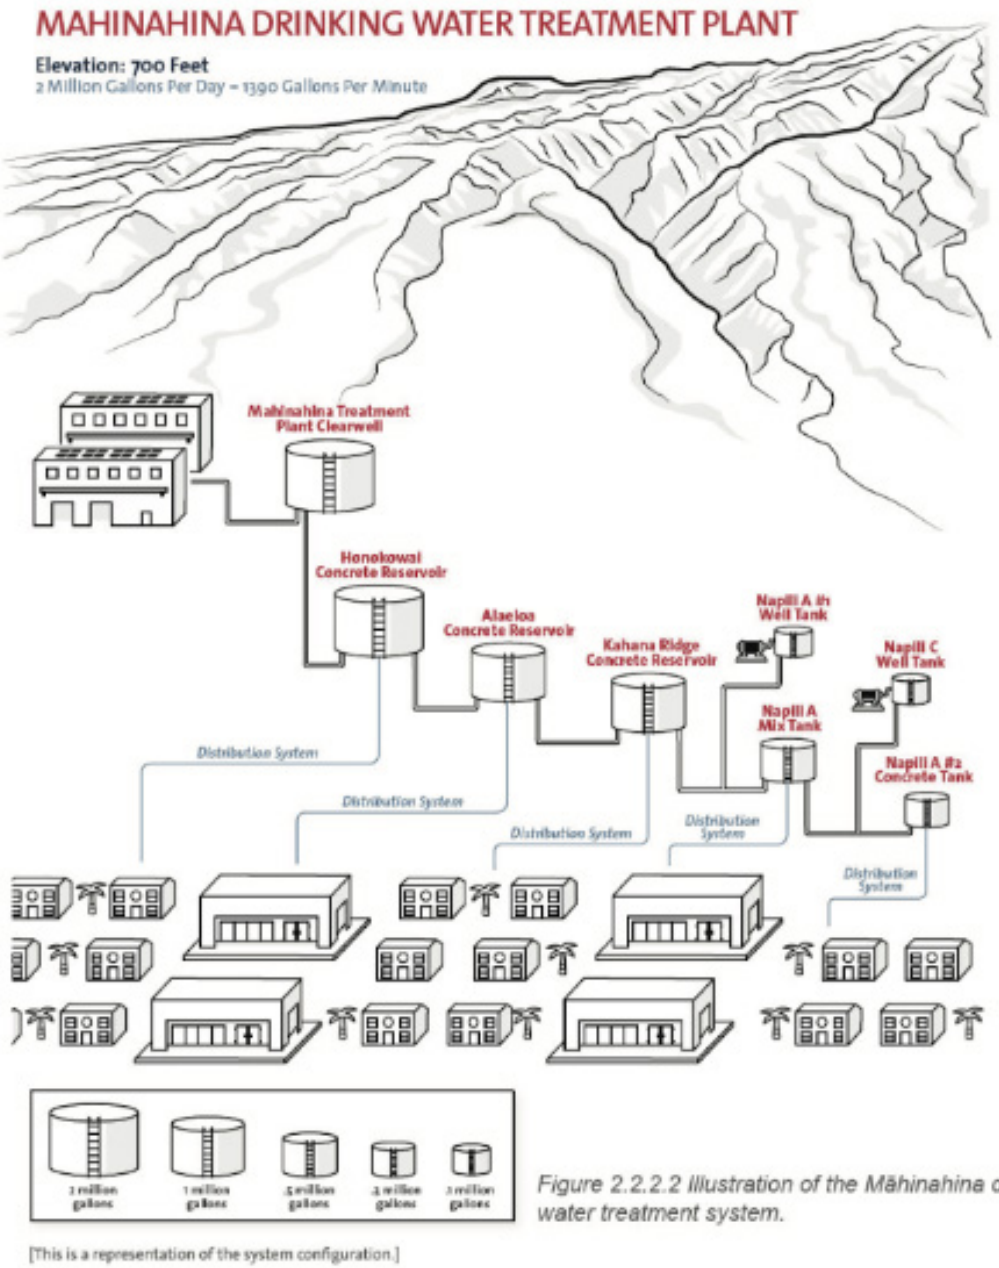
The Māhinahina system to the north and the Lahaina system to the south in West County of Maui are connected using water main(s) with a maximum diameter of 16-inches located along Lower Honoapiʻilani Road and Hawaiʻi Route 30 (Hwy-30). Again, pressure generated in the drinking water distribution system is a result of elevation change and water tank/reservoir levels. Pumps are not used to provide pressure within either the Lahaina or Māhinahina drinking water distribution systems.

Figure 6.8.2 Māhinahina drinking water treatment system
