Rapid Lesson Sharing

Event Type: Skidgine Rollover

Date: August 7, 2020

Location: Neals Hill Fire, Burns Interagency
Fire Zone, Burns District, BLM
Oregon

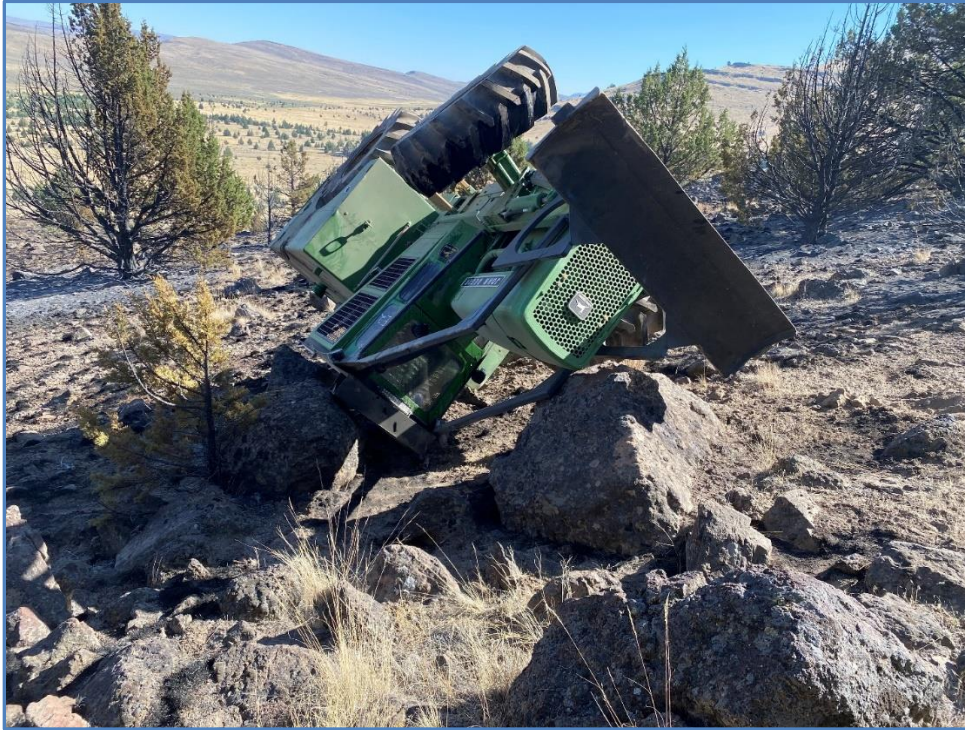
Skidgine Rolls from Three to Five Times

The REM completed a patient assessment. It was determined that the operator sustained no injuries and was released from the incident. Damages to the skidgine were minor, mostly cosmetic—not structural or mechanical.

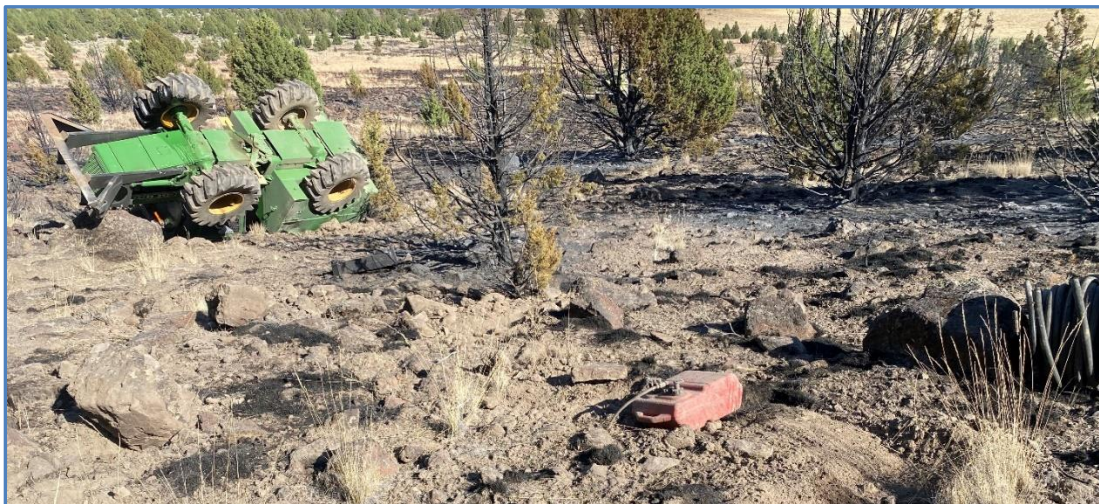
As he made the turn and headed downhill, the Skidgine A operator felt the machine shift sideways as his rear right tire rolled off a half-buried two-foot boulder that rolled to the surface. Slopes were estimated at approximately 20 percent.

Observations from NW Team 9 Safety Officer: *"Upon my initial review of the scene, the skidgine was not operating on excessive slopes or overly rugged terrain. There was no glaring cause evident other than the shifting rock under the rear passenger tire. Additionally, the operator was wearing his seat belt and the roll cage performed as designed, which led to the positive outcome of no injuries."*

- ❖ You may be operating within the slope capabilities of the equipment. However, big, loose rocks change the slope percentage each time you go over one, making the slope much steeper within a two-foot area.

- ❖ Heavy Equipment Bosses should be assigned to work with heavy equipment. While the lack of supervision did not contribute to this incident, it may have allowed for a spotter on the ground to help identify hazards.
