**Bald Mountain Wildland Fire  
Firefighter Injury and Engine Burnover Incidents  
Lessons Learned Review**

**July 11, 2019**

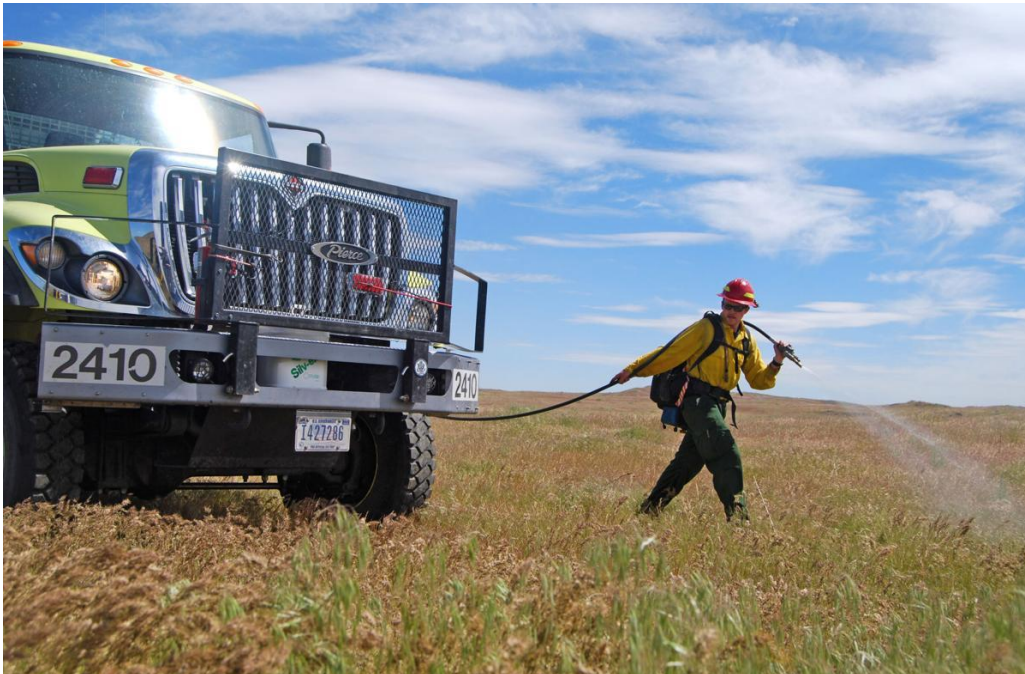
**Representative photo of mobile attack using an engine. Photo is not from this incident and is provided for reference purposes only.**
