**Peer Review Report
of
Balls Canyon Near-Miss
June 27th, 2006
Humboldt-Toiyabe National Forest**

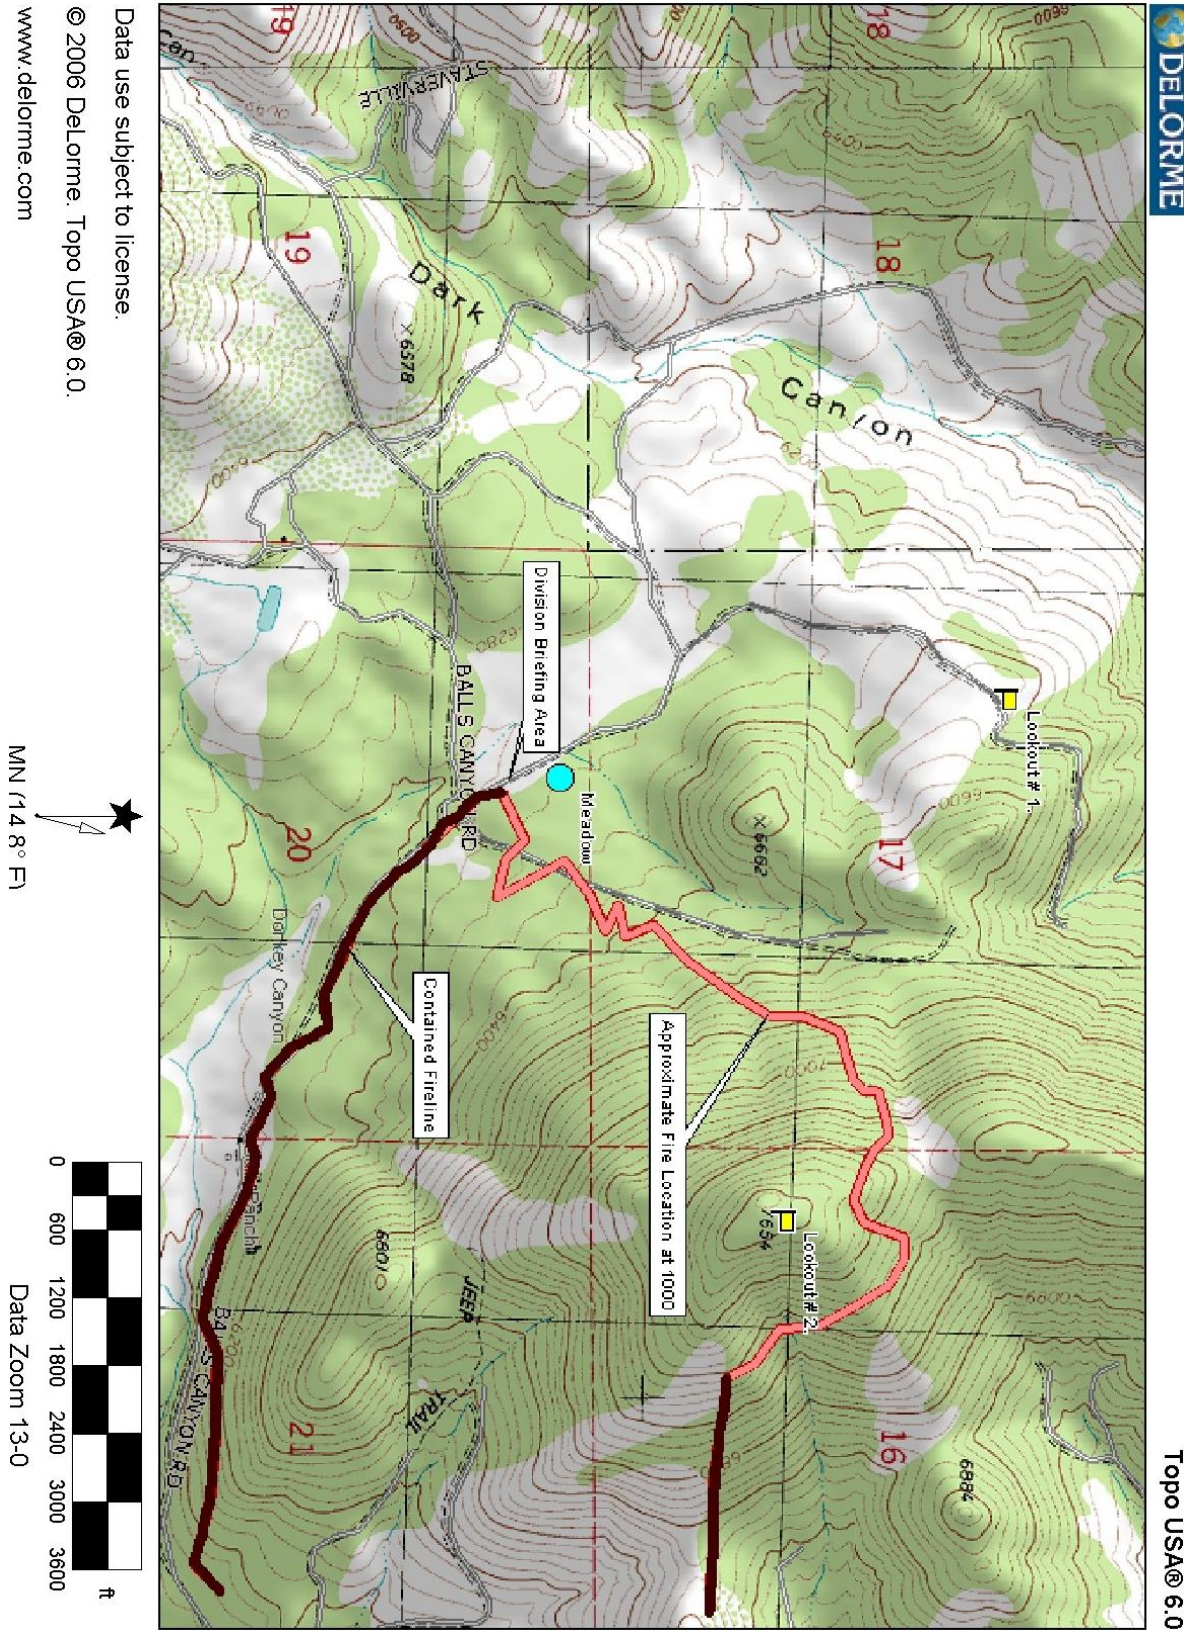
On June 27, following the morning briefing at ICP, Division A Supervisor (DIVS) met with his resources at the meadow near the Southwest corner of Division A at about 1000. {SEE MAP 1.} Division A resources consisted of two CDF strike teams of five Type-3 engines, two CDF strike teams of two Type 1 (inmate) hand crews and a field observer. Two dozers arrived on the division shortly after 1000. DIVS and the field observer had witnessed the previous day's fire activity but this was the first shift on the fire for all of the strike teams. DIVS has a trainee Division Supervisor with him throughout the day.
