ACCIDENT INVESTIGATION

Tractor Accident Resulting in Injury to Service Personnel and Damage to Government Property

Blackwater National Wildlife Refuge

September 16, 2014

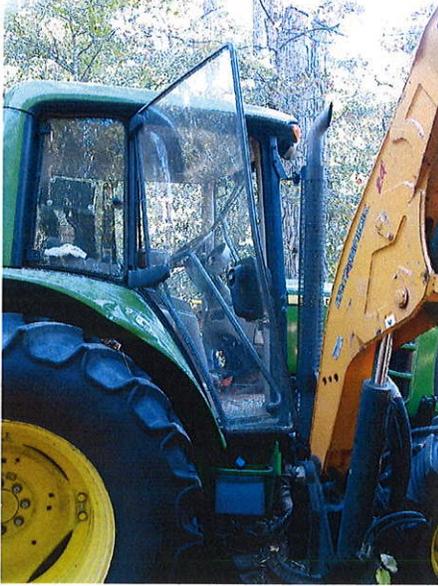
CASE NO: Accident Report – Blackwater NWR
PICTURE: 1-11
DATE: 09-22-2014
LOCATION: JD tract of Unit D at Blackwater National Wildlife Refuge, Dorchester County, Cambridge, Maryland
DEPICTING: Tractor Damage
PHOTOGRAPHER: Zone Officer Mark McGee
DIRECTION FACING: N/A
CAMERA: Bushnell 3.2 megapixel

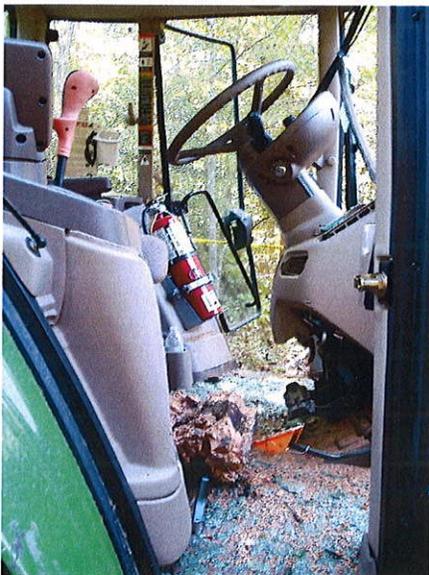
CASE NO: Accident Report – Blackwater NWR
PICTURE: 1-12
DATE: 09-22-2014
LOCATION: JD tract of Unit D at Blackwater National Wildlife Refuge, Dorchester County, Cambridge, Maryland
DEPICTING: Tractor Damage
PHOTOGRAPHER: Zone Officer Mark McGee
DIRECTION FACING: N/A
CAMERA: Bushnell 3.2 megapixel

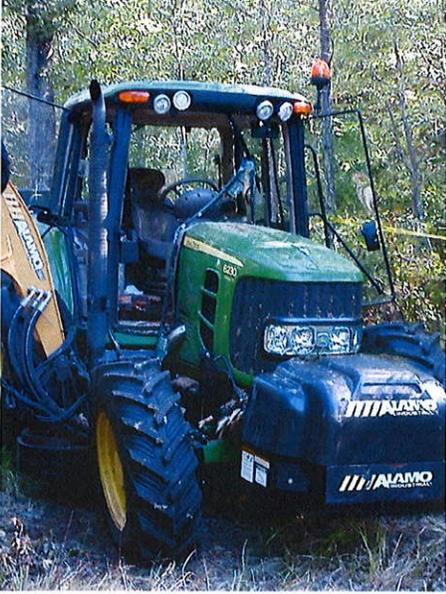
CASE NO: Accident Report – Blackwater NWR
PICTURE: 1-15
DATE: 09-22-2014
LOCATION: JD tract of Unit D at Blackwater National Wildlife Refuge, Dorchester County, Cambridge, Maryland
DEPICTING: Tractor Damage
PHOTOGRAPHER: Zone Officer Mark McGee
DIRECTION FACING: N/A
CAMERA: Bushnell 3.2 megapixel

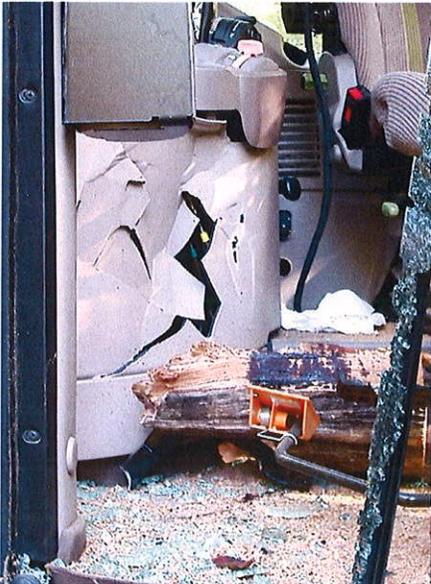
CASE NO: Accident Report – Blackwater NWR
PICTURE: 1-16
DATE: 09-22-2014
LOCATION: JD tract of Unit D at Blackwater National Wildlife Refuge, Dorchester County, Cambridge, Maryland
DEPICTING: Tractor Damage
PHOTOGRAPHER: Zone Officer Mark McGee
DIRECTION FACING: N/A
CAMERA: Bushnell 3.2 megapixel
