# **Bowles Creek Bottom Fire**

## **Lessons Learned Review**

**Texas Forest Service**  
**August 18, 2011**

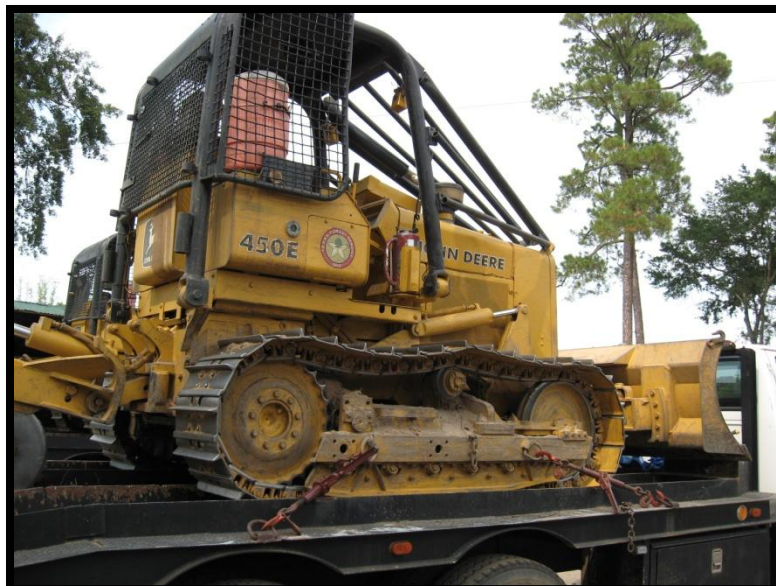
*The Texas Forest Service Type 5 Tractor Plow that worked on the north flank of the Bowles Creek Bottom Fire. Note the plow attachment on the rear of the tractor.*  
[Click here for a video of a tractor plow in action](#)

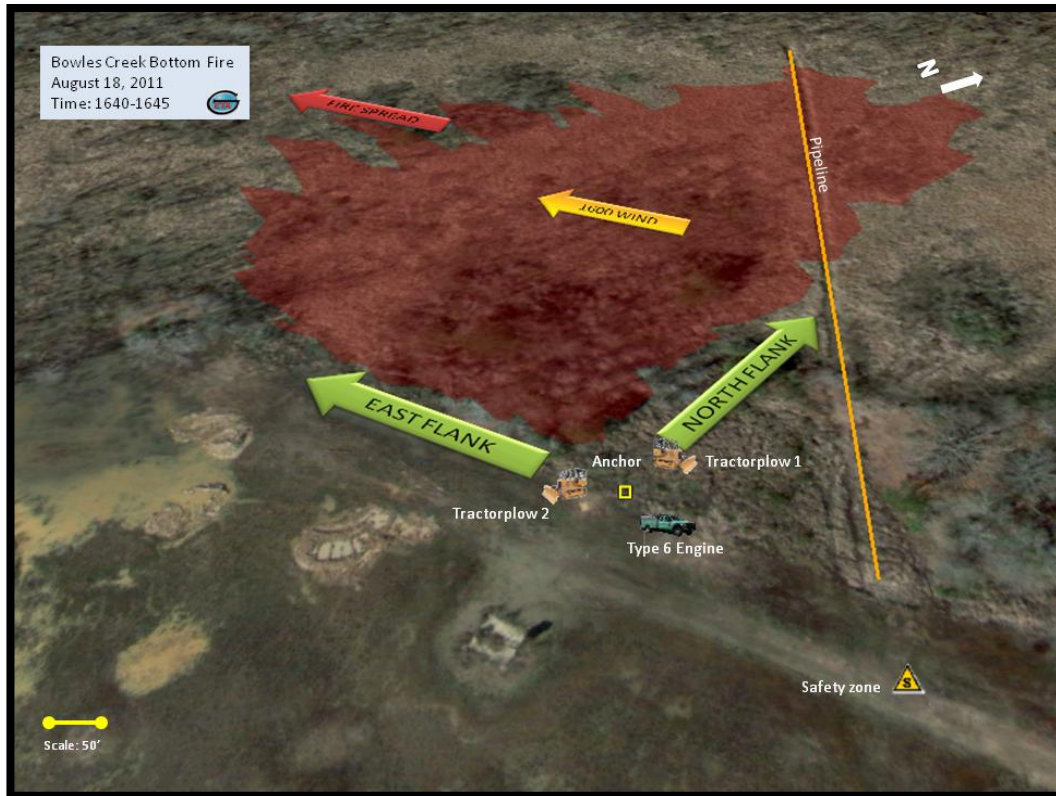
*The Bowles Creek Bottom Fire, estimated at 10-15 acres in size upon arrival of Initial Attack Resources. Initial suppression action on this fire was a classic “anchor and flank” method of attack.*

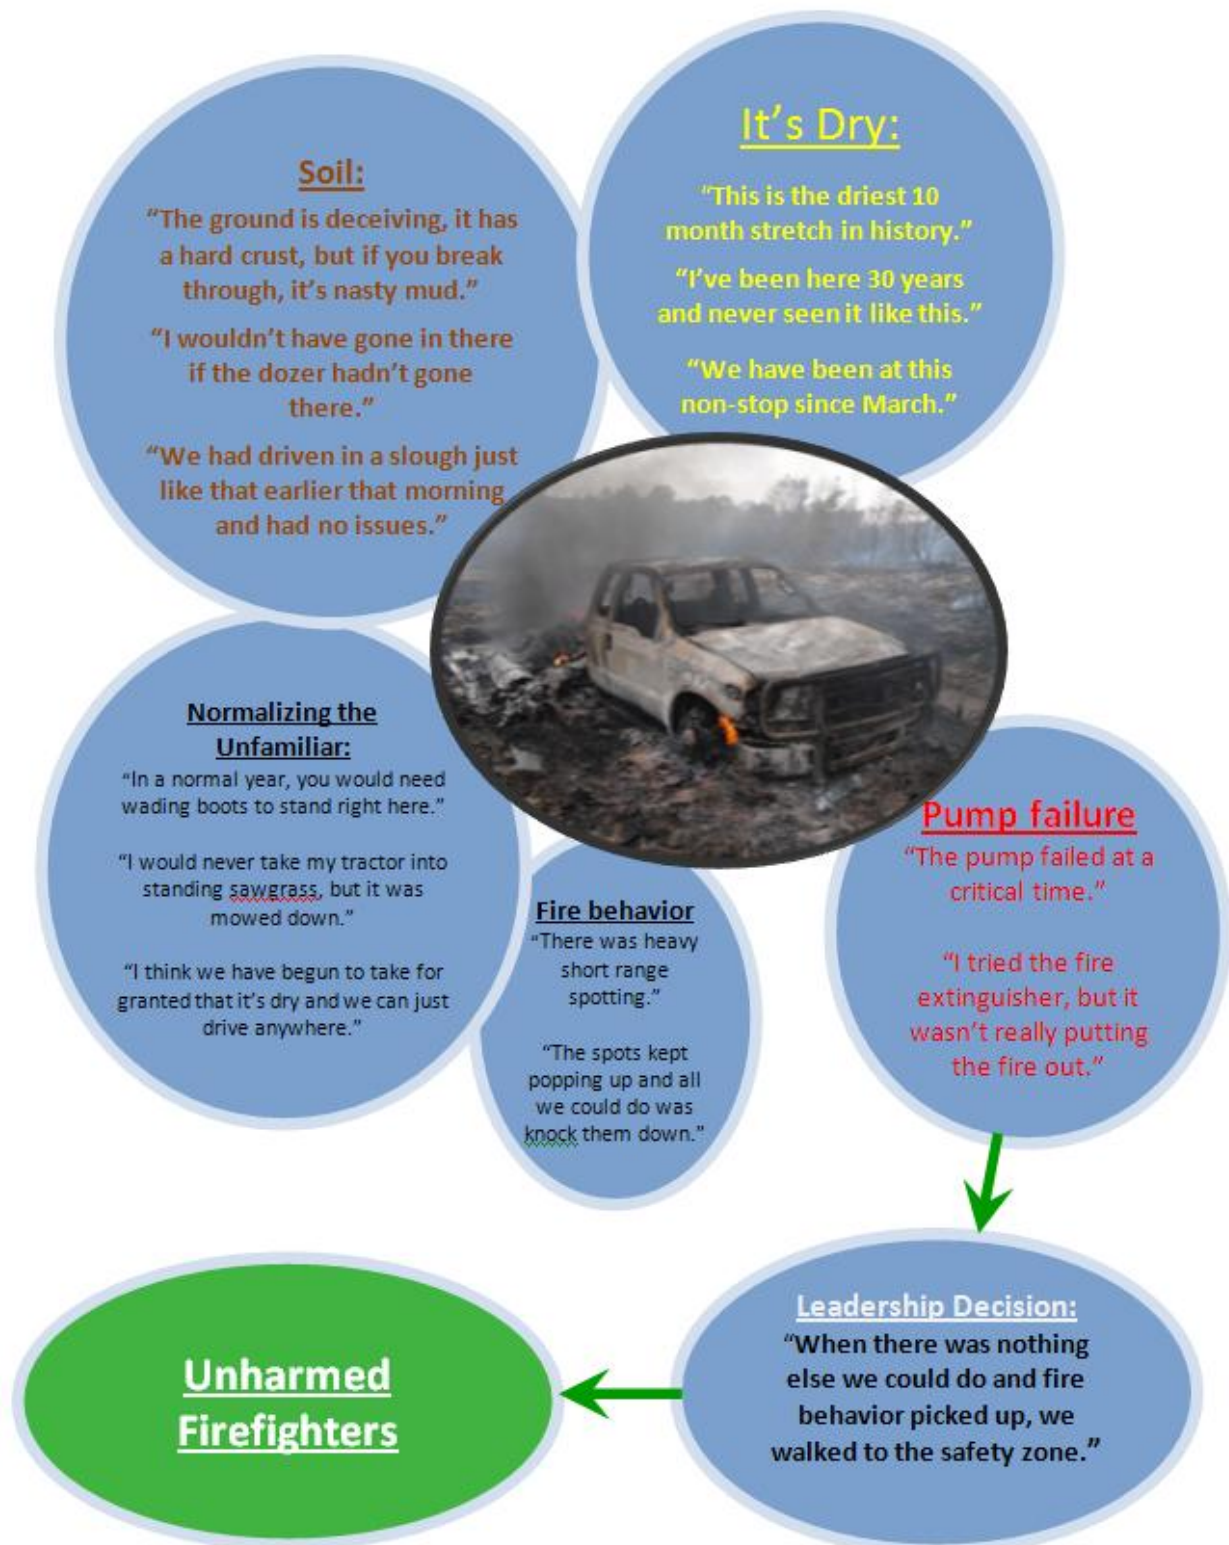
*Diagram which shows the inter-related nature of the conditions, represented in the words of firefighters, that led up to the Type 6 Engine burning on the Bowles Creek Bottom Fire.*
