BRUSH 18

FACILITATED LEARNING ANALYSIS

Bridger-Teton National Forest • September 2012

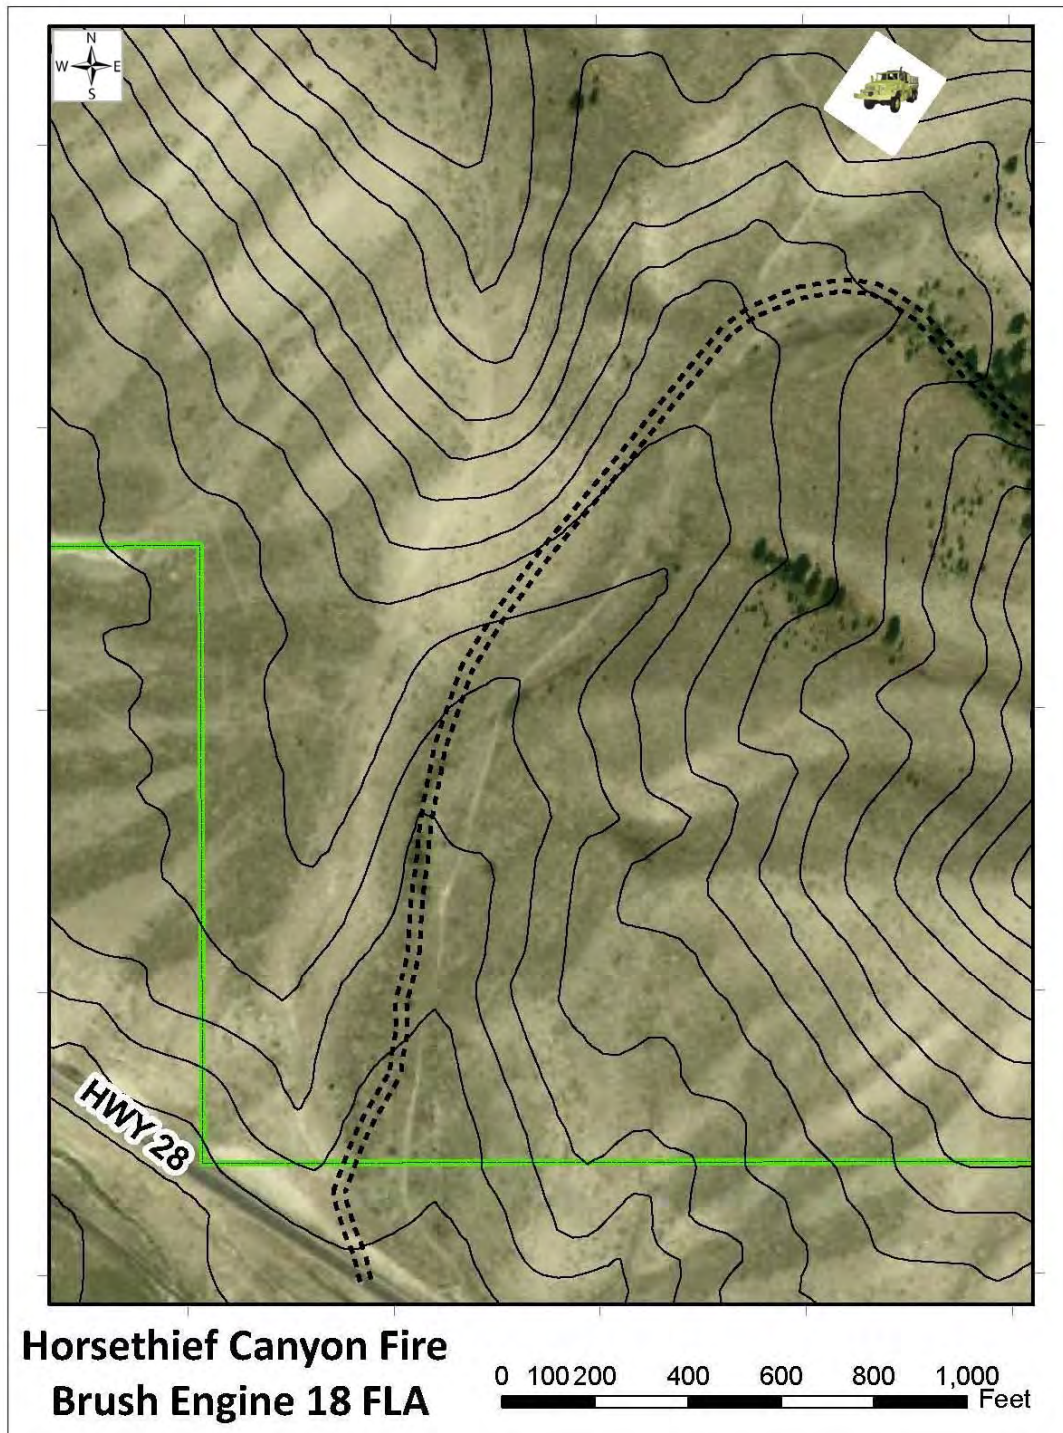
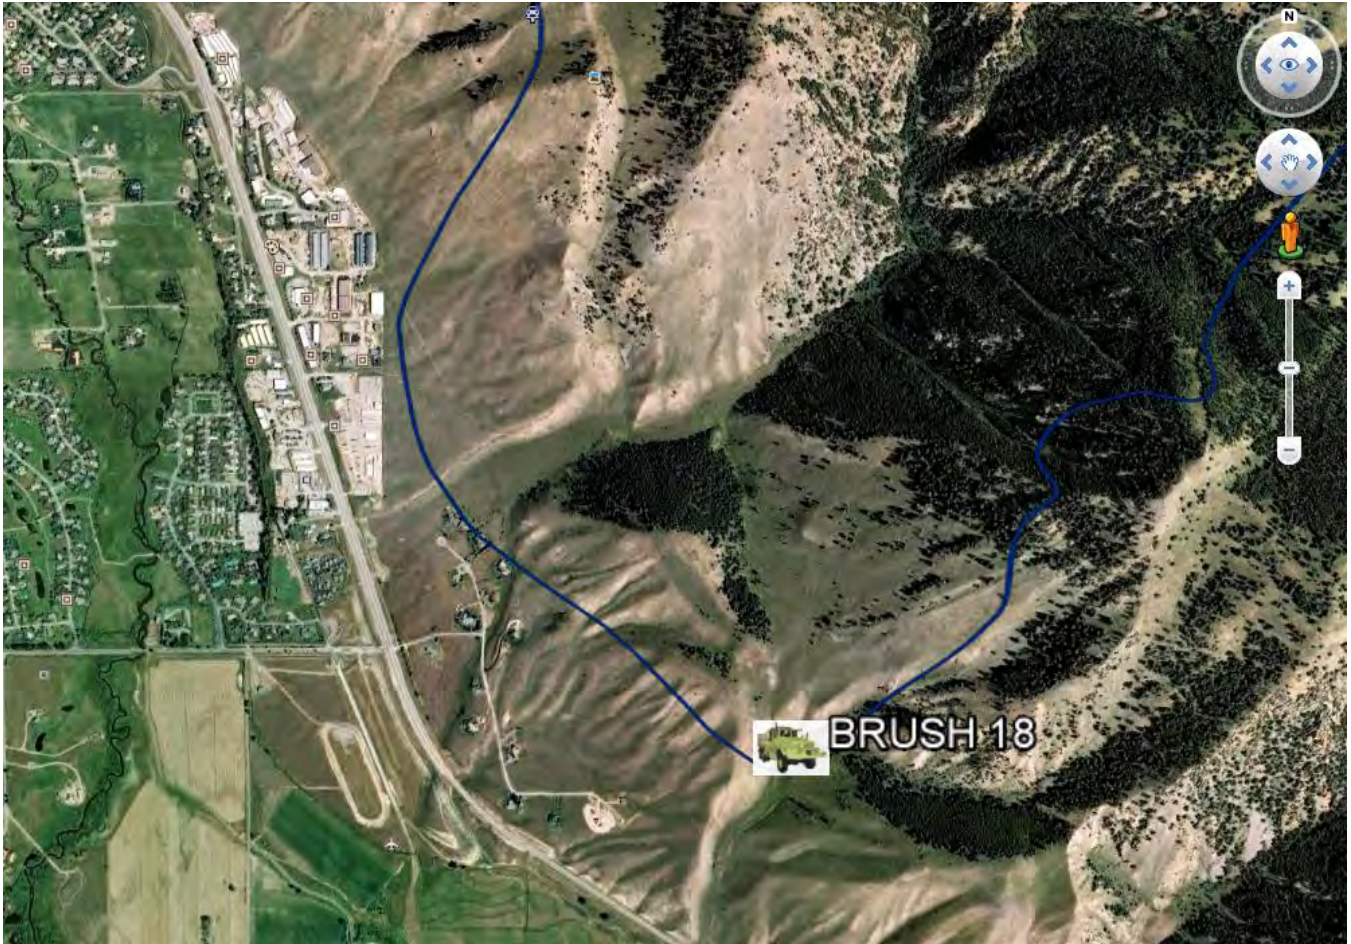
The image above is a Google Earth depiction of the heel of the fire. It is oriented so that the top of the page points north. The blue line is the fire perimeter. The image labeled as Brush 18 shows the location of the incident. Brush 18 initially started working near the structures northwest of the incident site. As the day went on, Brush 18 moved along the perimeter to the southeast. Their last assignment took them well away from the houses, and farther into the wildland.
