Accident Investigation Final Report

Committee Drive Fire Burnover

Brunswick County

October 7, 2008

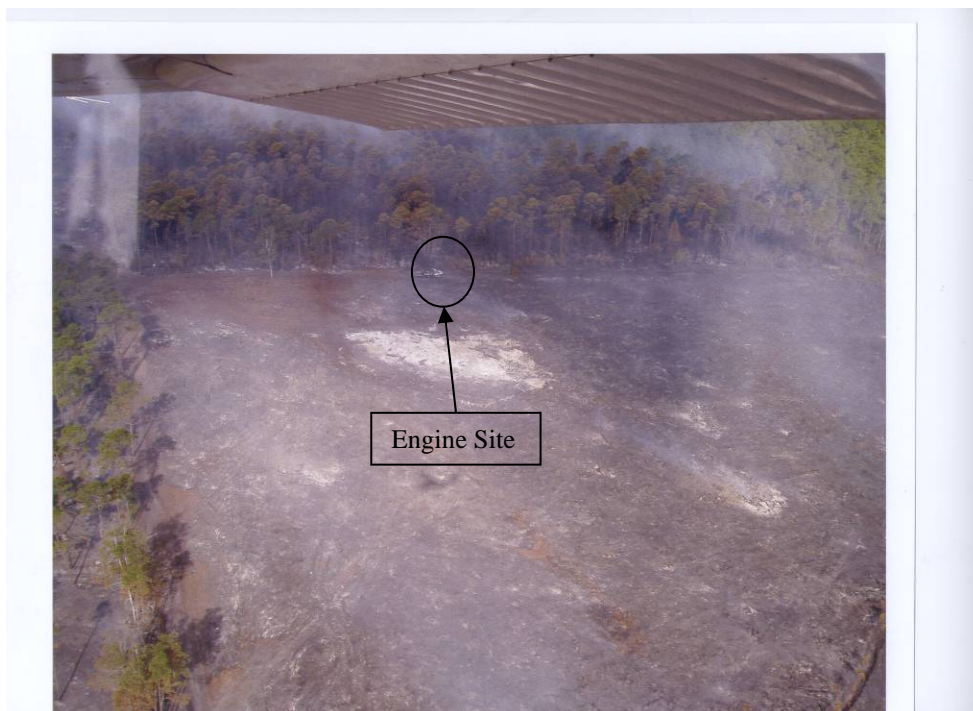
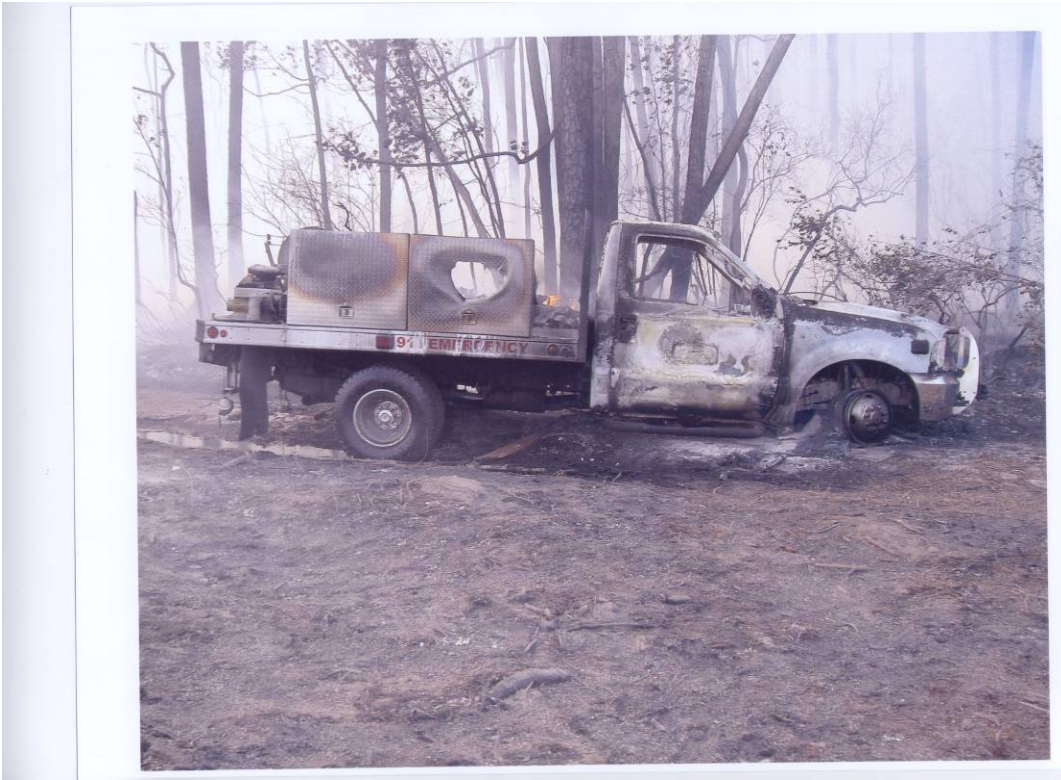
1. Site of engine turnover
2. Tower site
3. Near the point of origin
4. Road adjacent to tower where mutual aid resources responded
