Event Type: Electrical Hazard, ICP Trailer

Date: August 23, 2018

Location: Davis Fire, Kootenai National Forest, Montana

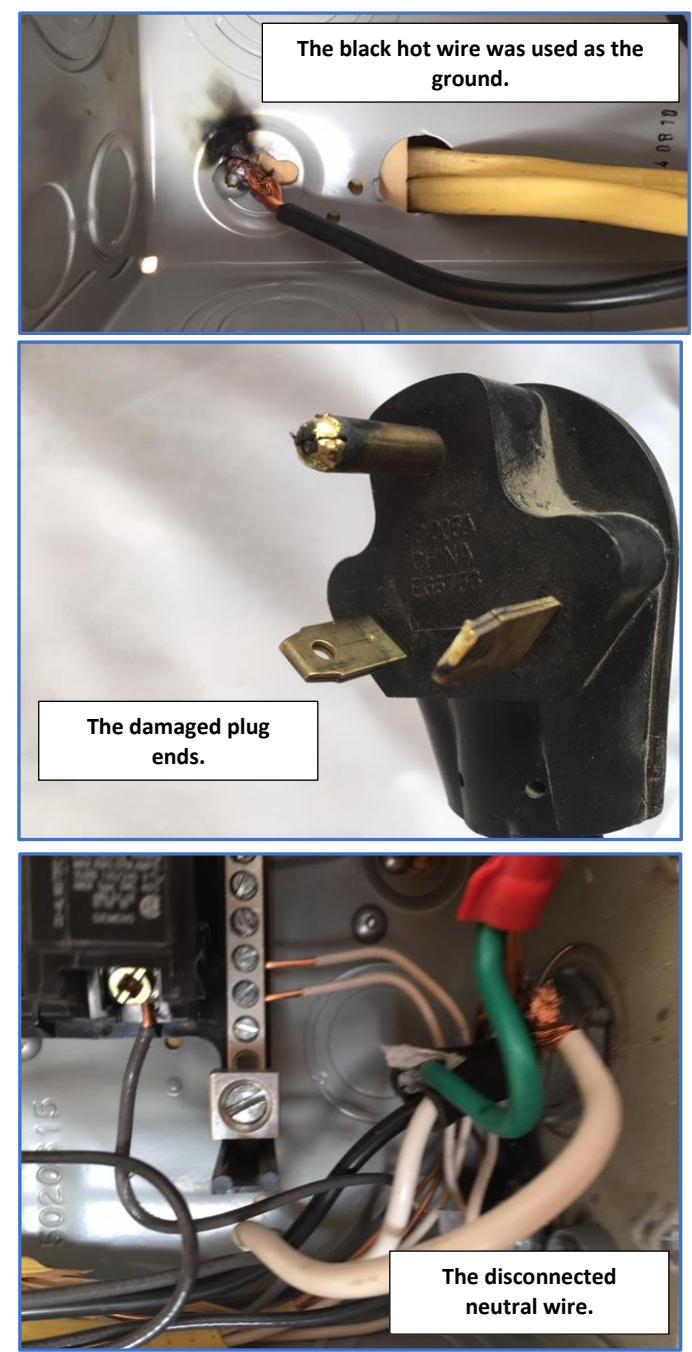
The Base Camp Manager for the Davis Fire was plugging in power to the Information Technology trailer for the Incident Management Team when the electrical panel arced and scorched the fuse panel. This also caused a fusing of the ground on the three-pronged 120-volt adapter.

After a certified electrician evaluated the fuse panel, he determined that the hot wire was grounded directly to the panel mounting screw and the neutral wire was not connected. The panel wiring allowed the metal of the trailer to be energized—causing an electrical shock hazard.

After further investigation, it was determined that when this trailer was on the previous Rattlesnake Creek Fire it was directly wired to the service drop panel. When the trailer was demobed from the Rattlesnake Creek Fire, it was determined that the wiring to the service drop panel was disconnected and someone attempted to rewire the fuse panel on the trailer incorrectly.

1. A certified electrician should handle all wiring needs.

2. Lock Out/Tag Out any primary electrical wiring.
