Accident Investigation: Factual Report

Pine Fire Dozer Entrapment

Descanso Ranger District
Cleveland National Forest
Pacific Southwest Region

Wednesday, September 12, 2007

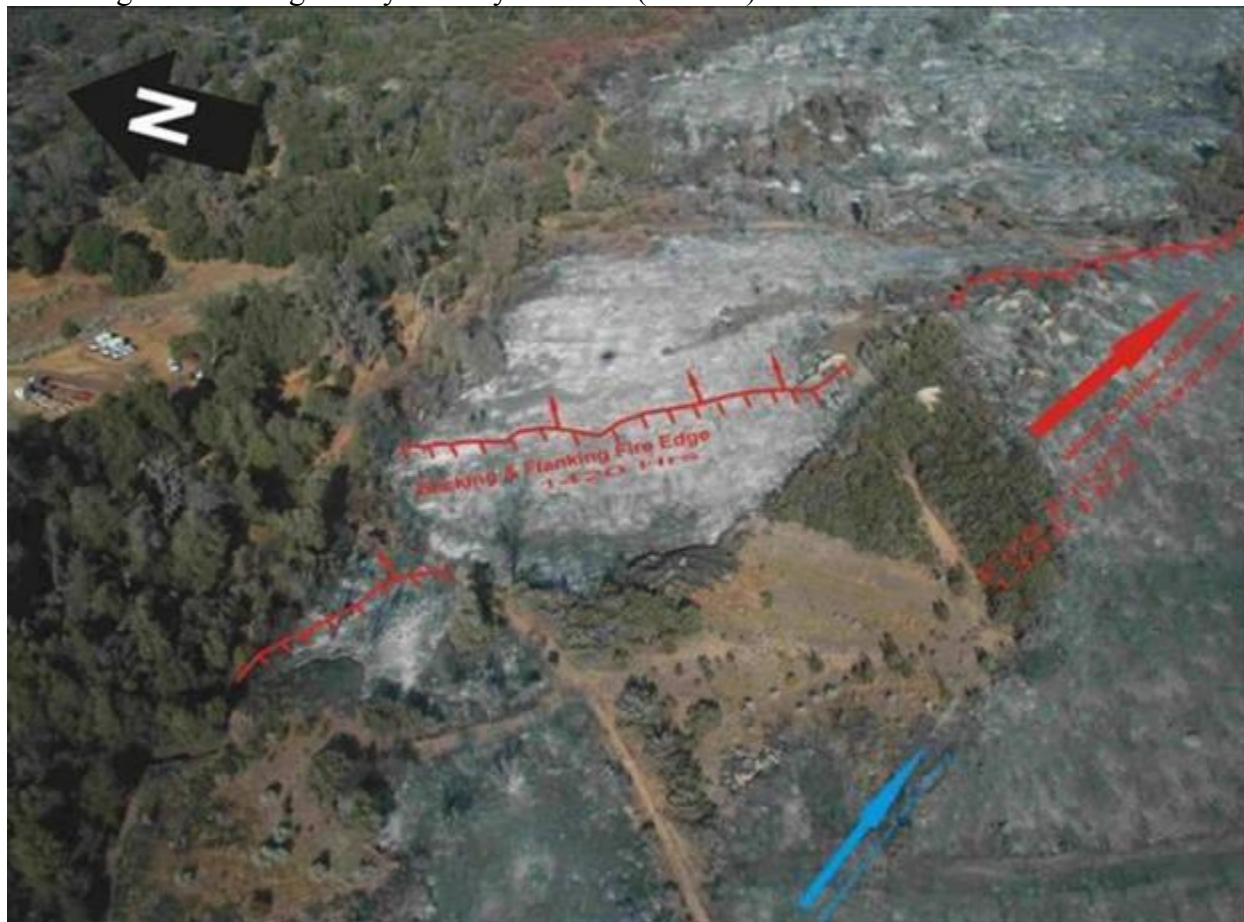
Photo 4

Above the accident site the fire crested the rocky knob and clear cut area which became the left flank. Topographic wind sheltering was encountered in the Oak Valley Creek and Corte Madera Road area as well as the entrapment area (left flank) from the prevailing westerly wind component. The fire now precluding the entrapment was backing and flanking down the West Northwest flank West of the entrapment site. The main fire front was well to the Southeast extending toward Long Valley Peak by 1345hrs. (Photo 4)
