**USDA Forest Service  
Rocky Mountain Region**

San Juan Public Lands, Columbine Ranger District

# **Jones Creek ATV Rollover Facilitative Learning Analysis**

August 16th, 2011

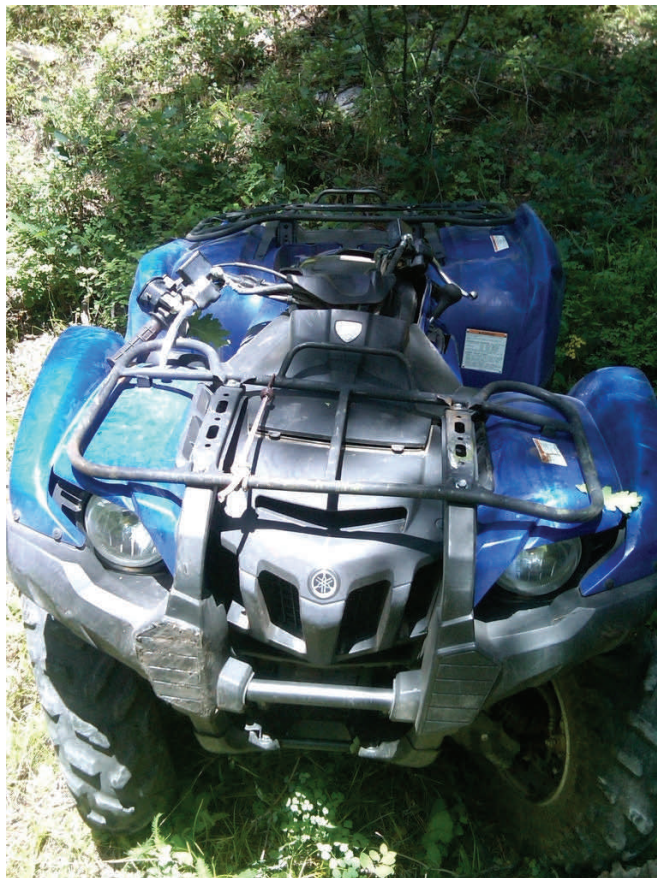
**"Even though the ATV is a total loss the outcome of the incident is a positive one due to the fact that no employees were injured"**

**Summary-**On Friday August 16, 2011 at approximately 1400 hours two persons were driving ATV's up the Jones Creek Trail North East of Lower Hermosa Camp Ground. They began driving through a narrow switchback along the trail when the first ATV's right front tire nudged a rock on the right side of the trail causing the ATV to slide to the left of the trail and the edge to give way. The ATV then proceeded to roll down a steep drainage approximately 80 feet. The operator was able to jump off of the ATV as it began to roll. No individuals were injured in this incident.

- 1-**Review the Trail Management Objective (TMO) for a trail that has not been utilized for operating an ATV before – the trail must be wide enough for safe ATV operation
- 2-** It is not recommended to take an ATV on a motorcycle trail.
- 3-**Operators should always know the width of the ATV they are operating.
- 4-**During planning and preparation of field work – reviewing RMA- consider and discuss the worst case scenario. An open discussion/conversation of site specific hazards can further identify potential risks.
- 5-**Evaluate terrain/trail for conditions that influence how you may have to operate the ATV.
- 6-**Not recommended to ride with wheels on uphill slope – putting the ATV off balance
- 7-**Look for an alternate way to get the job done; continuously re-evaluate all hazards.
- 8-**Ensure Notification of Dispatch as soon as possible.
