MORTON INCIDENT SUMMARY SHEET

Informational Summary of San Bernardino County Fire Department
Near Miss Incident and Vehicle Accident

Morton Fire Incident
99 Incident-Vehicle Rollover

August 9, 2010
Morton Fire

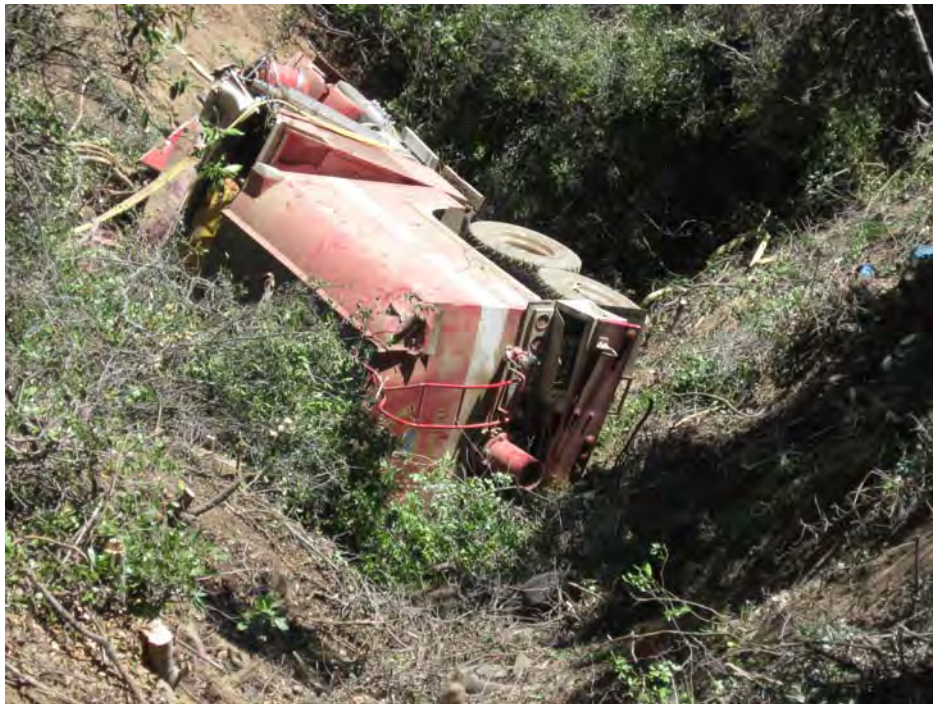
Water Tender 99 had completed one round trip water shuttle operation and was returning with its second load of water. At approximately 1612 hours the personnel from Water Tender 99 reported

Both Paid Call Firefighters sustained minor injuries and were transported to Arrowhead Regional Medical Center (ARMC) for evaluation. Both firefighter's were evaluated and released from ARMC. Water Tender 99 sustained substantial damage and has been removed from service.

- Need to stay focused on the roadway and conditions, and ensure that traffic controls are in effect to safely negotiate the roadway.
- Need to know vehicle limitations, as pertaining to size, weight, turning radius and visibility from the driver's perspective.
- Need to have a through understanding of agencies Off Highway Driving Procedures and Protocols
- We all need to speak up if we notice someone having difficulties operating equipment.
