Facilitated Learning Analysis Runaway Fire Engine on the Mountain!

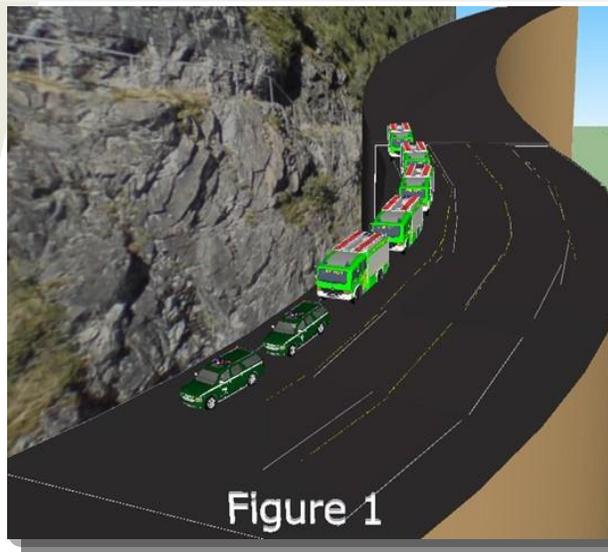
On August 5, 2013 at 1419 hours a strike team of engines was driving downhill on Hwy 168 after departing the Aspen incident on the Sierra National Forest. They were en route to the Power incident on the Stanislaus National Forest. The caravan of vehicles consisted of the Strike Team Leader (STEN) trainee and a firefighter driving a utility vehicle in the front, followed by a Ford Expedition driven by the STEN, and then five Type 3 engines (Figure 1). The lead engine was equipped with a manual transmission with two-speed differential, built in 1998 with 84,408 miles. Of the 272

Type 3 fire engines in service in Region 5, only 13% are manual split shift transmissions and of these, most are swing engines (used Intermittently while the primary engine is out of service).
