WHISKY FIRE ACCIDENT INVESTIGATION REPORT

ACCIDENT: PERSONAL INJURY - NON-FATAL

LOCATION: PACIFIC SOUTHWEST REGION
KLAMATH NATIONAL FOREST
SCOTT RIVER RANGER DISTRICT

DATE: OCTOBER 27, 1992

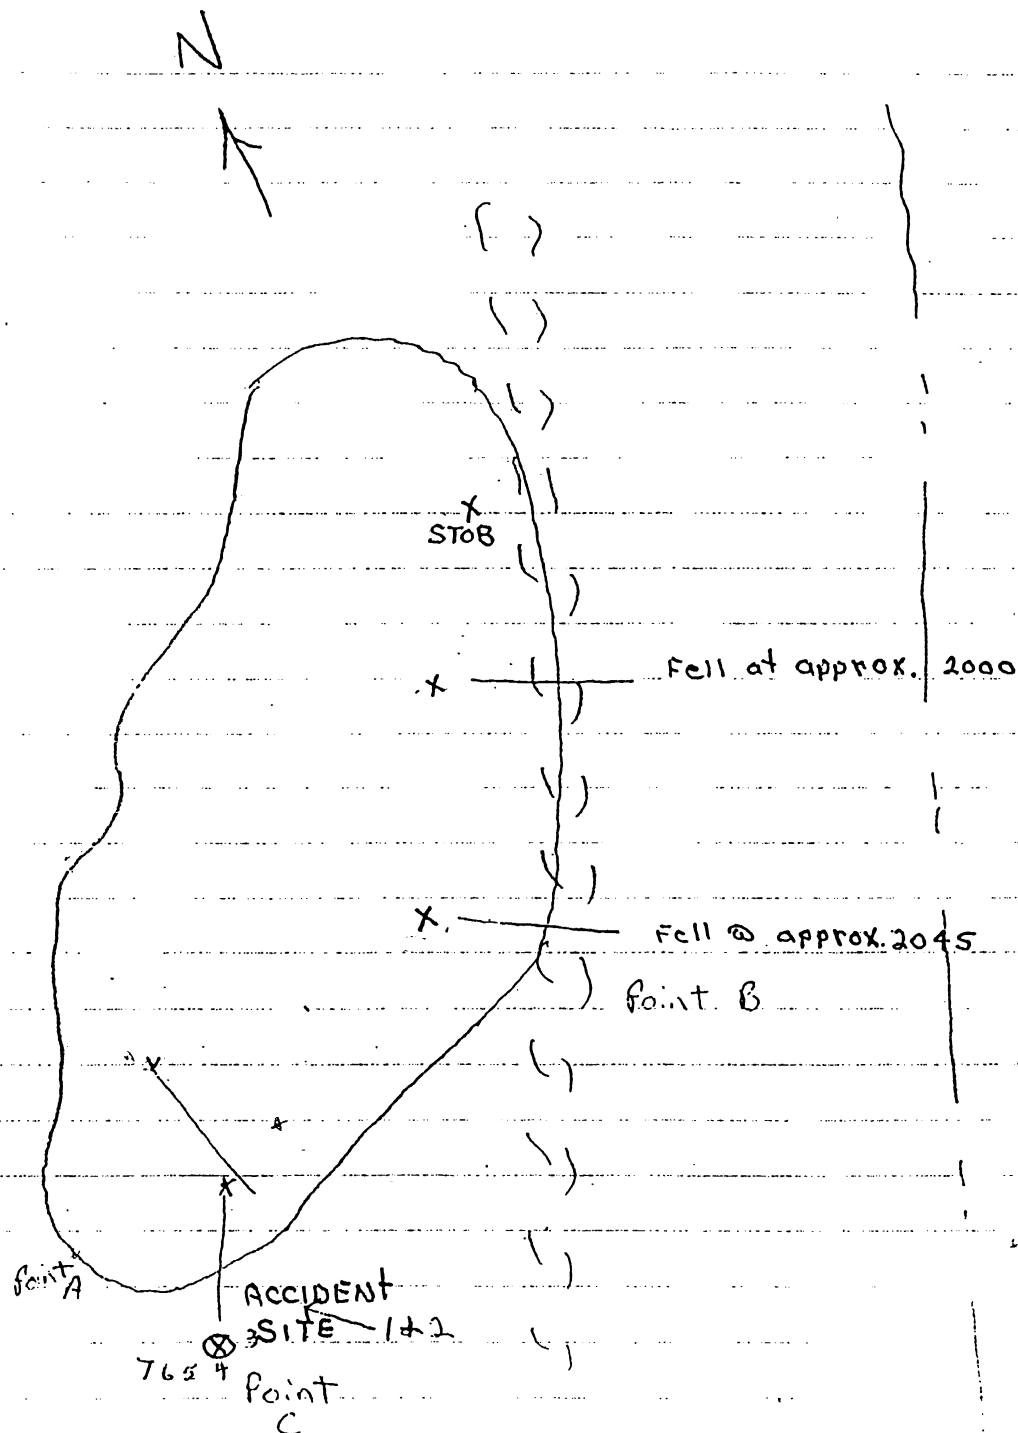
Raimer was not struck by a snag. He was struck by a portion of a green tree that was burning.

Raimer was traveling within the fall zone of the burning green tree that fell. This tree caused the accident.

THIS PHOTO DEPICTS THE SOUTHEASTERLY FALL PATH OF THE LARGE PONDEROSA PINE. NOTE THE SMALLER PONDEROSA PINE WITH IT'S TOP MISSING WITHIN THE TREE'S FALL PATH. THE MISSING TOP WAS SNAPPED OFF DURING THE TREE'S FALL AND ALSO STRUCK ADAM RAIMER.
