WITHERS FIRE ENGINE INCIDENT

Facilitated Learning Analysis

Paisley, Oregon

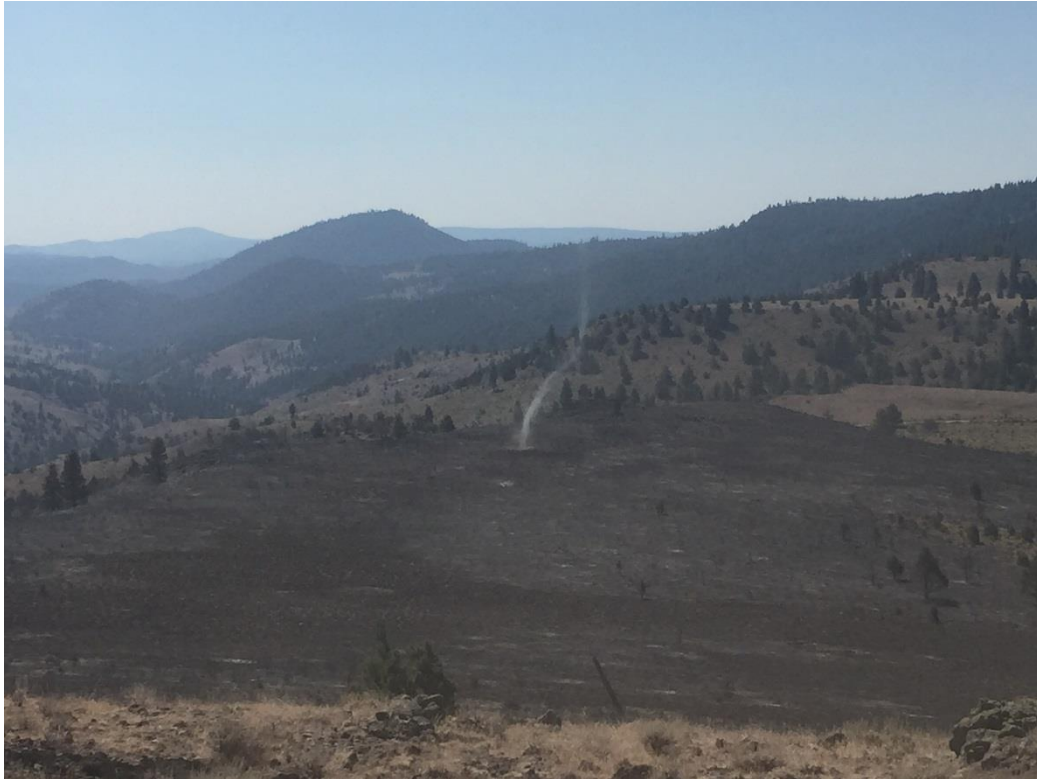
The participants were familiar with the terrain and the fuel type in the area, but weren't able to see the topography in the dark of night. Thus, they couldn't have been aware of how the topography was going to affect fire behavior in that area. In this instance, a comparatively wide and shallow saddle split by a small knob (see figure 4 on next page) served as a funnel which concentrated the winds into an eddy effect in the area where the engine was burned. This example serves as a reminder to maintain situational awareness, as even small features can have profound effects on fire behavior.

FIGURE 3: DUST DEVIL IN THE LOCATION OF THE SHALLOW SADDLE AND THE SMALL KNOB.
