Four Corners Fire

April 5 & 6, 2000

Entrapment Investigation Report

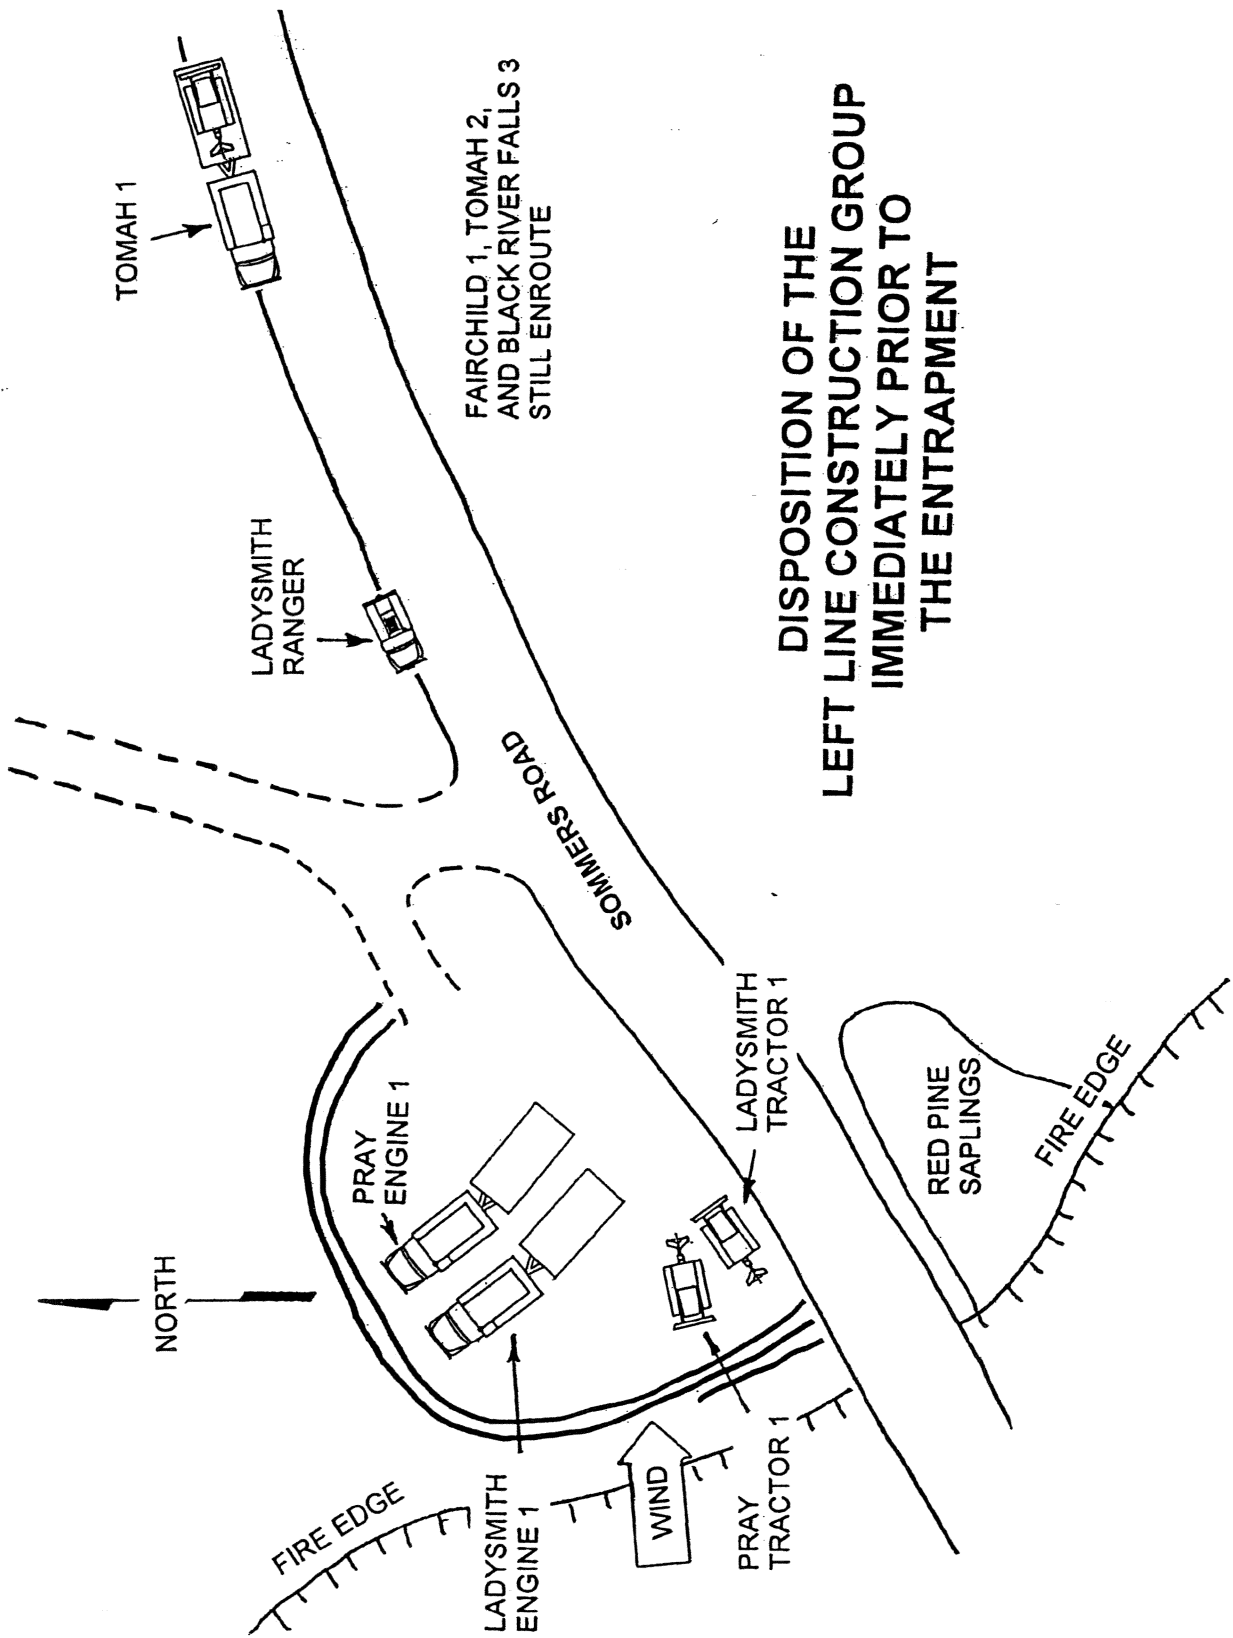
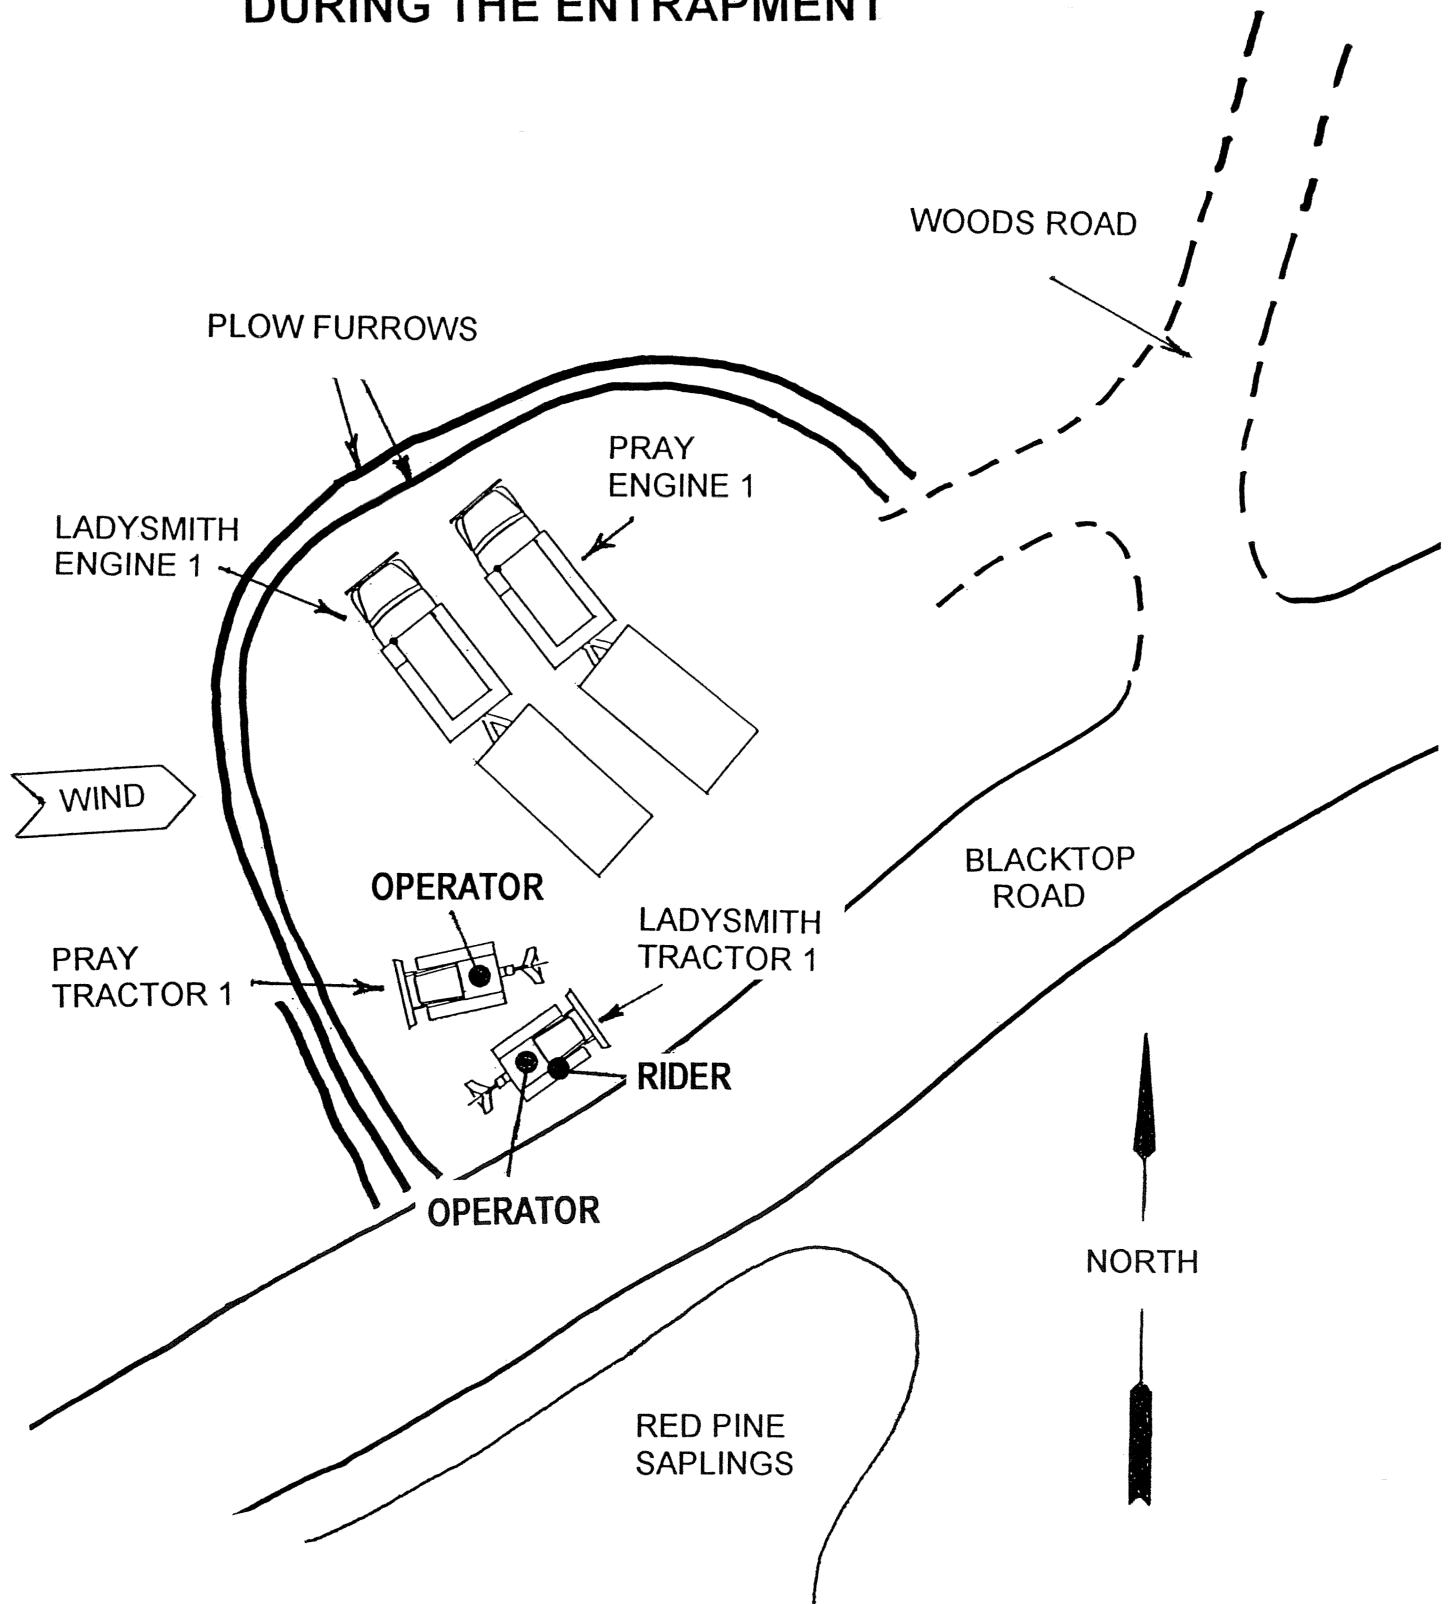
LOCATION OF PERSONNEL AND UNITS DURING THE ENTRAPMENT

In the confusion, three firefighters and two tractor-plow units positioned to begin fire line construction were entrapped and overrun by the fire. One fire shelter was used and no serious injuries or equipment damage occurred.
